VISTA R. E. INSPECTIONS

PROPERTY INSPECTION REPORT

Prepared For:	Mr. Maradiaga (Name of Client)	
Concerning:	0000 Leafy B. New City, Tx 77000 (Address or Other Identification of Inspected Property):	
By:	Felix Angel, 20185 (Name and License Number of Inspector)	00/002018 (Date)
	N/A (Name, License Number of Sponsoring Inspector)

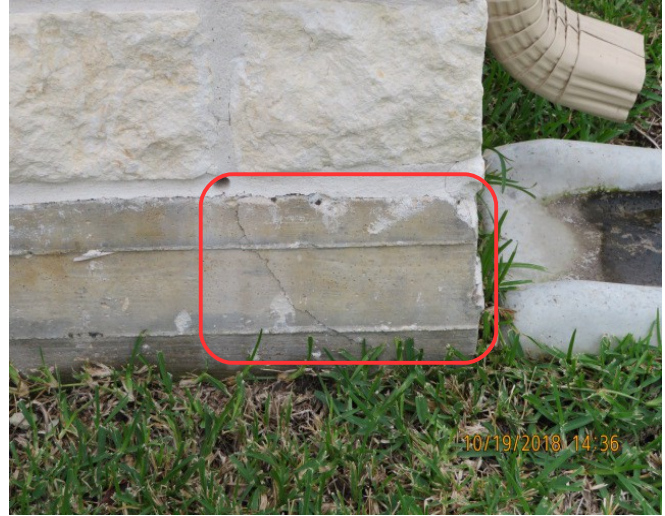
- Noted spalling on at least two corners.
Note: This usually is caused by thermal expansion of the brick wall and a typical tight connection connecting the brick and concrete surface. The brick will expand in the hot weather and will put forth a force adequate to shear the corner from the foundation. This is quite common and is not to be considered a structural defect. Recommend to properly seal gaps to avoid any further damage and deter the possible entrance of termite or other bugs

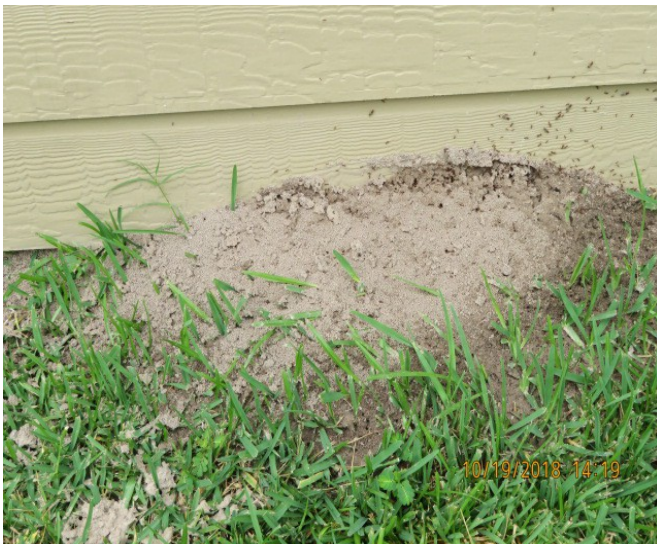
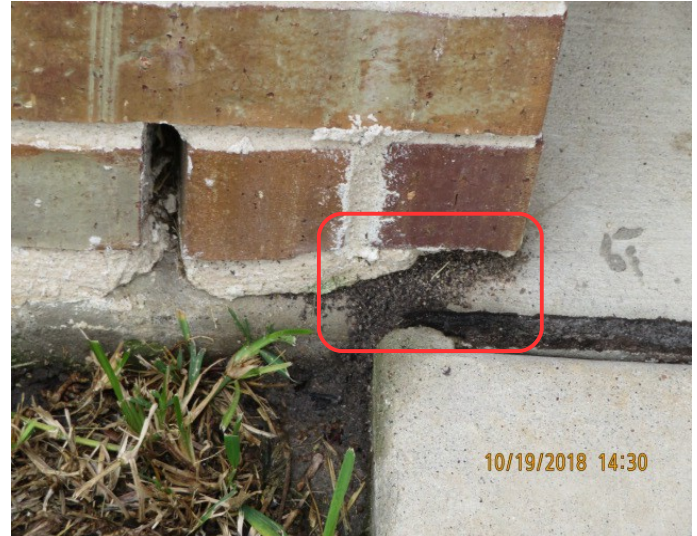
- Other: Noted ant/insect activity. Recommend to consult a pest control professional for treatment

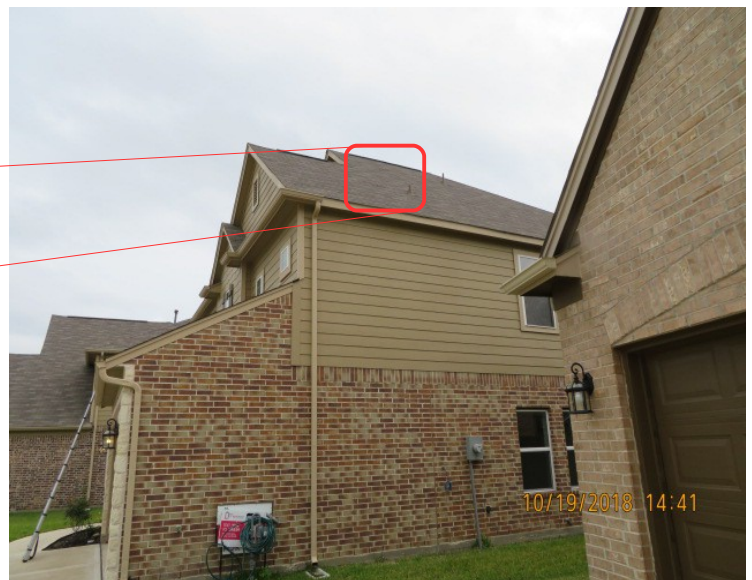
- Observed slightly lifting shingles on right roof plane. Properly repair to avoid further deterioration and possible water intrusion

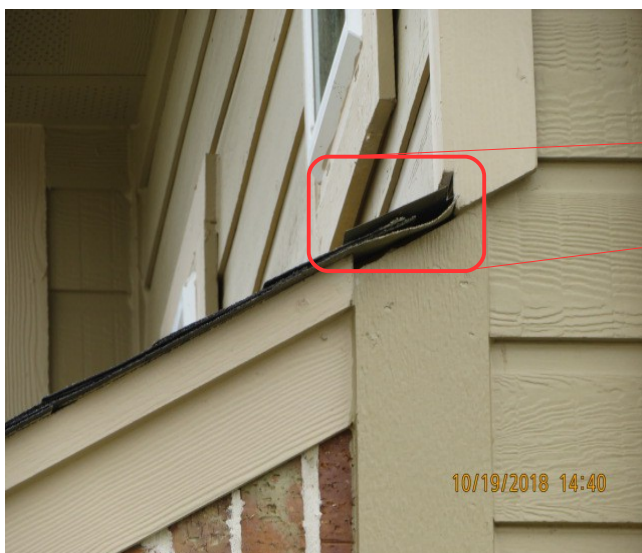
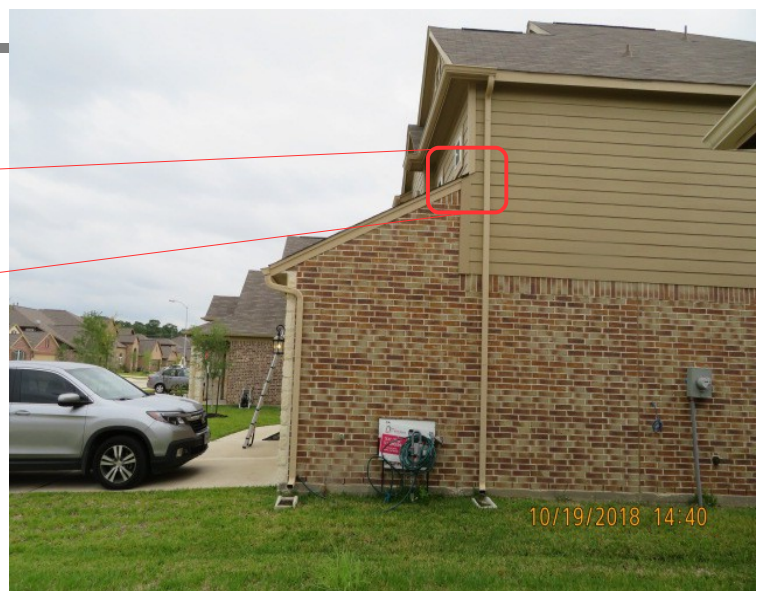
- Also spotted lifting flashing and short trim on right corner. Properly repair to prevent water intrusion

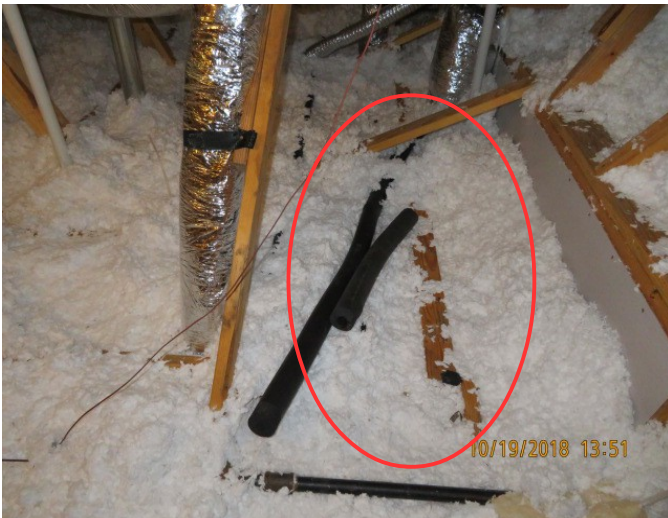
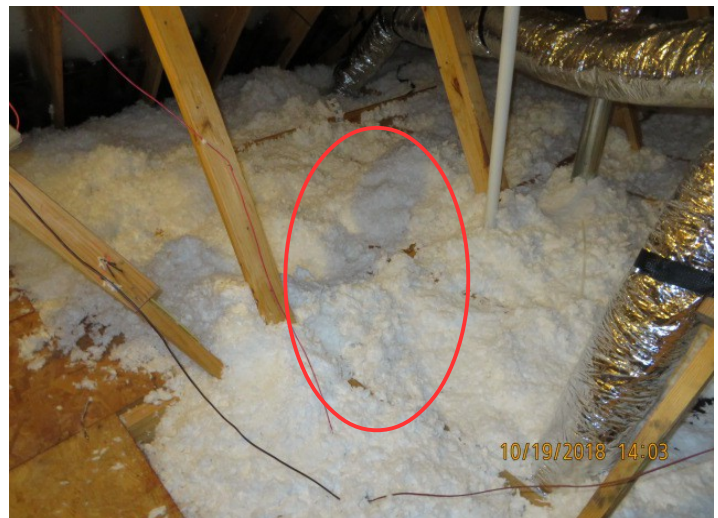
- Insulation is shallow at some locations. Proper amount should be added for insulating value

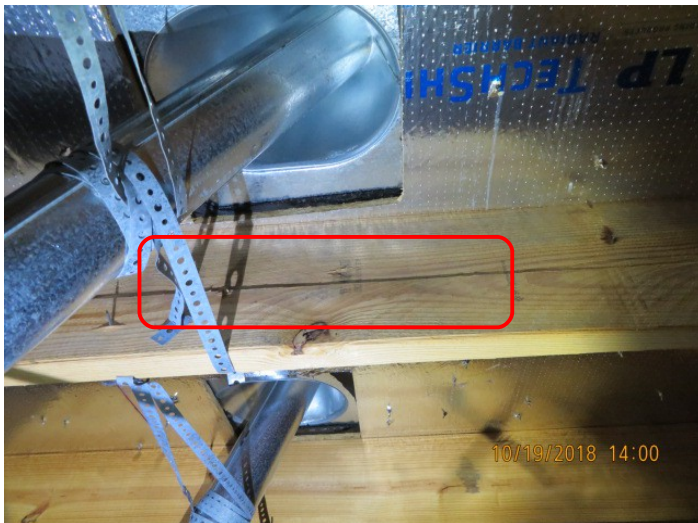
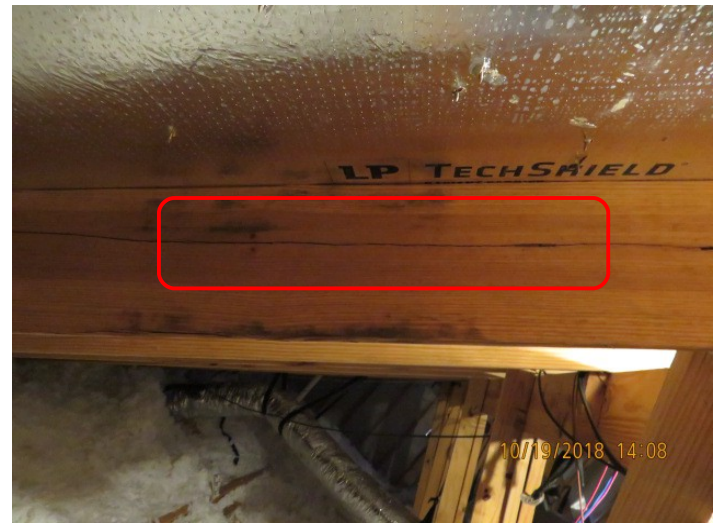
- Cracking rafters noted above the water heaters and above the attic access. Recommend proper repair to avoid further deterioration and possible roof sagging.

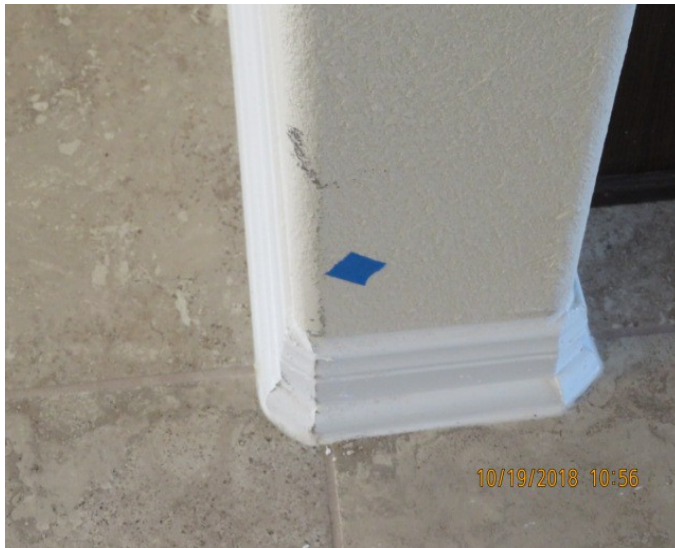
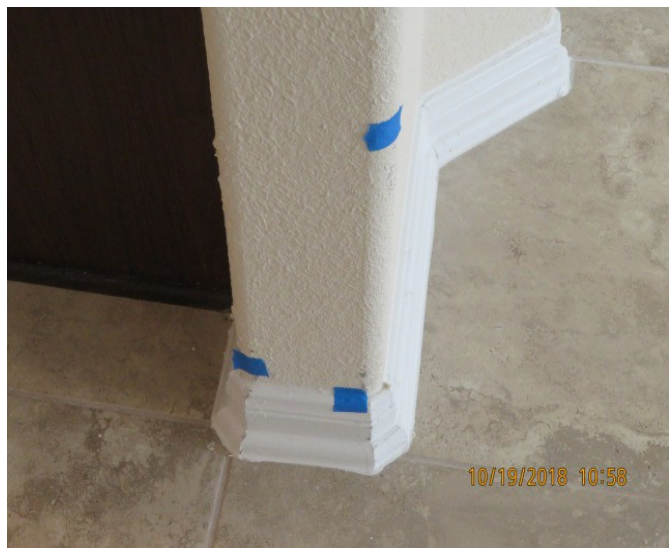
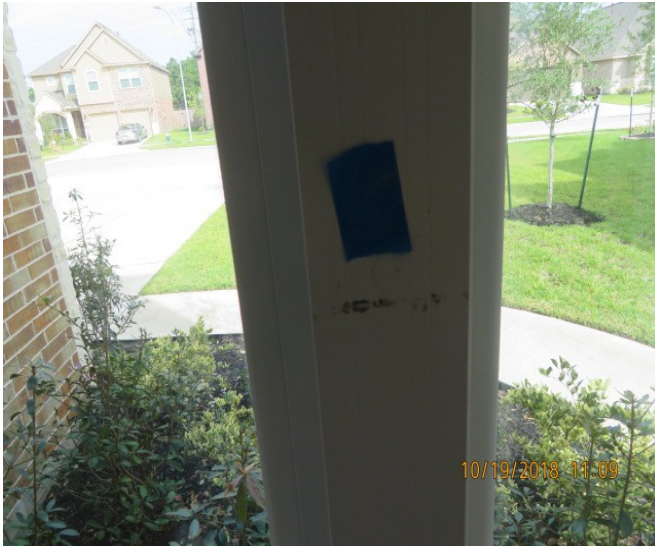
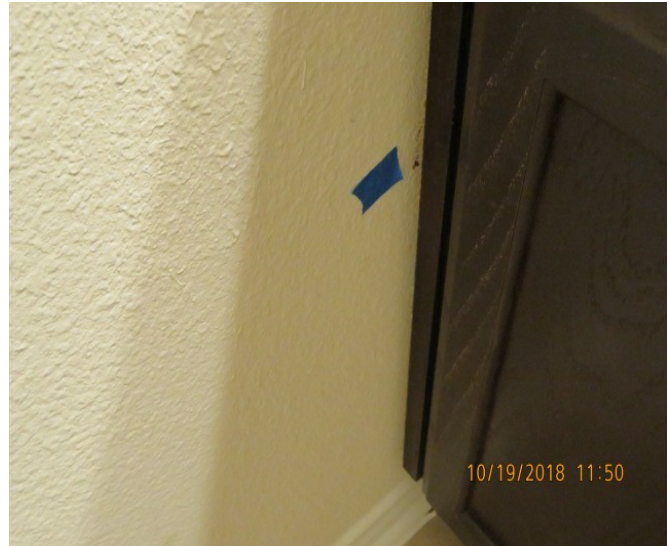
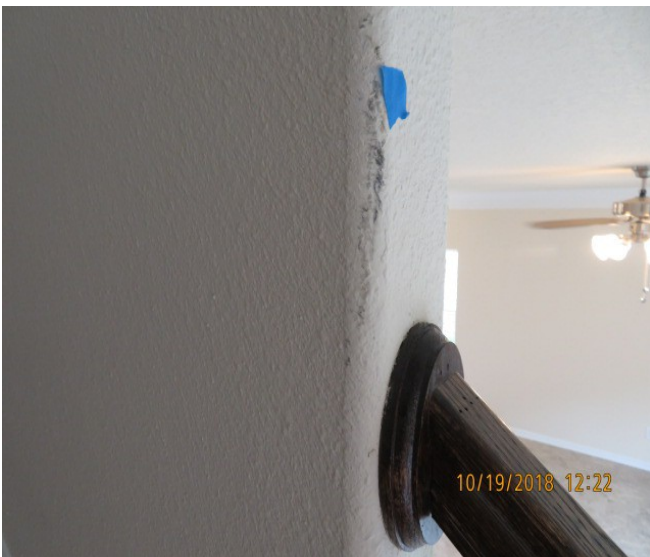
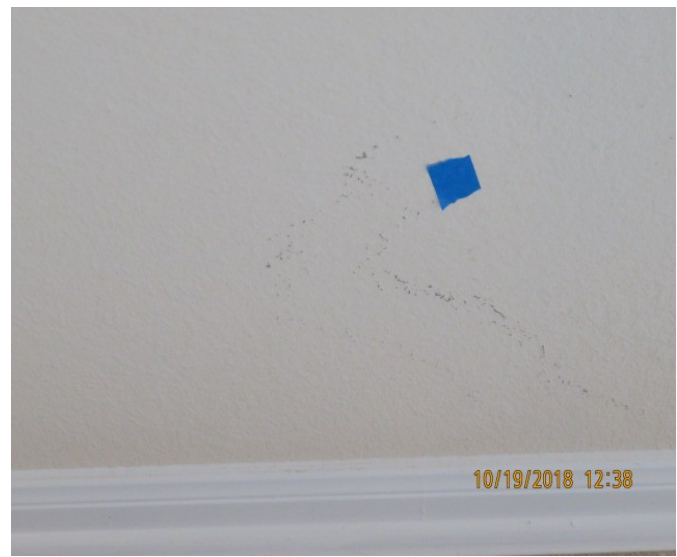
- Observed stains and defective wall paint throughout. Properly repair. Samples below

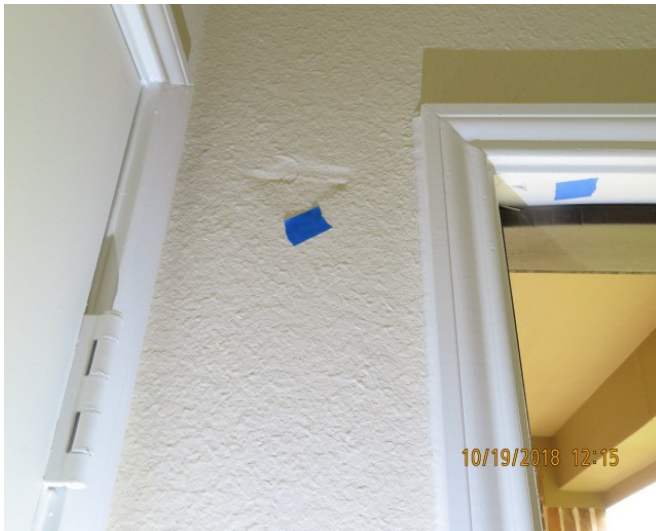
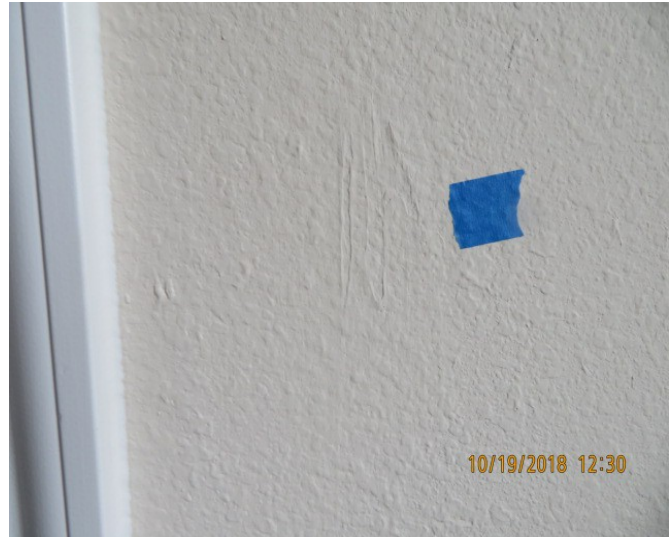
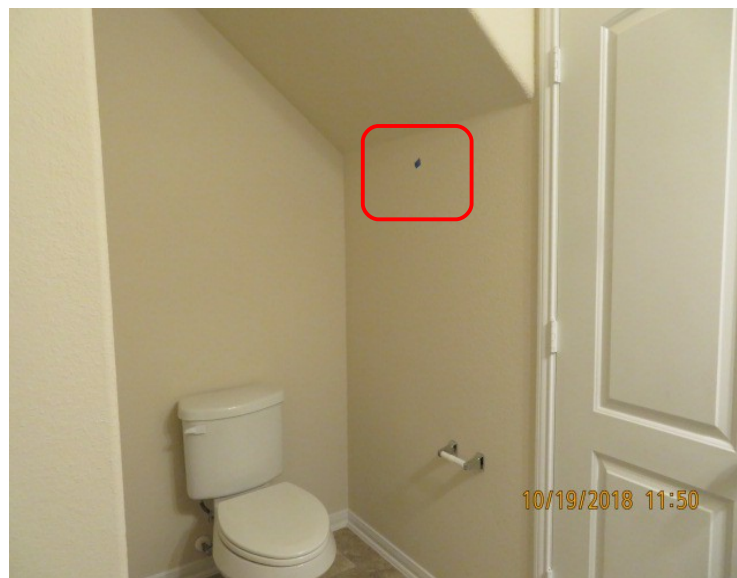
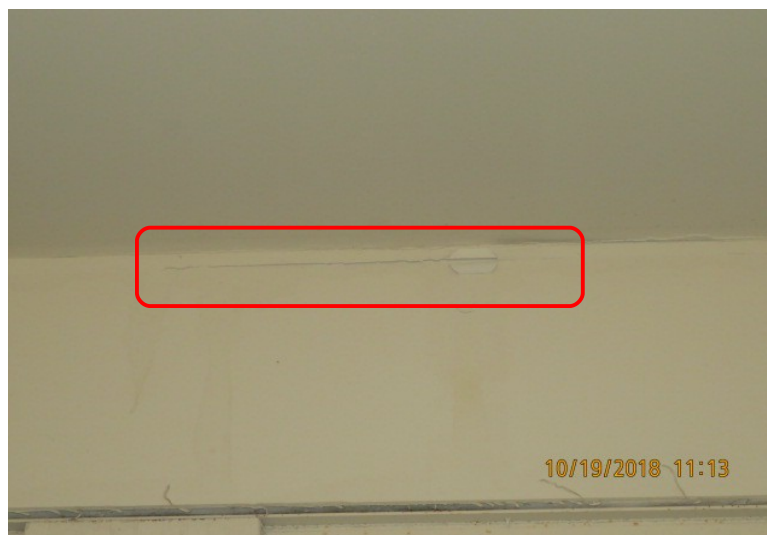
- Repair also, texture imperfections where needed. Examples:

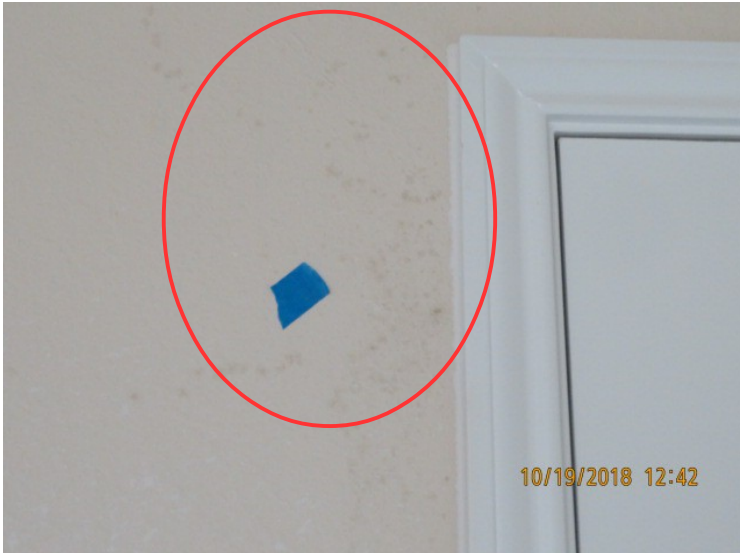
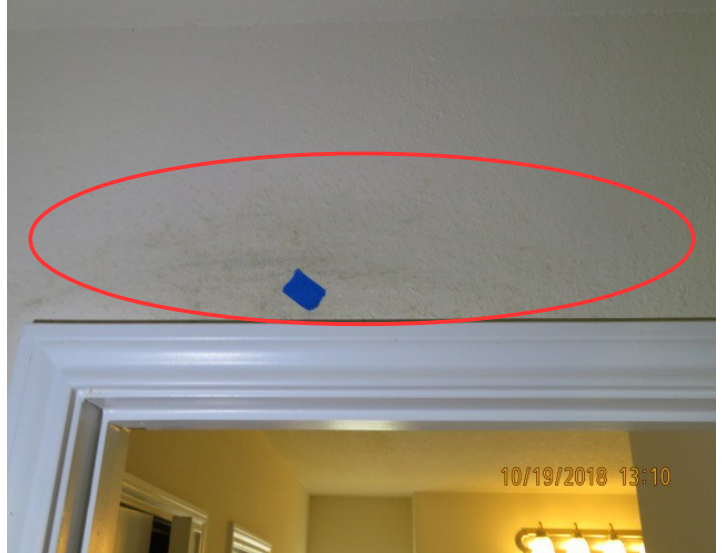
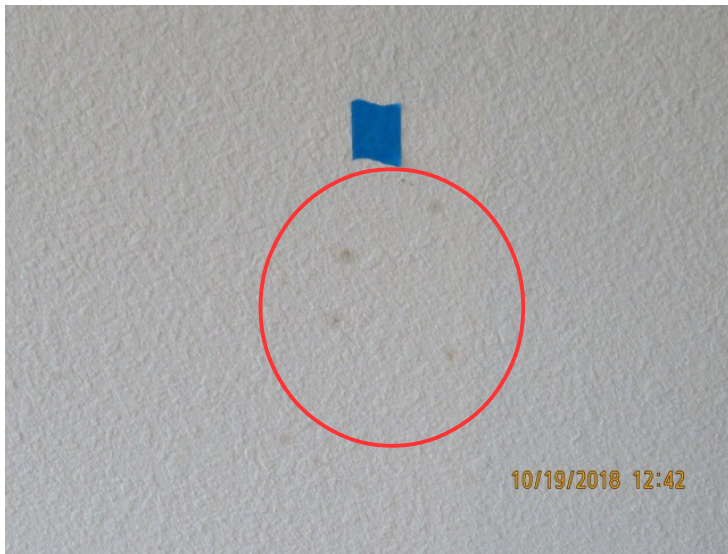
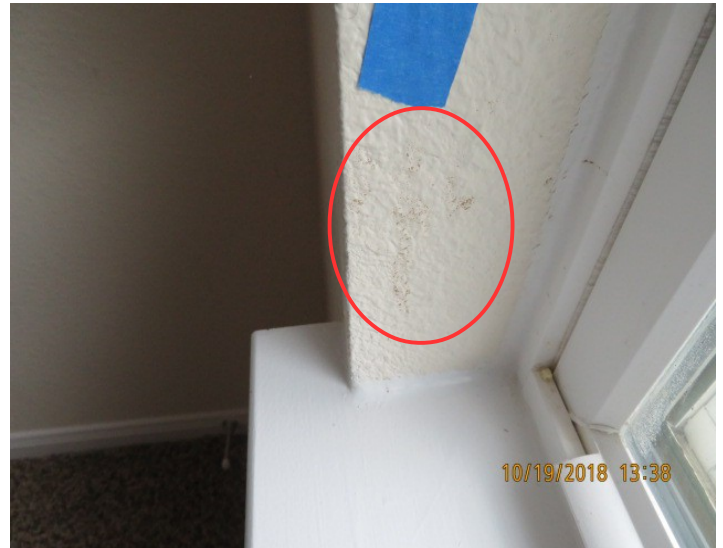
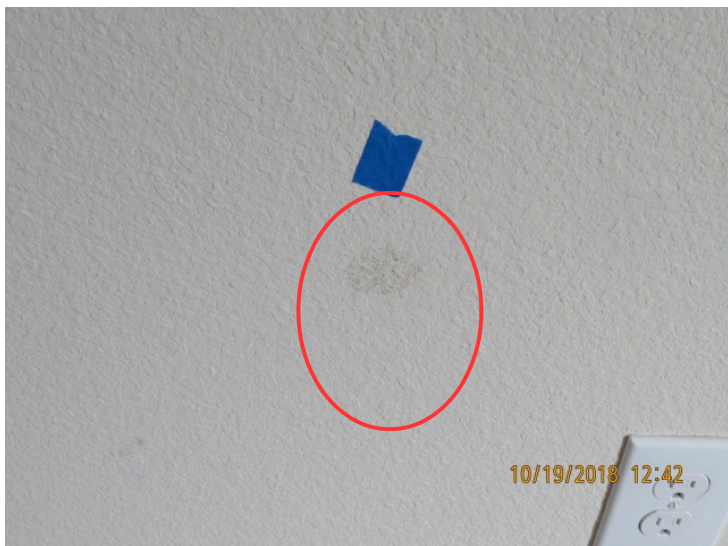
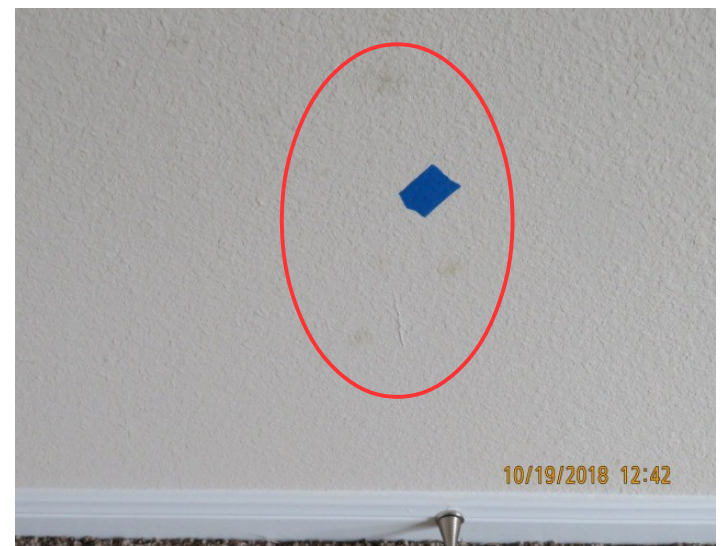
- Observed gray spots at several upstairs wall locations: bedrooms, utility room, hallway, etc. Inspector was not able to determine the source, or root cause. Consult a professional to conduct a thorough assessment, and perhaps an air quality test, moist level test, etc. Properly repair as needed

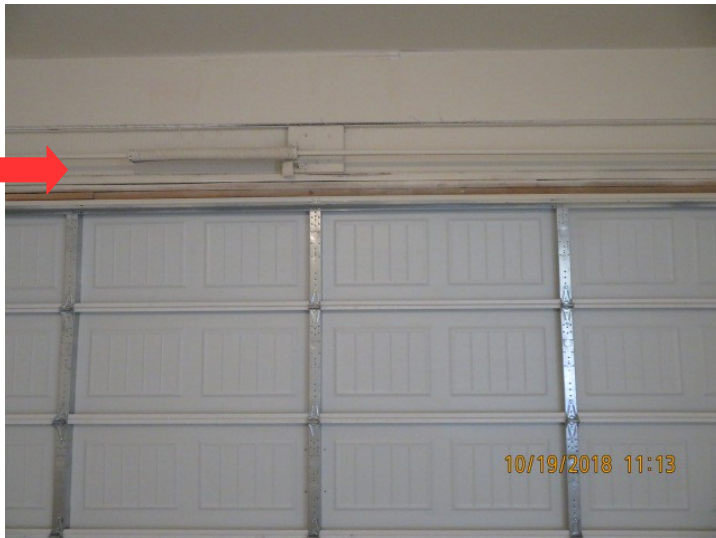
- Noticed missing filler (wood trim) above and on the sides of the garage door. In need of repair

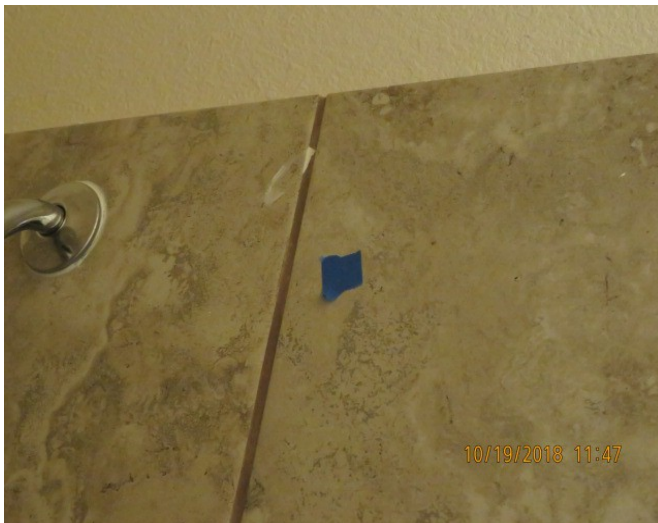
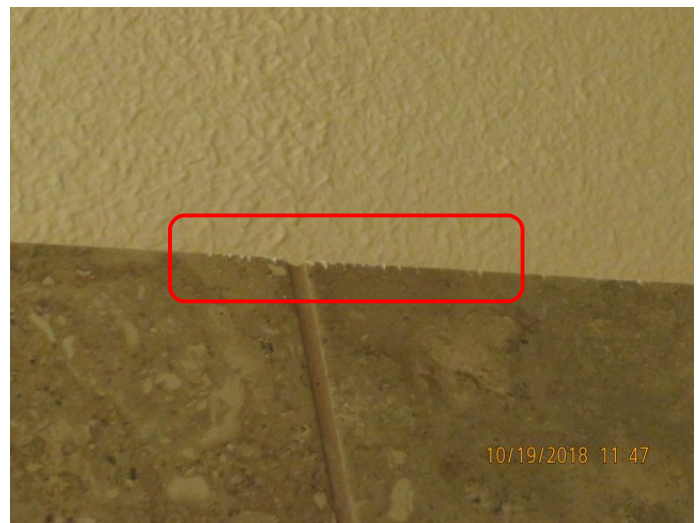
- Remove wall paint from shower tiles

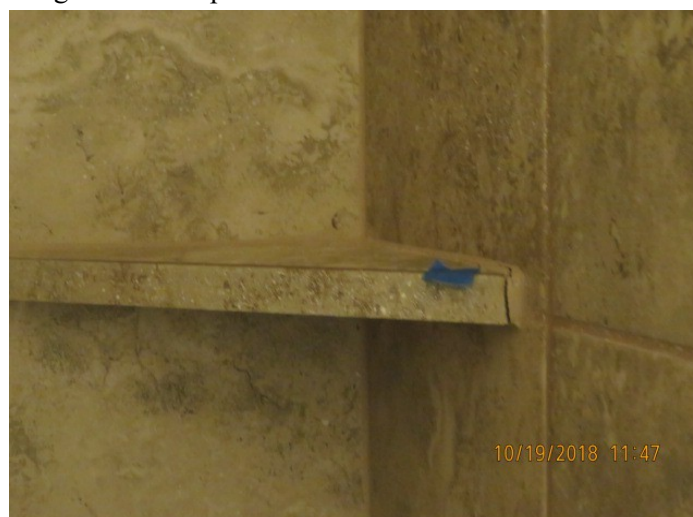
- Properly seal cracked grouts on soap holder

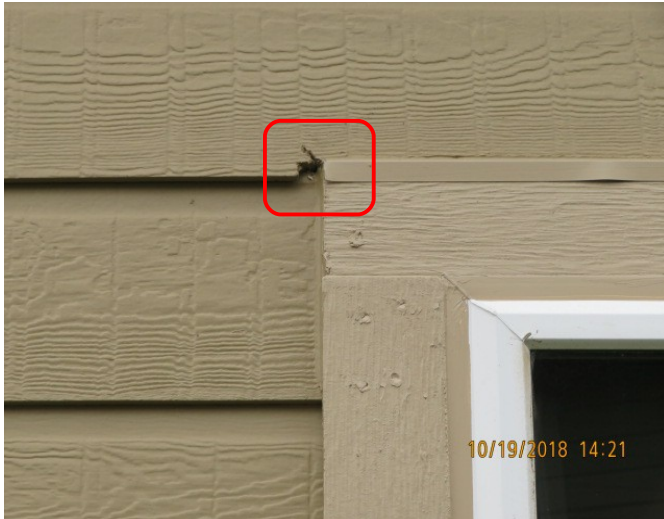
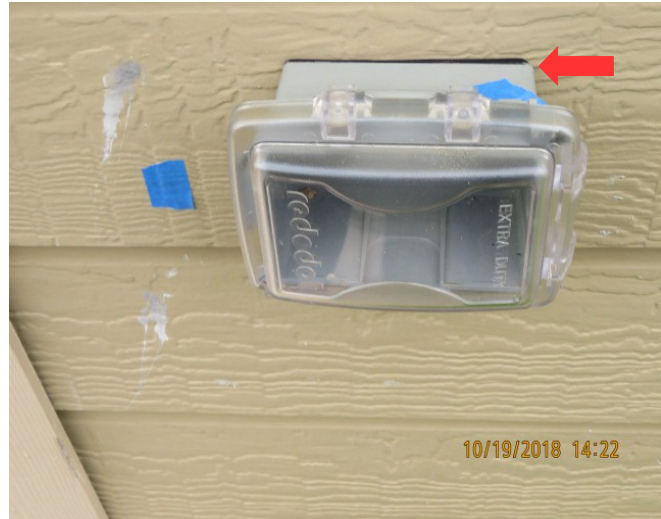
- Repair over-cut siding panel on rear wall
- Remove white paint from siding
- Secure loose outlet and seal around to prevent water seeping

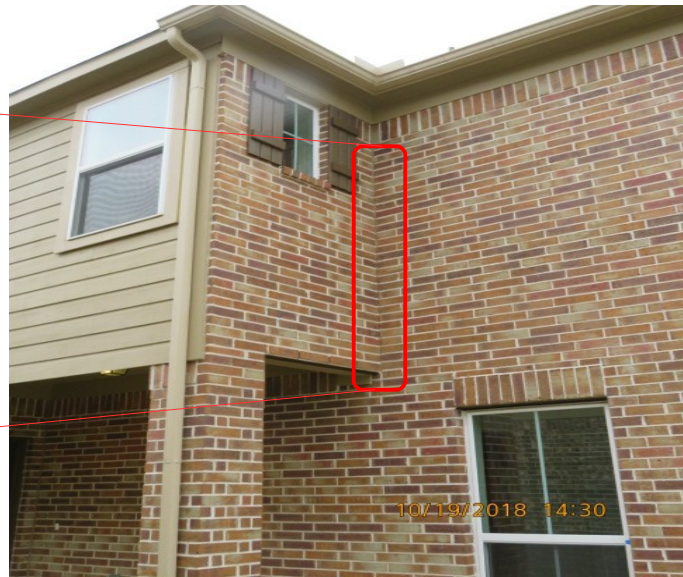
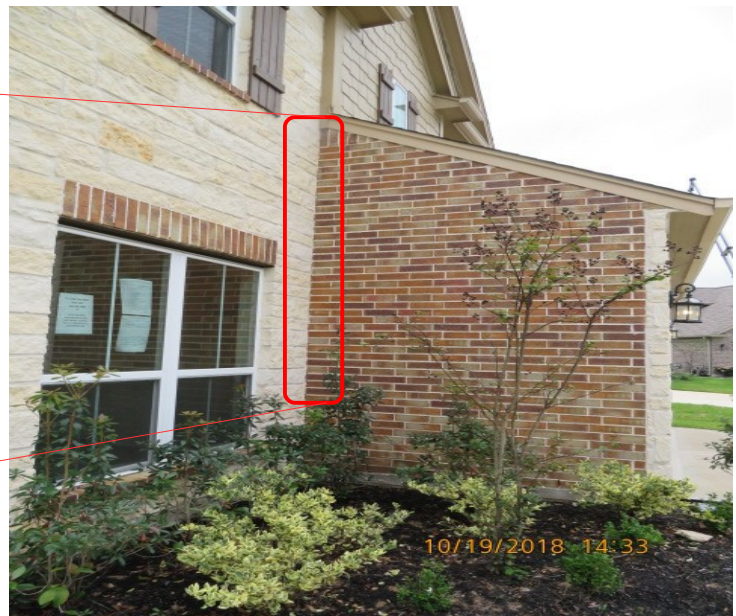
- Apply missing caulking on front exterior walls to avoid water intrusion

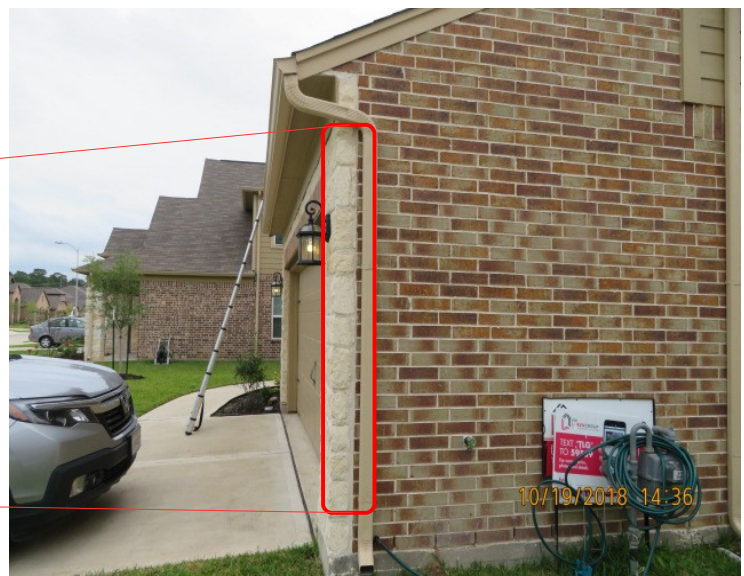
- Mortar separation in the masonry noticed in the garage area. Properly repair

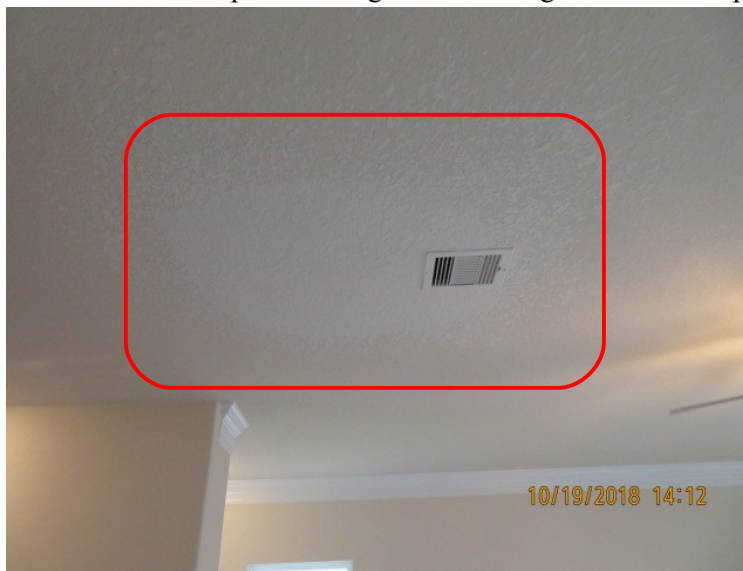
- Unpainted surface or evidence of repair in living area. Investigate further and properly repair

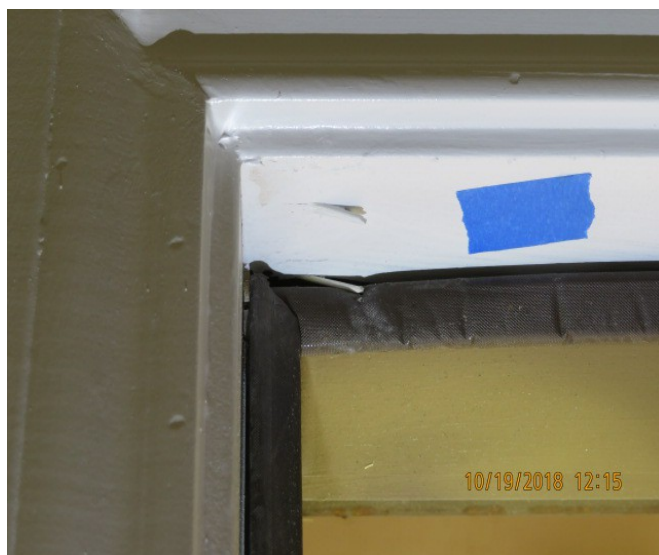
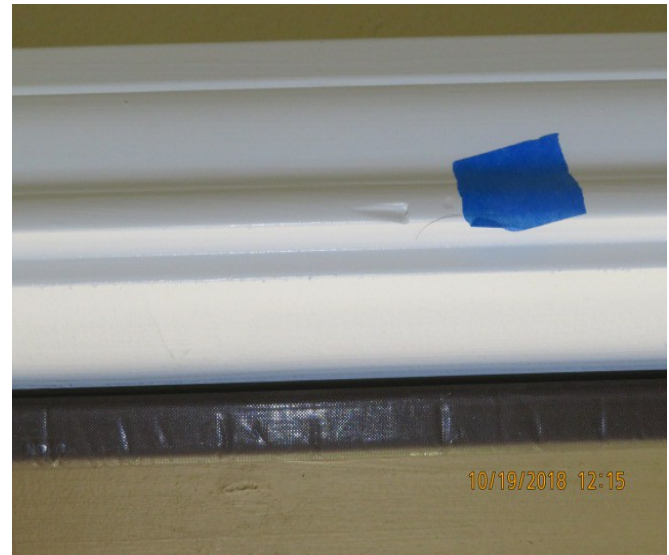
- Properly repair paint defects, dents, nicks, poor finish of door/frames

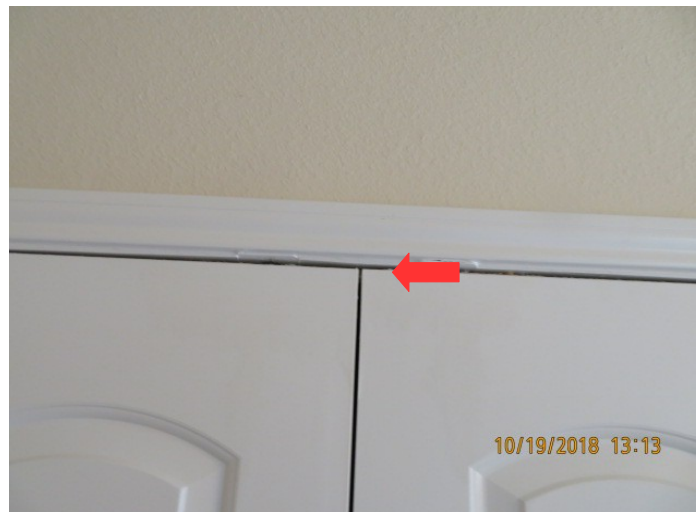
- Adjust ball-spring on upstairs closet doors

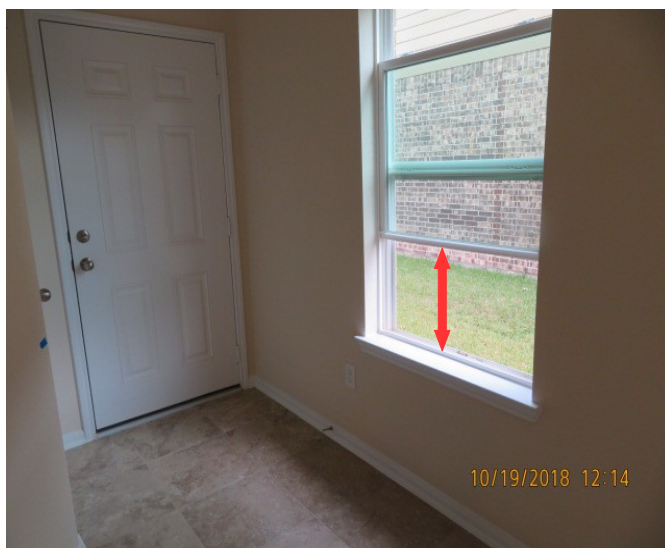
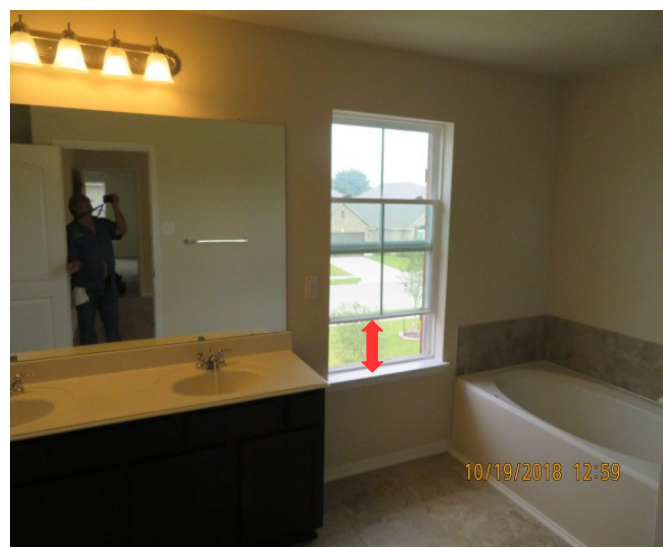
- Observed stiffness in front entrance and master bathroom windows. Note: All windows should be functional at all times to ease the egress in case of emergency

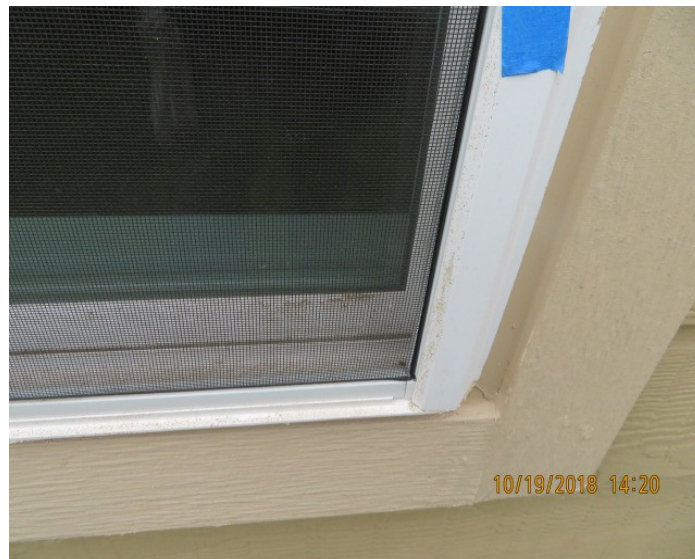
- Properly clean stains off window frames and sills

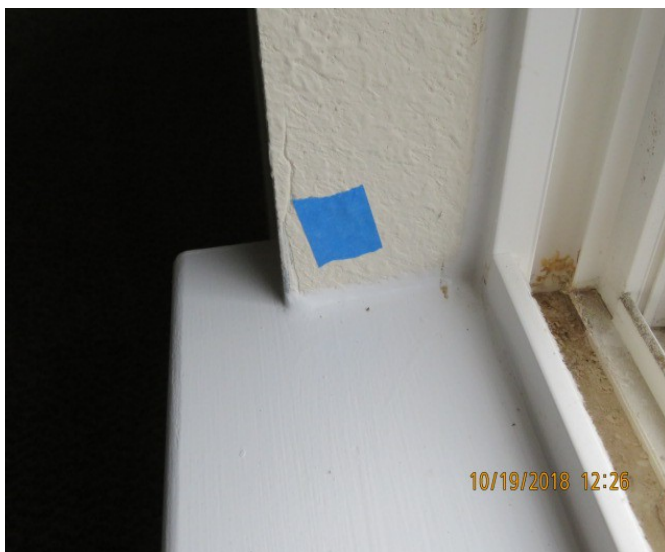
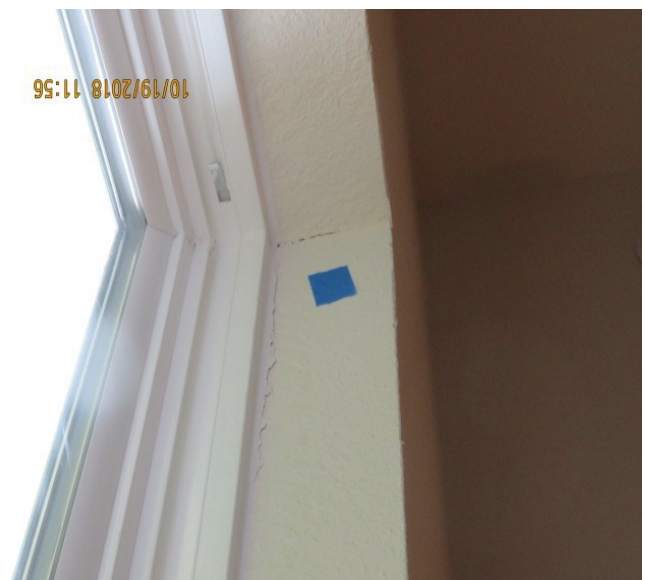
- Repair paint/texture imperfections where needed
- Seal cracks in window encasing where needed

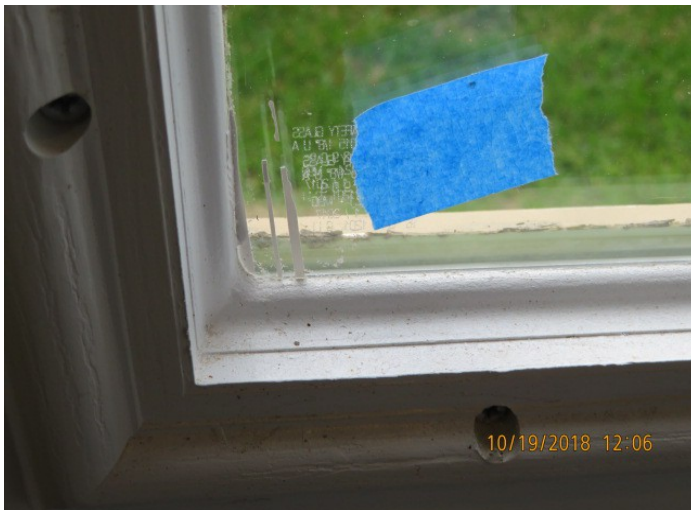
- Clean window surface/frames

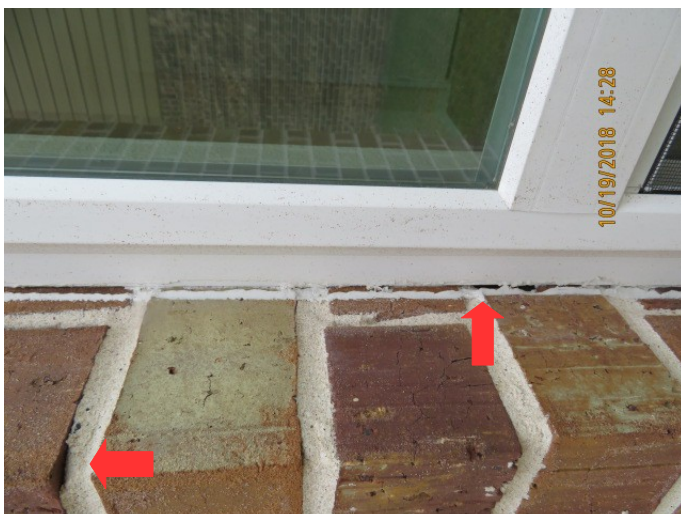
- Properly replace deteriorated caulking/mortar on exterior windows to avoid water infiltration

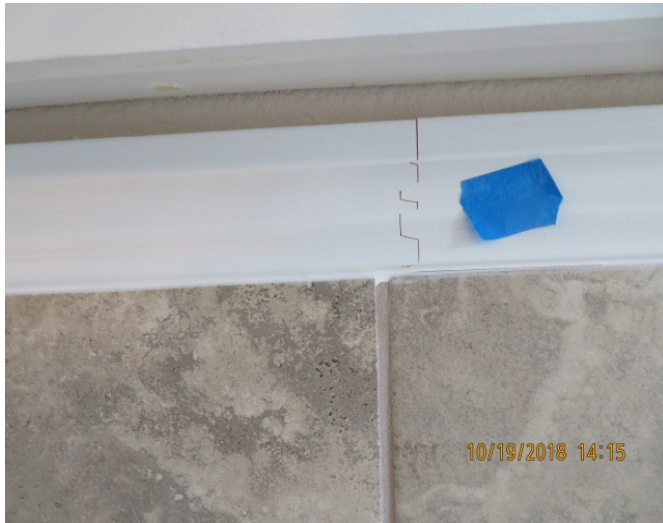
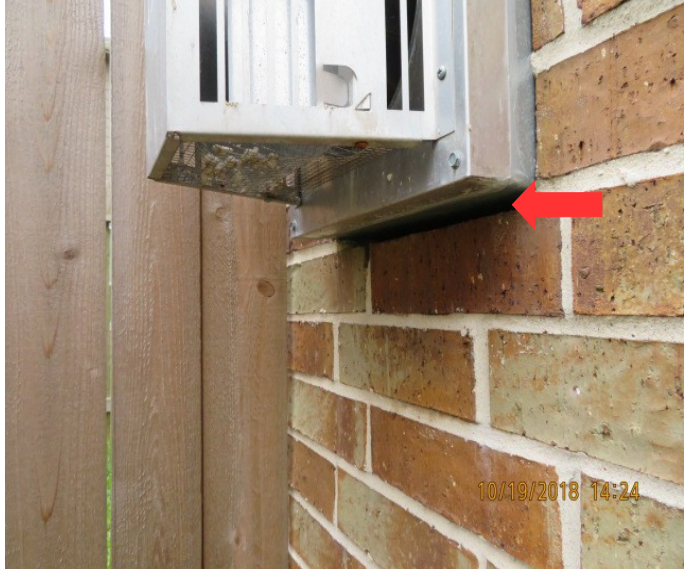
- Seal seam at fireplace trim
- Seal gap under the chimney exhaust to deter entry of insects, moisture, etc

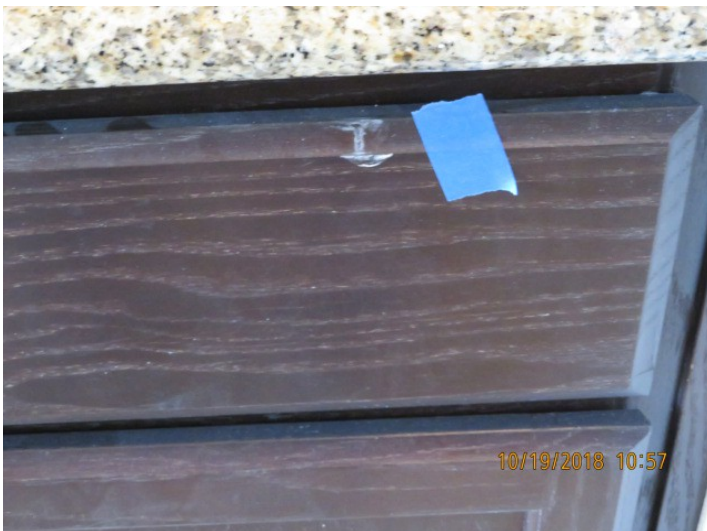
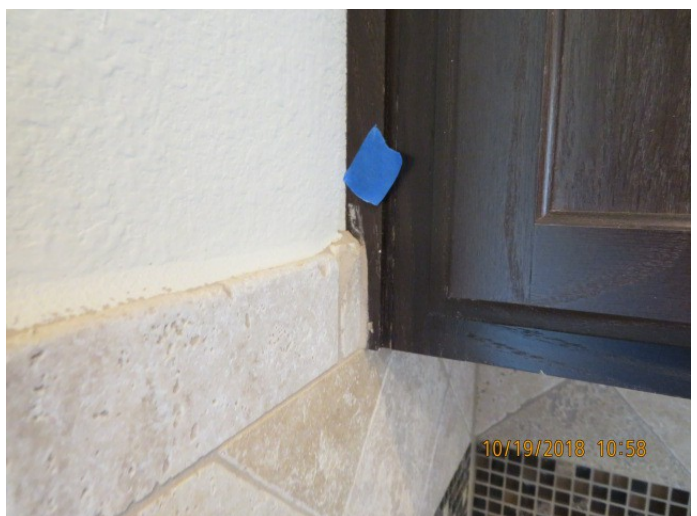
- Properly remove white paint, repair scratches, etc off kitchen and bathroom cabinetry

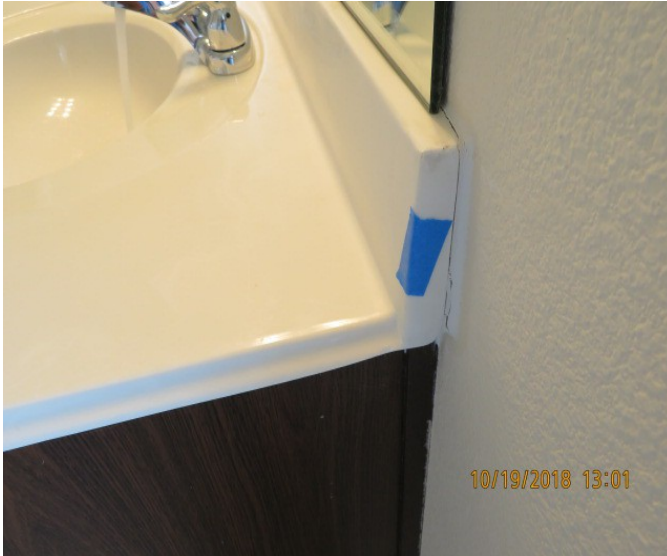
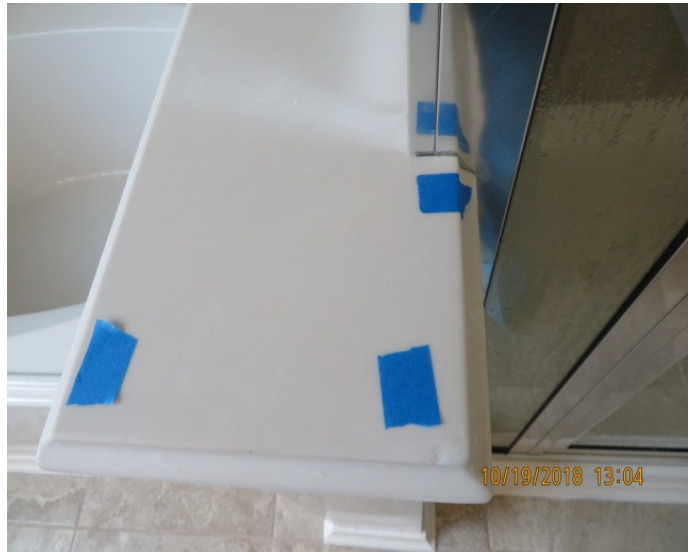
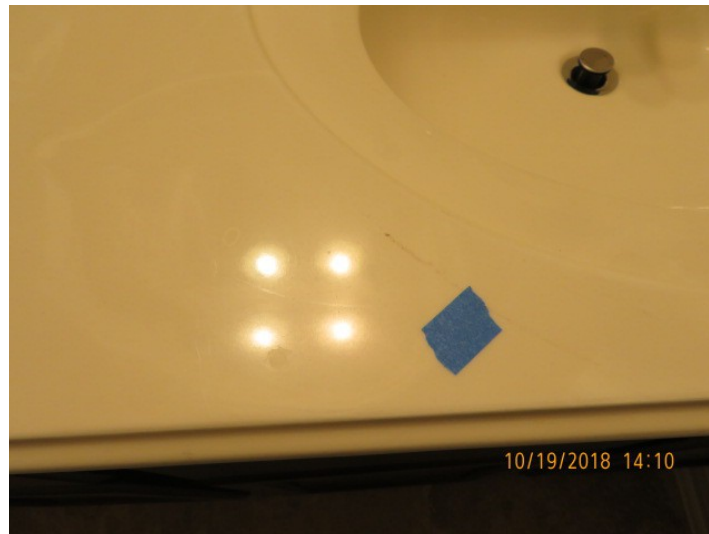
- Replace deteriorating caulking, apply caulking where missing, repair poor finish countertop surfaces.

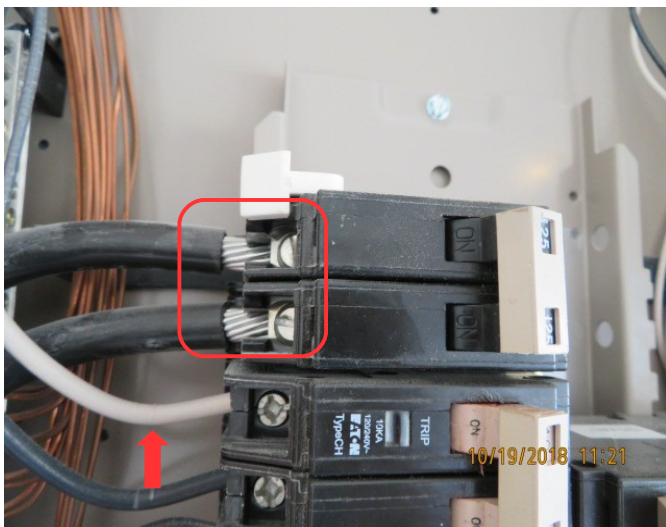
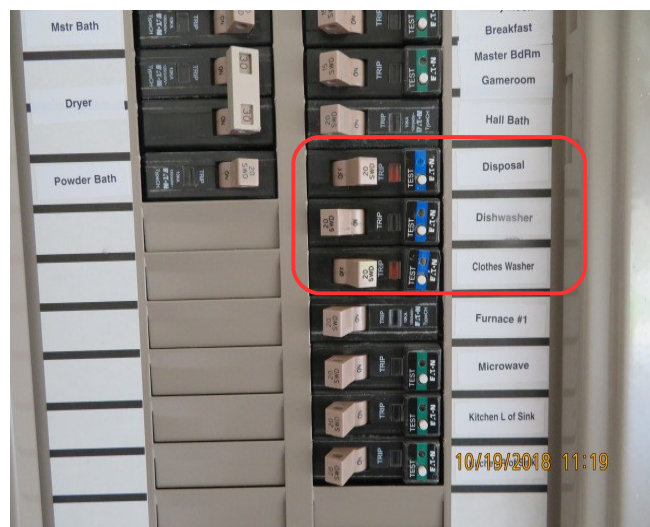
- No anti-oxidant compound on feeder aluminum cables. As oxide builds and continues to build on aluminum wires, it also builds up resistance. Recommend Alnox or Penetrox A13k
- Neutral wires are used as HOT wires. Neutral wires can be used as HOT wires when these are properly identified: Use of colored tape such as black, red etc is acceptable
- Observed tripped breakers: Disposal and c. washer. Investigate root cause and properly repair

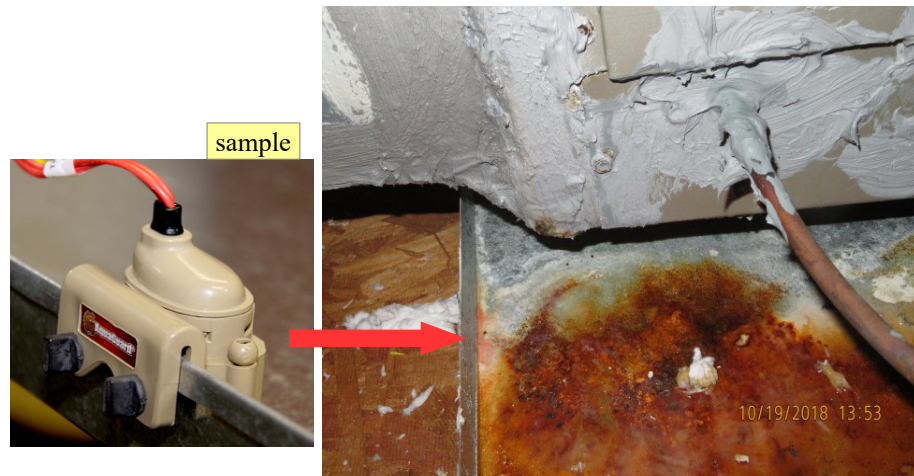
- Observed corrosion in secondary drain pan: Usually caused by condensation from evaporator coil. Further investigate root cause and conduct proper service/repair as needed
- Recommend the installation of an "Overflow" switch on secondary drain pan to prevent possible spills

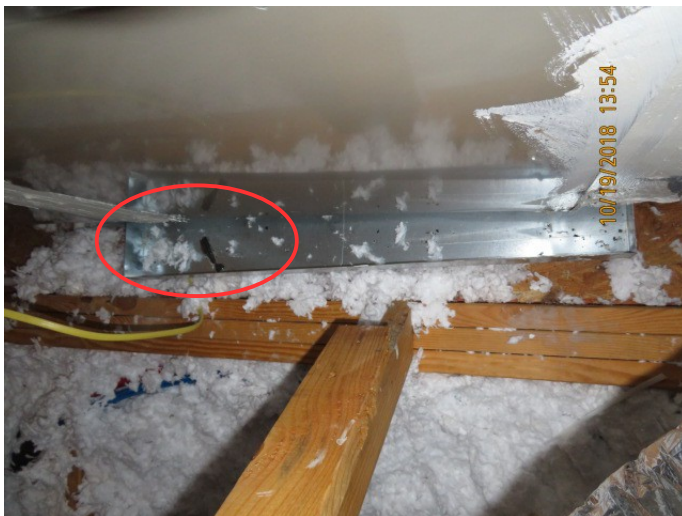
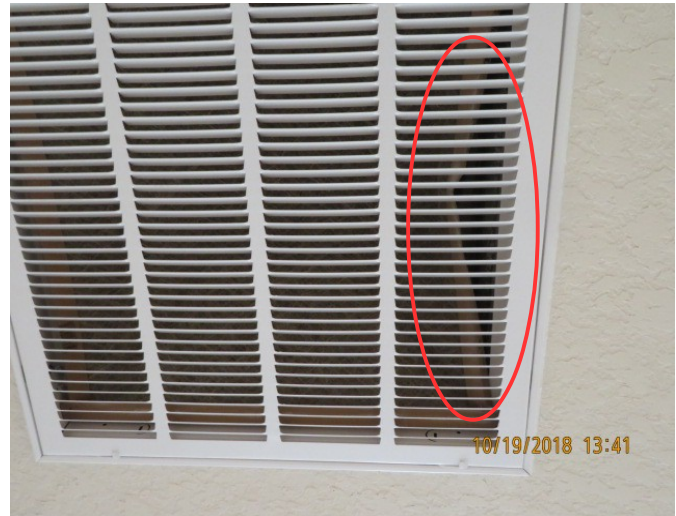
- Remove debris from emergency drain pan to prevent clogging of drain line
- Replace damaged filter
