PROPERTY INSPECTION REPORT

Concerning: Kleinwood Dr. Spring, TX 77379
(Address or Other Identification of Inspected Property):

By: Giovanni Angel, 22909 12/29/2018
(Name and License Number of Inspector) (Date)

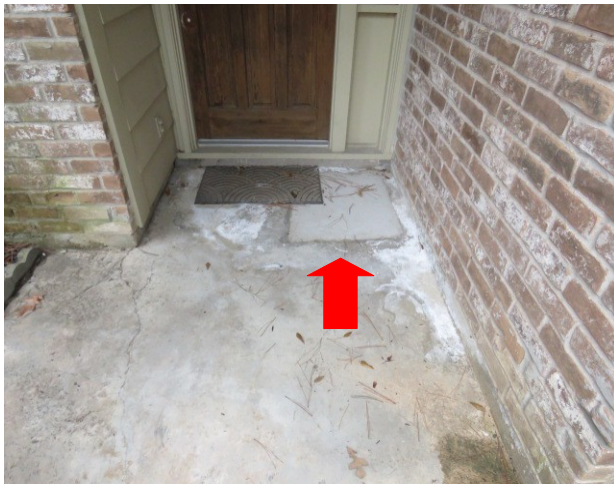
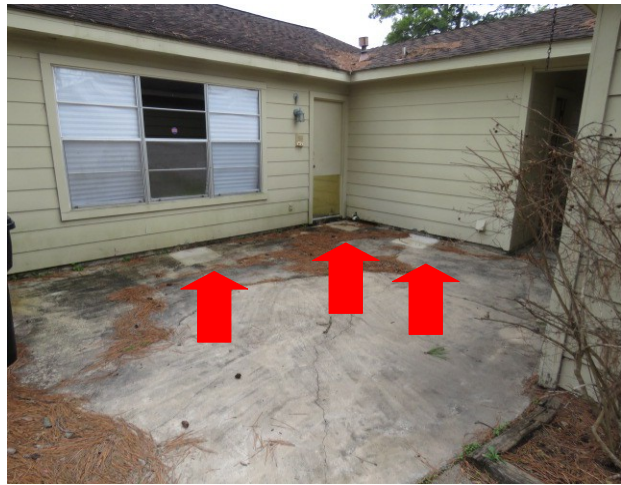
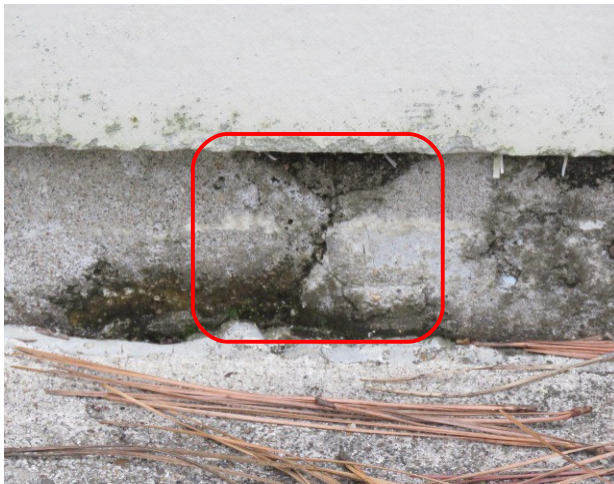
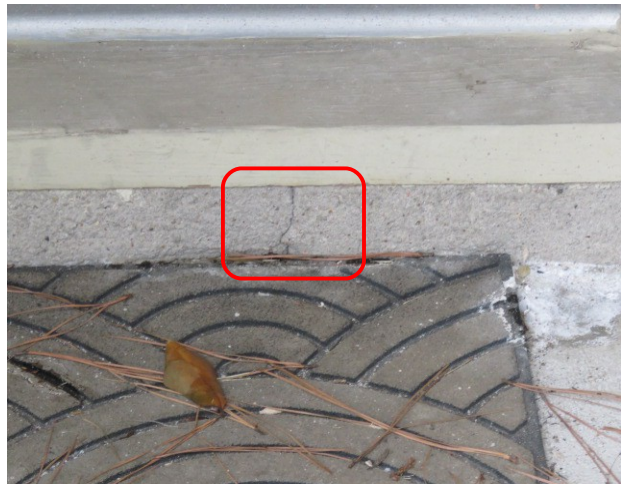
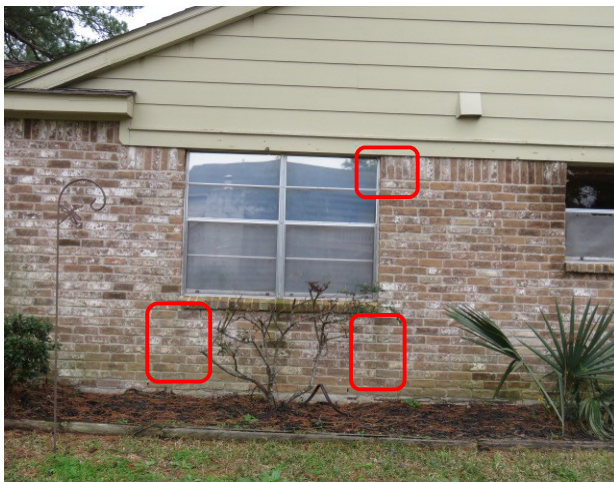
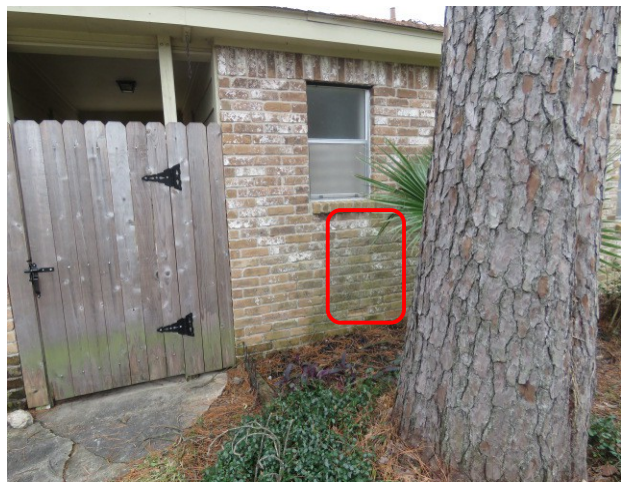
- Observed cracks on foundation slab exterior walls that may be associated with the evident foundation repair. Recommend to monitor cracks over time. If concerned at this time, or should the condition continue to deteriorate, we recommend to consult with a structural engineer to further assess the integrity of the foundation slab. Samples below.

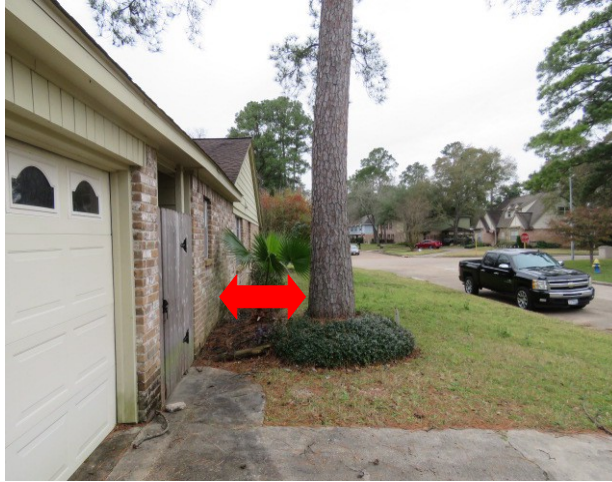
- Recommend the removal of mature trees in close proximity to the structure or the installation of root barriers to prevent possible damage to foundation. Note: Some types of mature trees can cause damage when these are too close to structure.

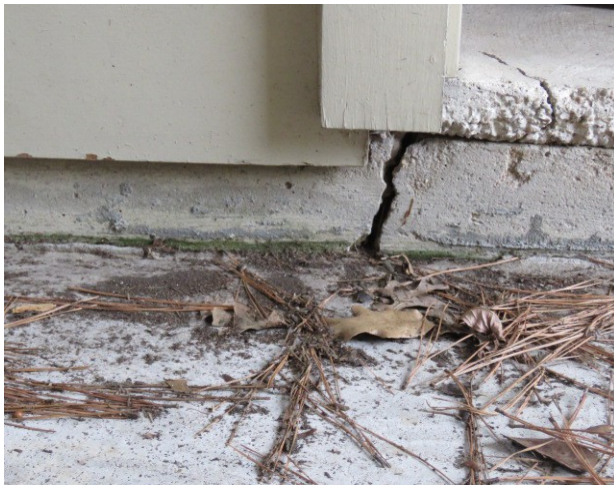
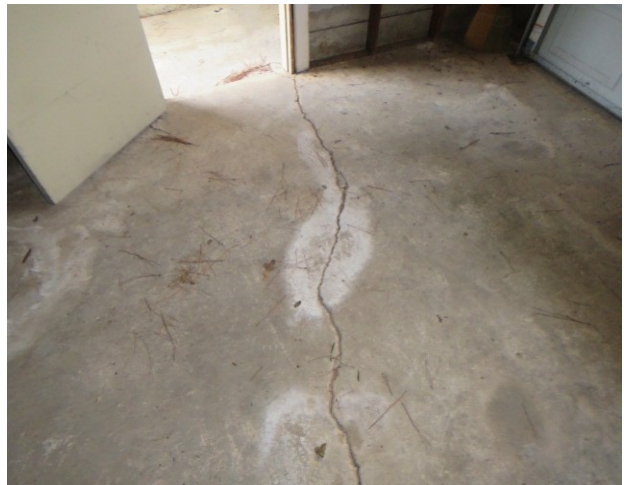
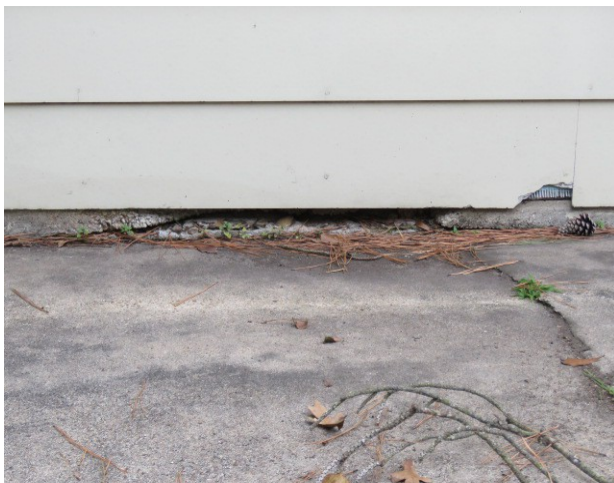
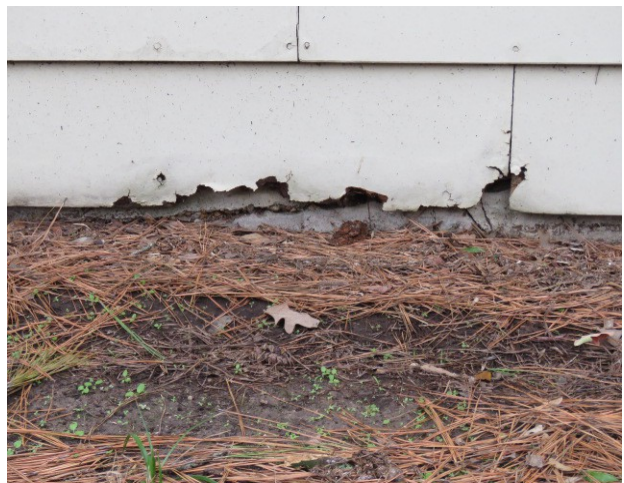
Garage foundation

- Noted cracks and crumbling foundation slab that may be associated with foundation failure. Consult with a structural engineer to further assess the integrity of the foundation slab to determine corrective actions to be taken at this time. Samples below.

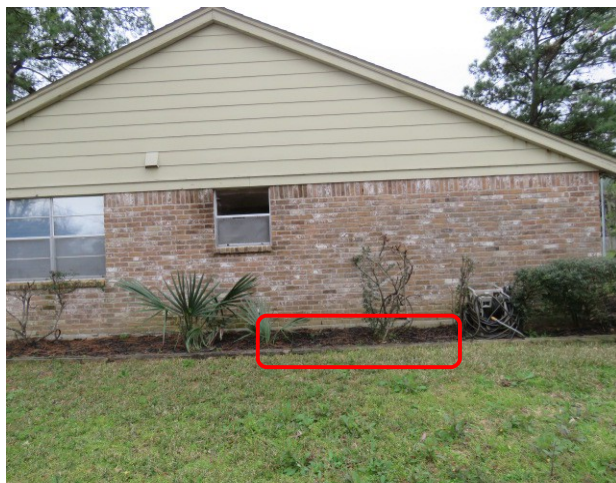
- Soil is of reverse grade on multiple sides of the house (low spots, negative slope, etc), creating vulnerability to the accumulation of standing water at the foundation wall, a condition known to be a factor in foundation failure. Re-grading is required for a more positive drainage

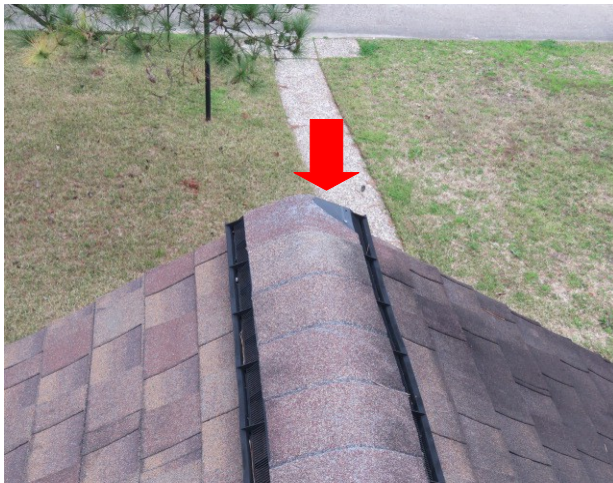
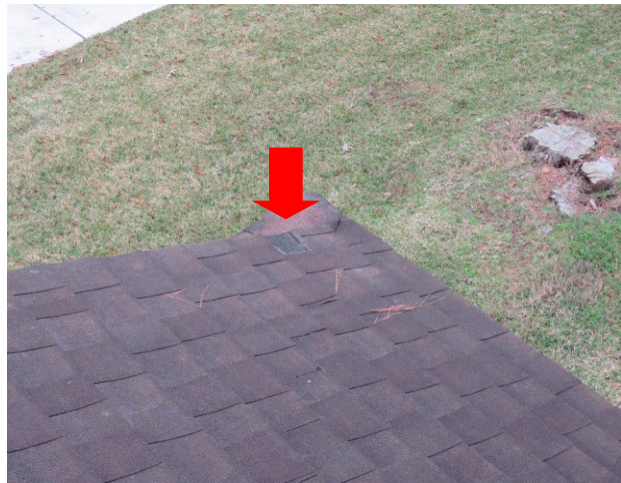
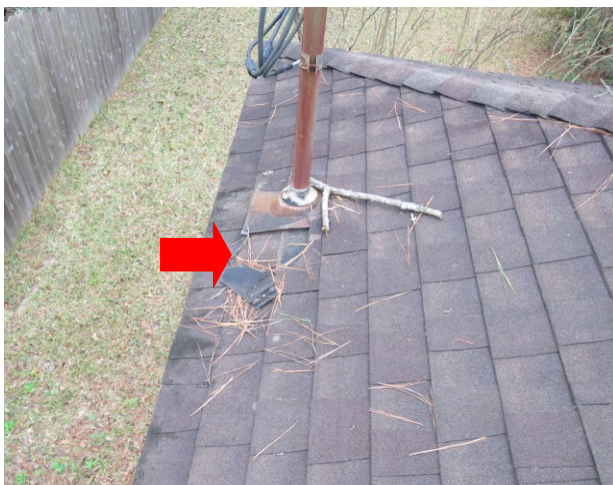
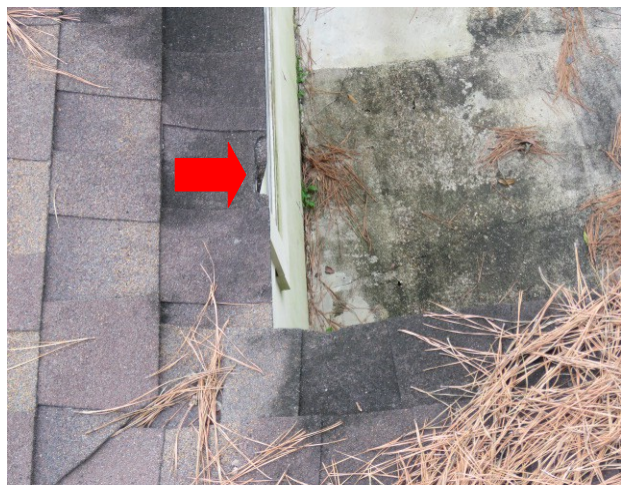
- Damaged shingles on multiple sides of the roof. Properly repair to prevent further deterioration and possible water intrusion. Samples below.

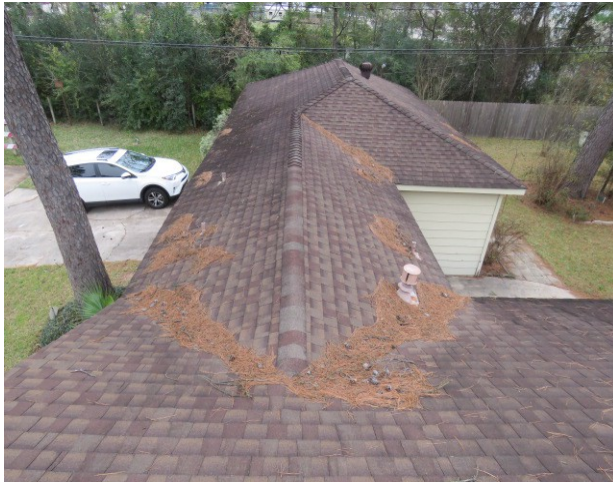
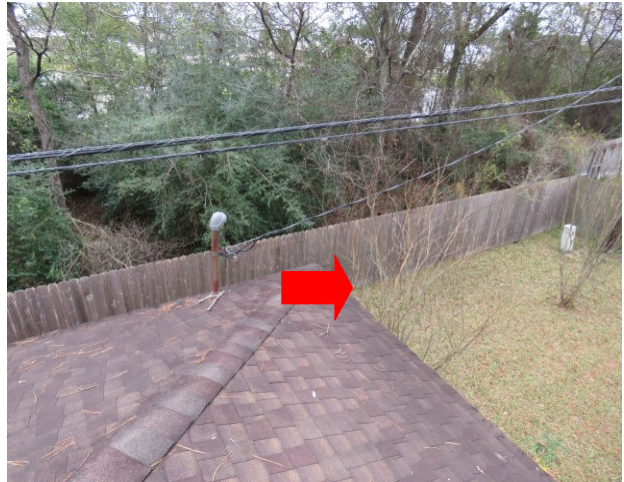
- Maintain roof free of debris to prevent premature deterioration of roof shingles.
- Recommend to maintain tree limbs trimmed to prevent from contacting and damaging roof shingles.

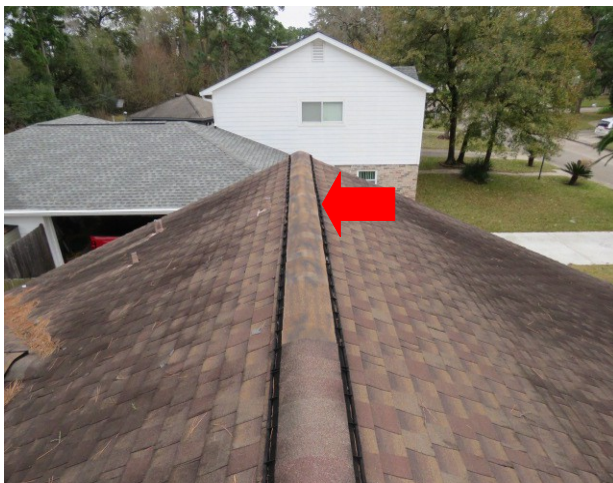
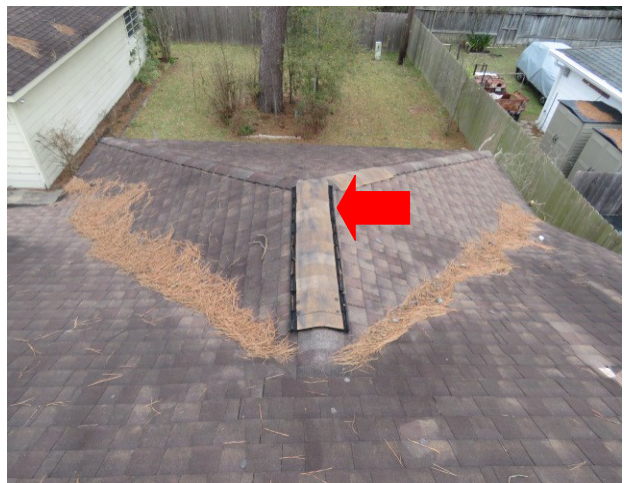
- Evidence of repair on roof ridge and hip. Further investigate root cause as needed.

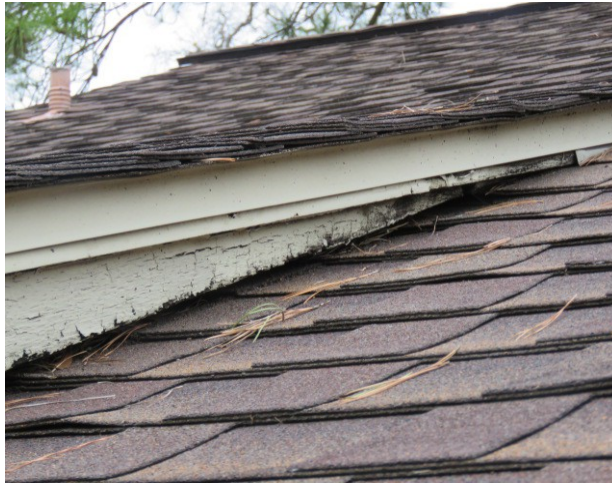
- Rotted fascia on the front side of the house. Recommend repair of damaged sections.

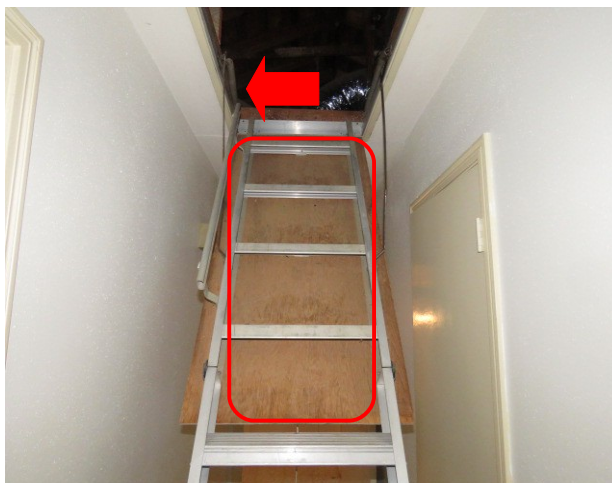
- Insulate ladder rungs for insulating value, install weather stripping on attic door edges or on access frame for energy efficiency and secure or replace defective hardware
- Left attic ladder spring is off the bracket. In need of proper repair.

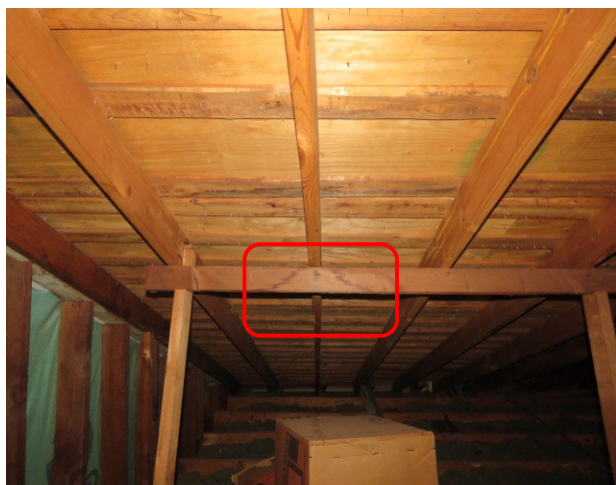
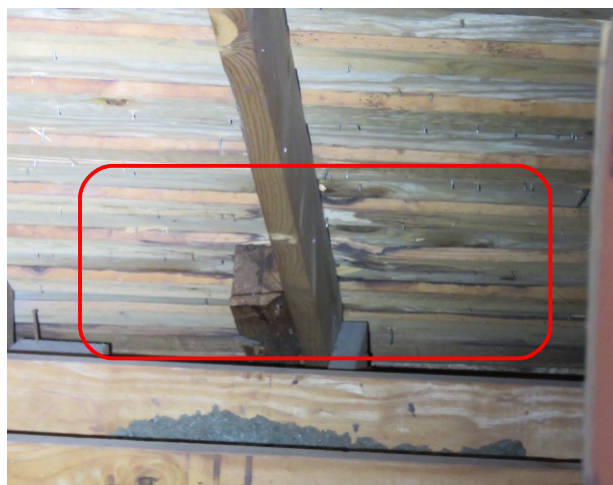
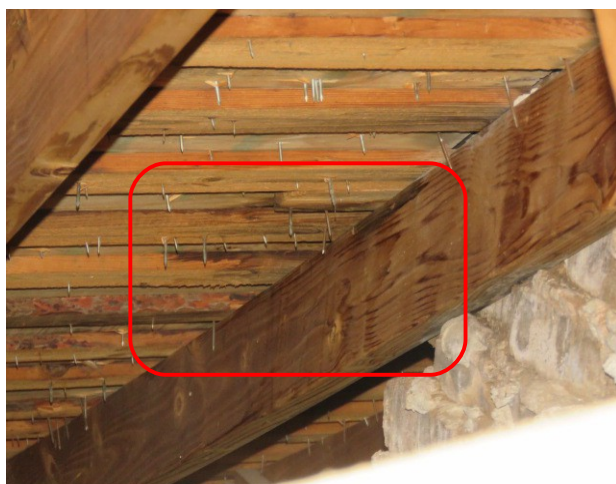
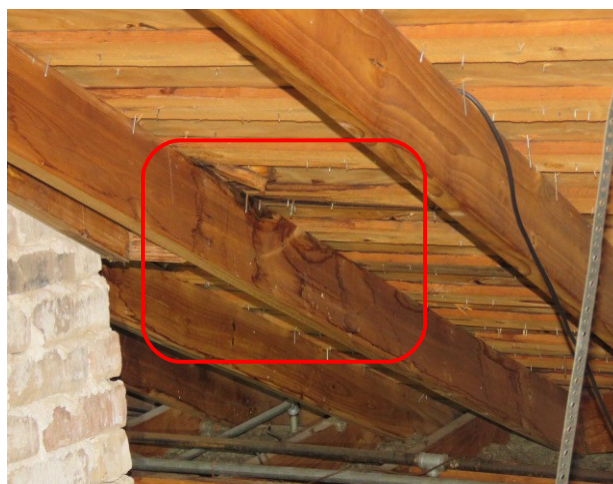
- There is evidence of water intrusion at various locations of roof deck. Inspector was not able to safely access all areas to determine if stains are recent. Further investigate condition and root cause and properly repair by a qualified contractor. Samples below.

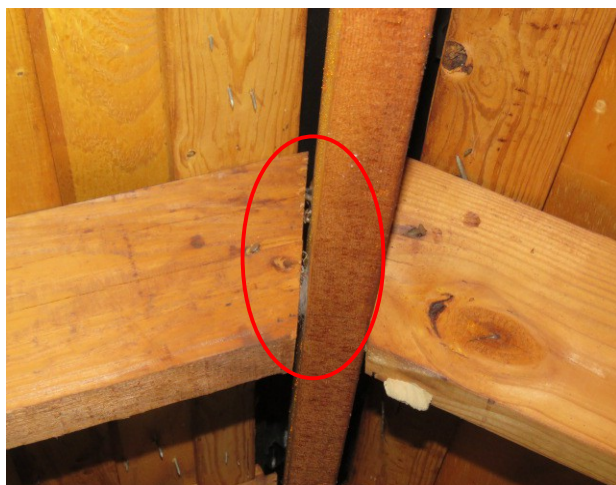
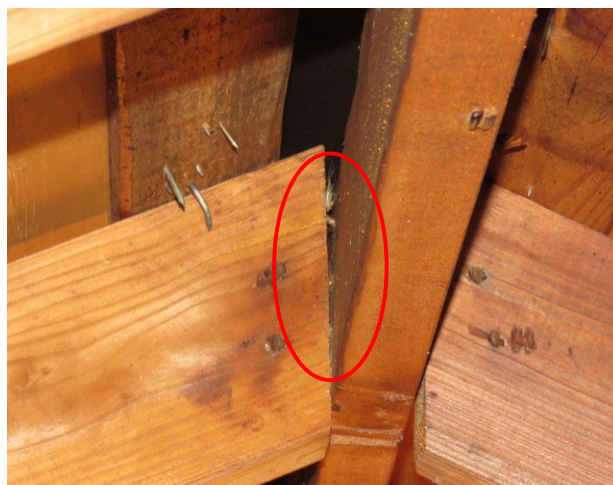
- One or more of the roof structure rafters were observed to be pulling away from the top ridge board. Recommend proper repair by a qualified contractor as needed.

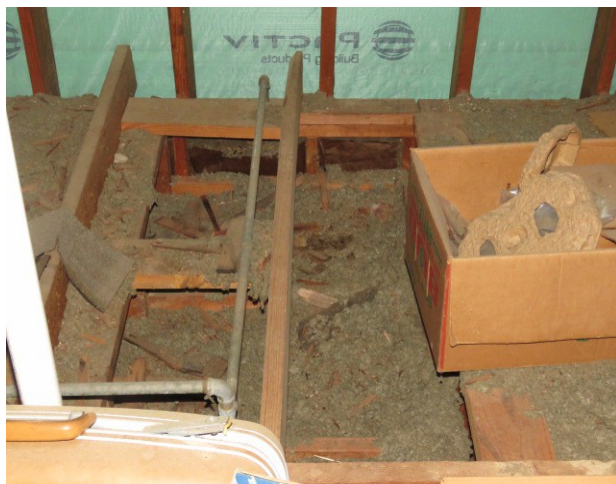
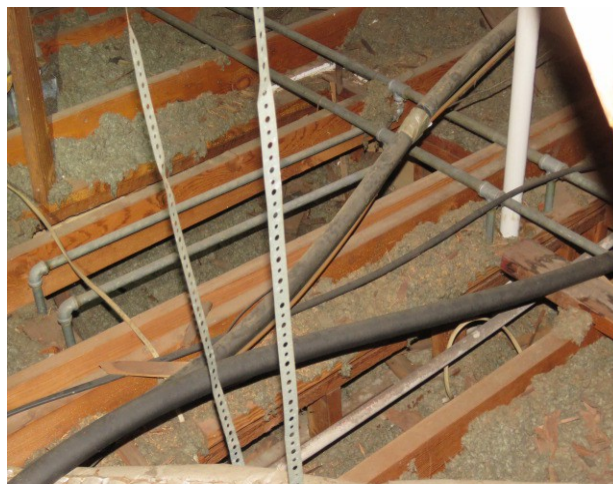
- Insulation in most rooms appeared to be shallow. This level may have been proper when home was constructed. Install required amount of insulation for insulating value

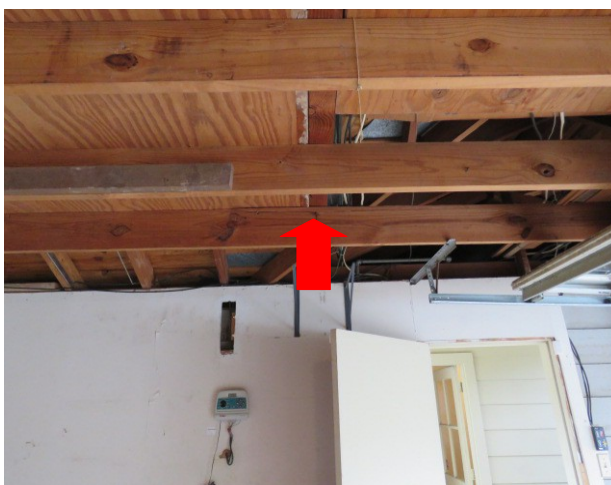
- Also noted cracked joist in the garage. In need of proper repair.

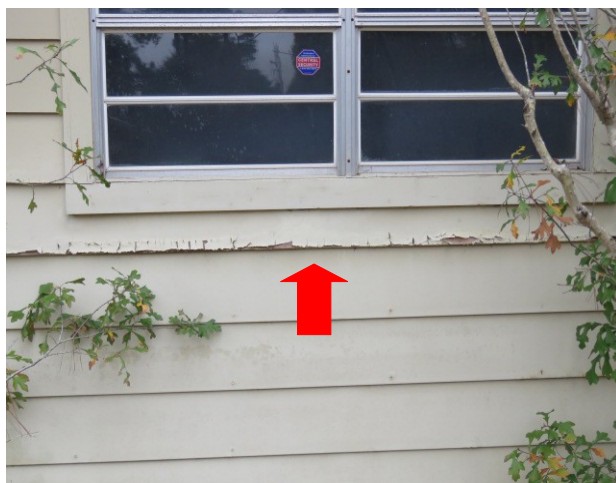
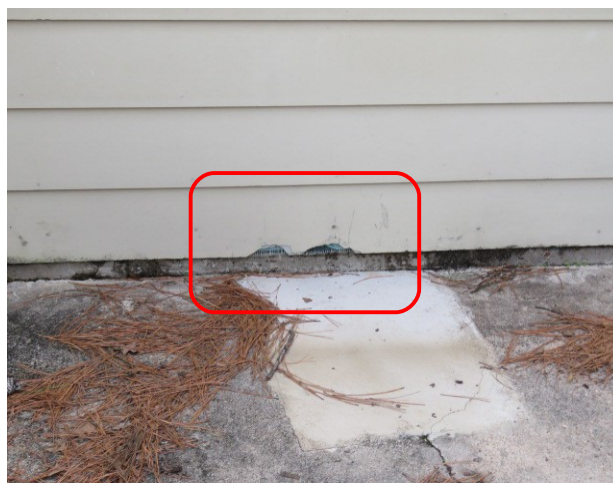
- Damaged/rotted siding on multiple sides of the house. Recommend proper repair of damaged sections. Samples below.

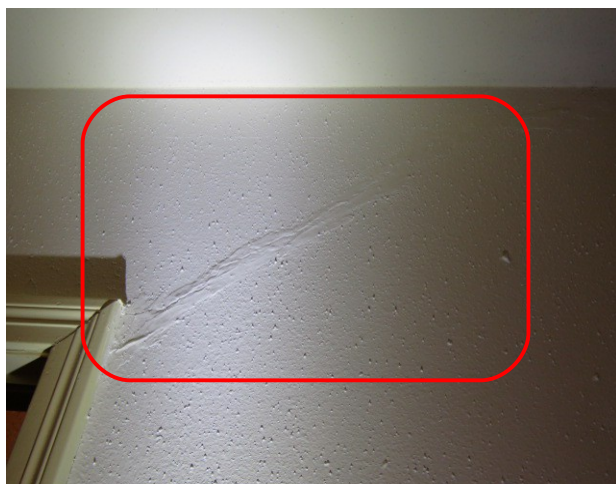
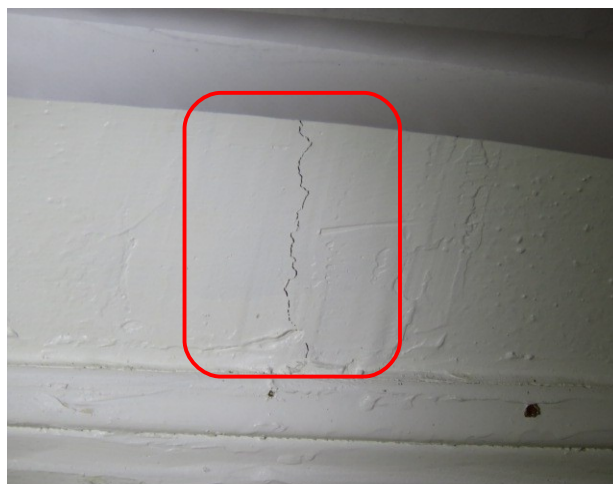
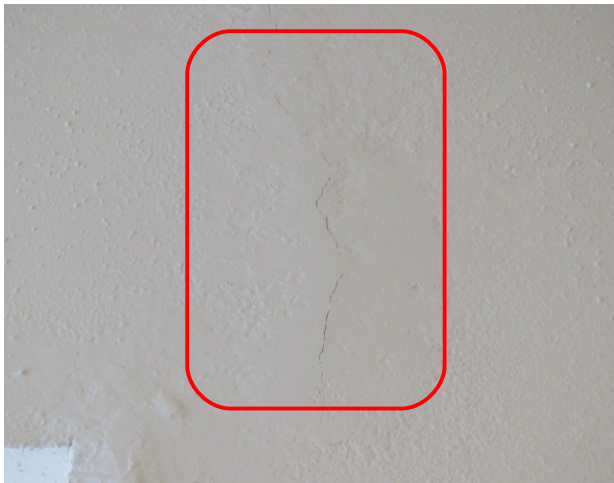
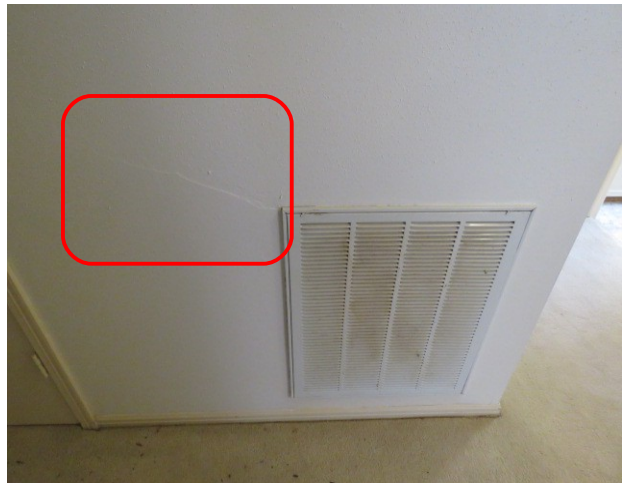
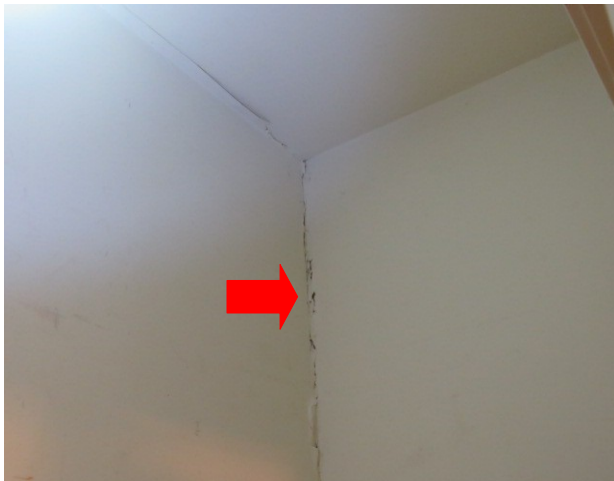
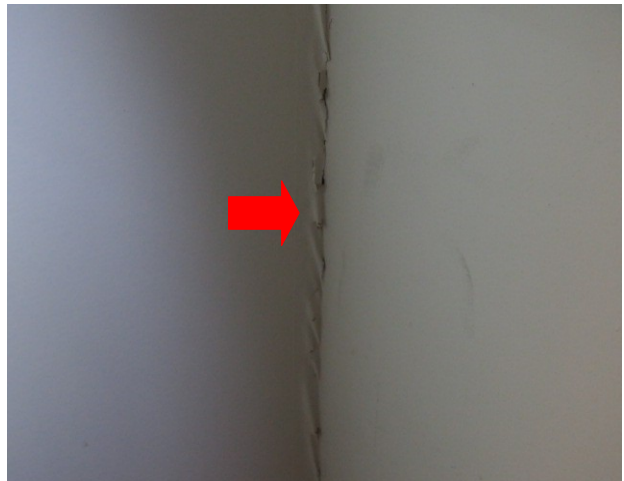
- Noted multiple cracks, some of which have been repaired, and wrinkled joint tape that may be associated with the evident foundation repair. Recommend to monitor condition over time. Should the condition continue to deteriorate, consult with a structural engineer to further assess the integrity of the foundation slab. Samples below.

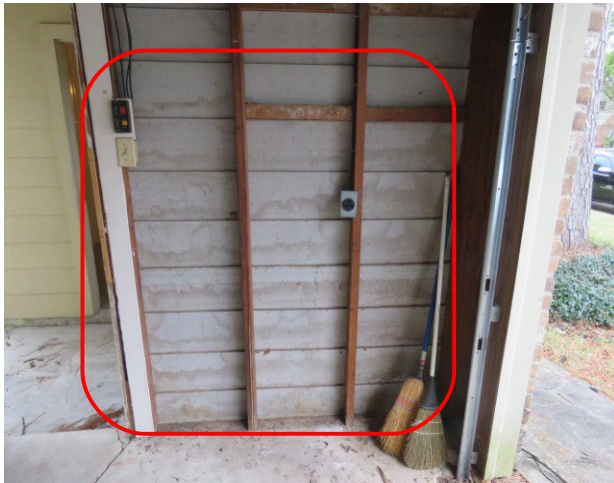
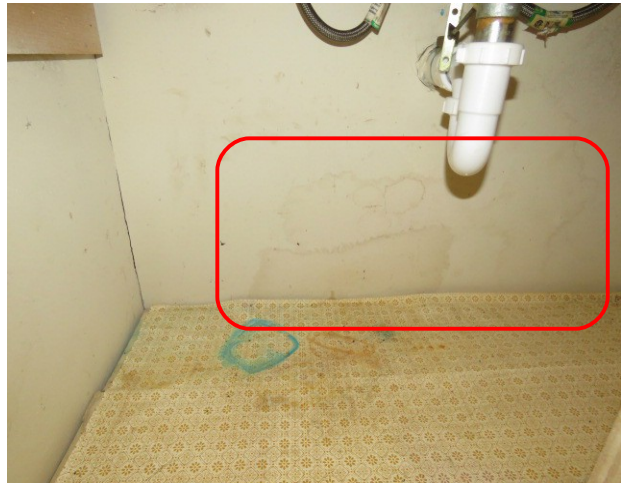
- Water stain noted on garage wall and utility room bathroom. Stains did not appear to be recent. Further investigate condition and root cause as needed.

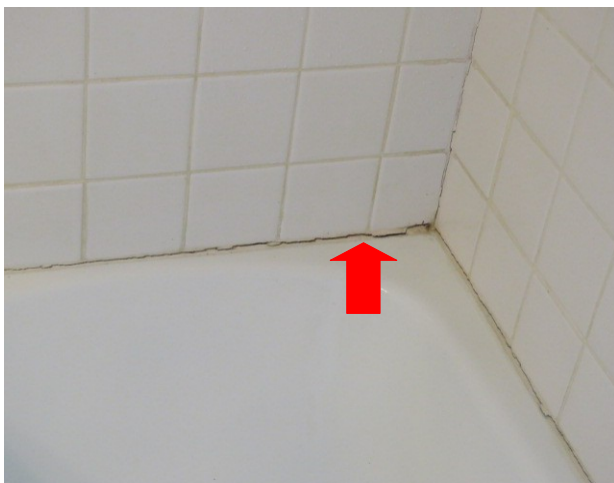
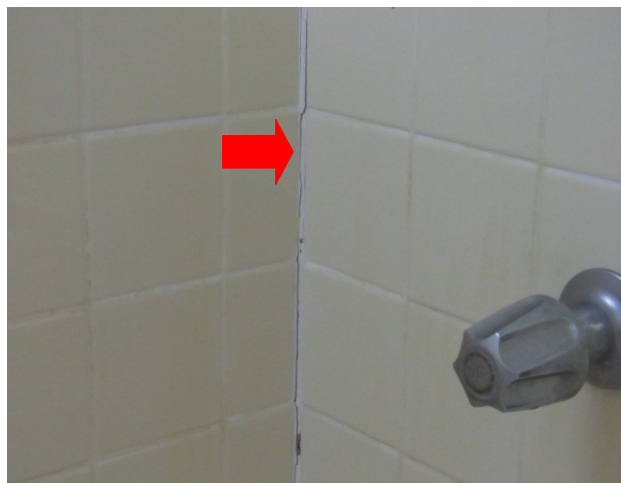
- Properly seal gaps in and around shower enclosures to avoid water infiltration and damage to property

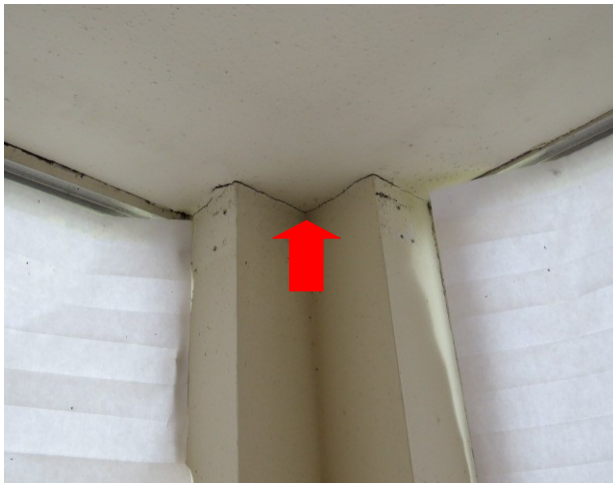
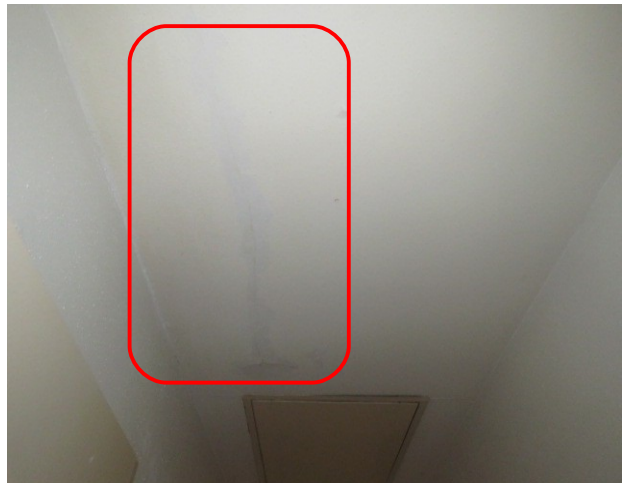
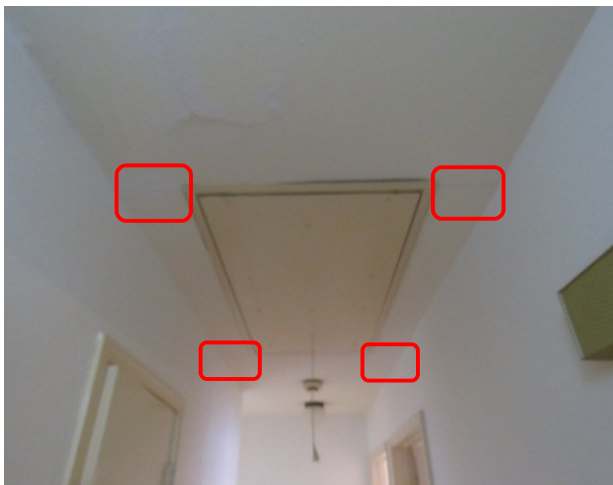
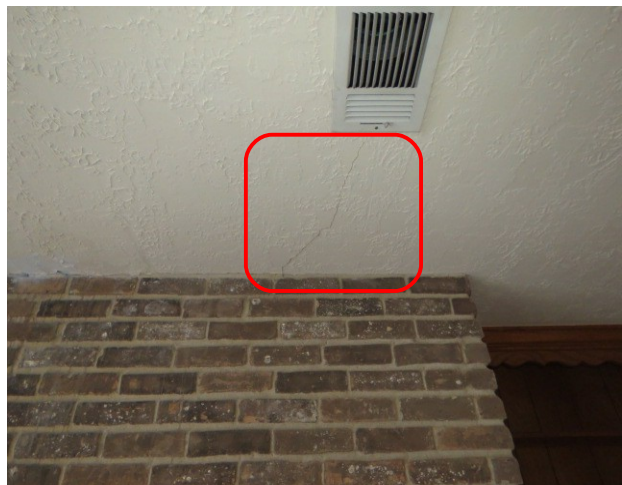
- There was separation, wrinkled joint tape, and cracks on multiple ceilings that may also be associated with the evident foundation repair. Recommend to monitor condition over time. Should the condition continue to deteriorate, consult with a structural engineer to further assess the integrity of the foundation slab. Samples below.

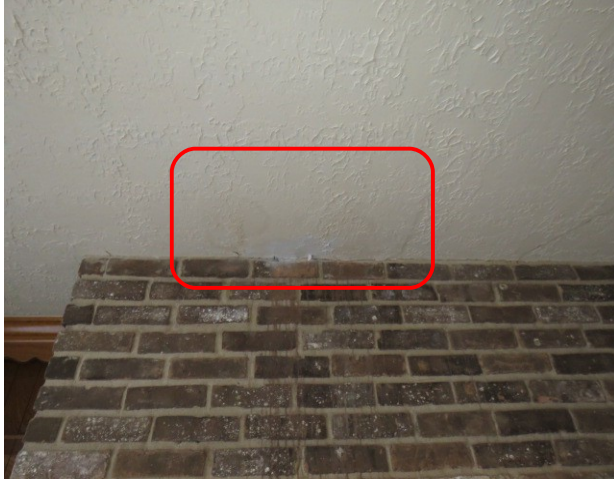
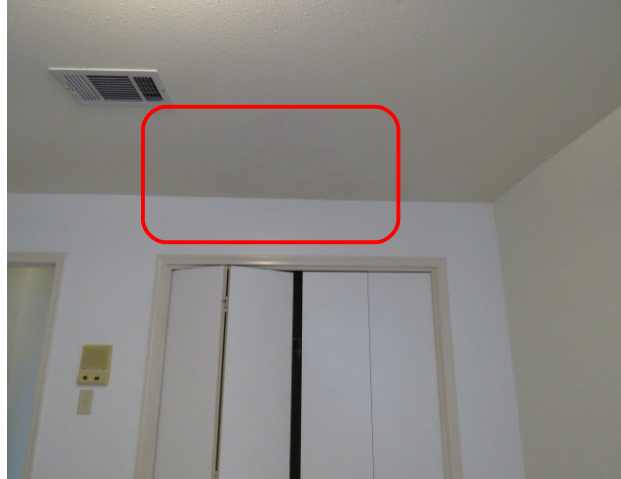
- Noted water stains on living room and front right bedroom ceiling. Further investigate root cause and confirm that all affected areas such as but not limited to: sheetrock, insulation, joists, etc, have been properly repaired/treated by a qualified contractor. Note: If not properly repaired and or treated, it can lead to microbial growth

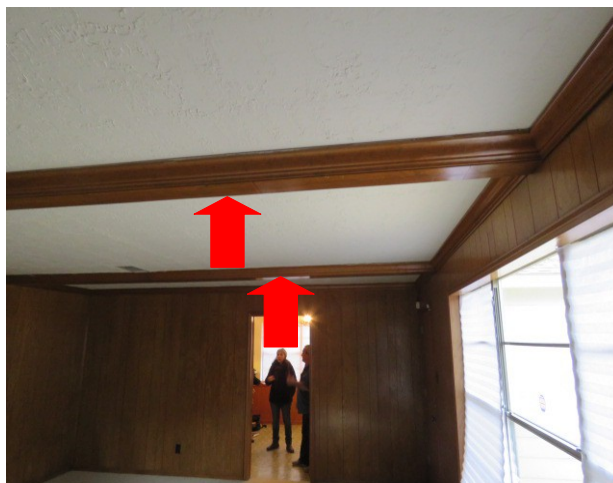
- Living room ceiling beams are pulling away from the ceiling. In need of proper repair for safety.

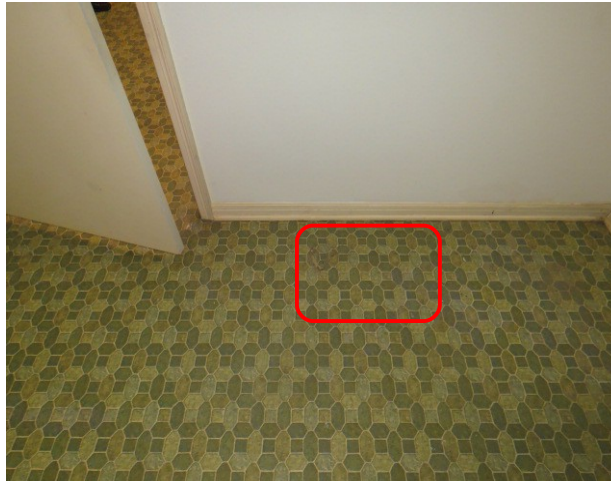
- Damaged flooring noted in the utility room. Recommend proper repair as needed.

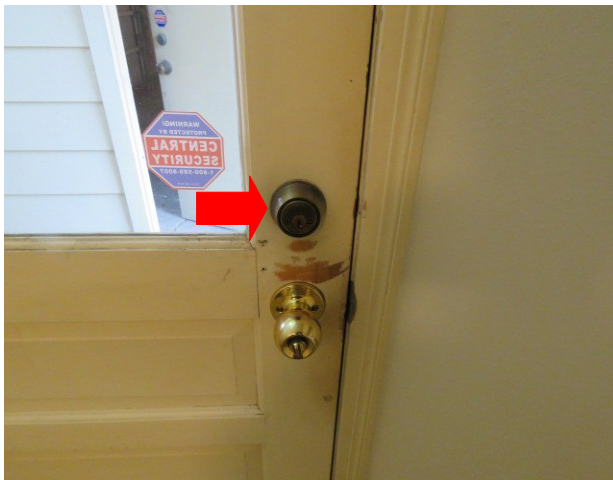
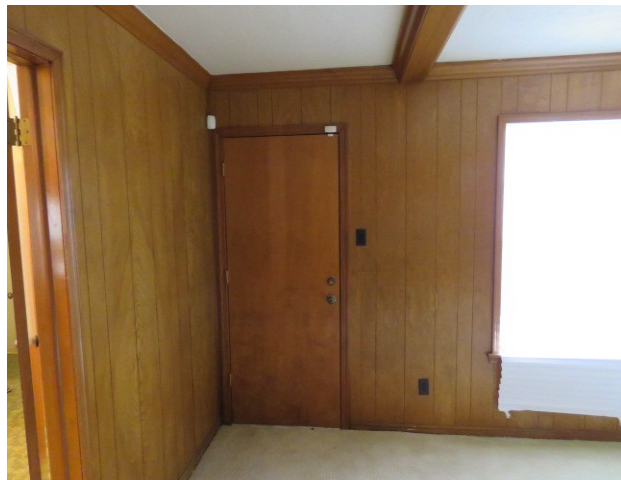
- Double key deadbolt on multiple doors. Note: while this feature improves security, it may also hinder access/egress in the event of an emergency.. Recommend the single key deadbolt for safety
- Inspector was unable to operate the living room exterior door due to an inoperable double key dead bolt. In need of repair for safety.

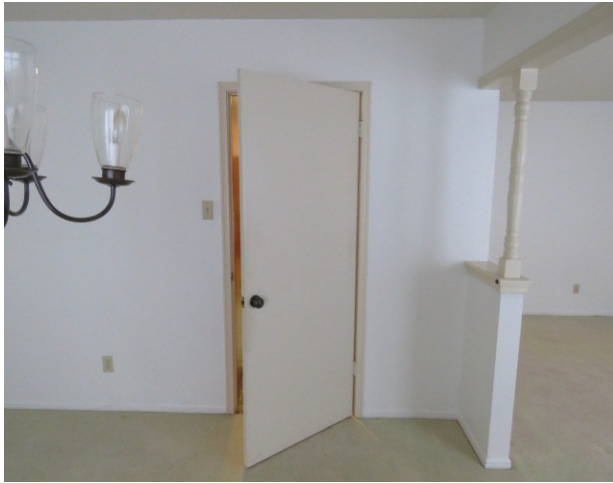
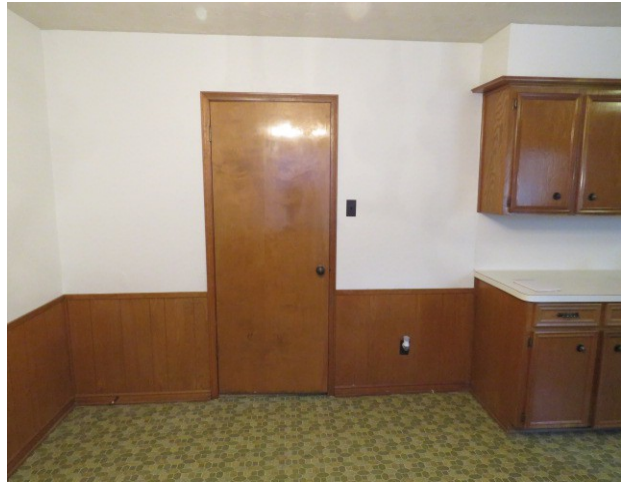
- Observed stiff kitchen door and multiple doors that swing open/closed. These conditions may also be associated with the evident foundation repair. Investigate root cause and properly repair

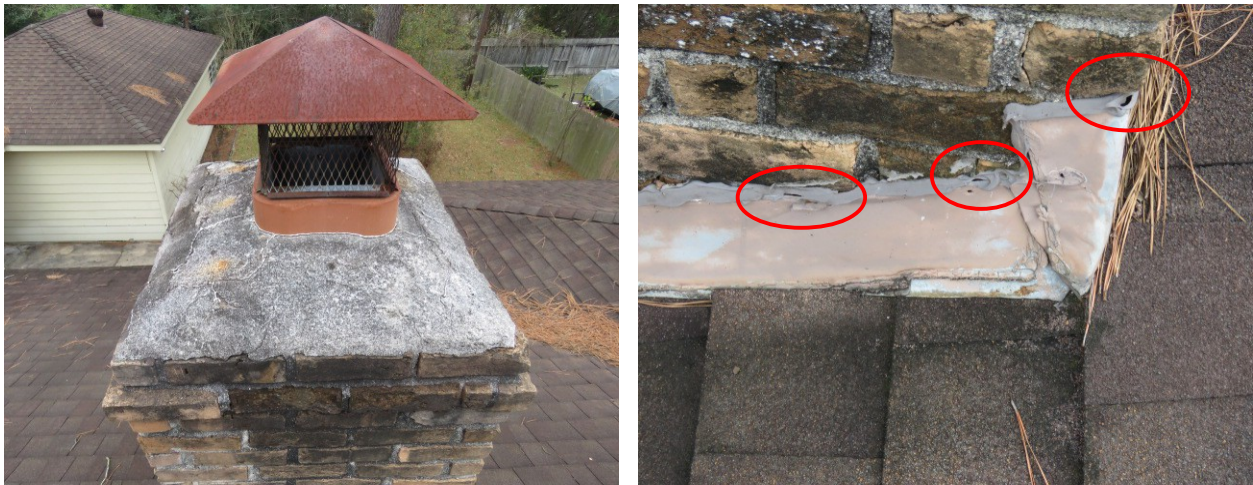
- Properly seal cracks in chimney cap to prevent possible water penetration.
- Repair deteriorated caulking on flashing details to prevent water penetration.

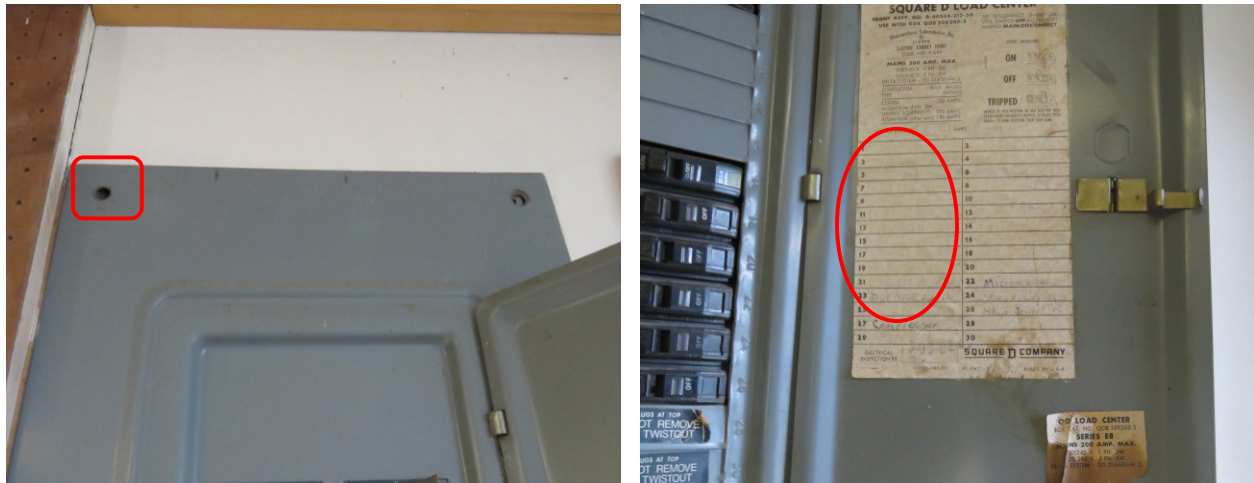
- Service panel is missing fasteners. Install proper flat tip fasteners to secure panel.
- Noted missing circuit breaker ID labels. Accurately identify each breaker according to their function

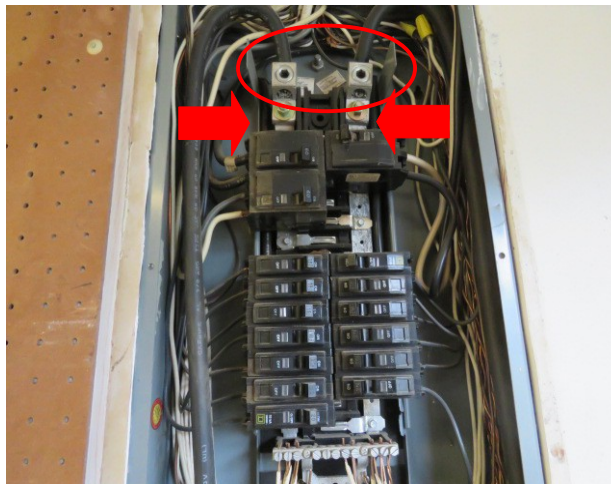
- The Main disconnect is not present in the service panel. Maximum 6 disconnects to shut off power. Consult with a licensed electrician for proper installation of same for safety.
- No anti-oxidant compound on feeder aluminum cables. As oxide builds and continues to build on aluminum wires, it also builds up resistance. Recommend Alnox or Penetrox A13k

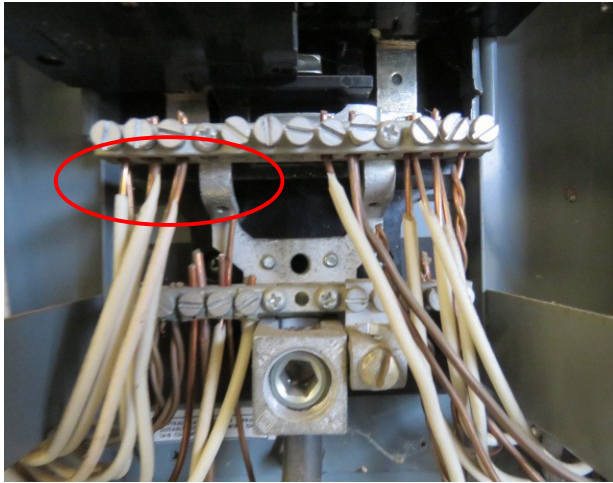
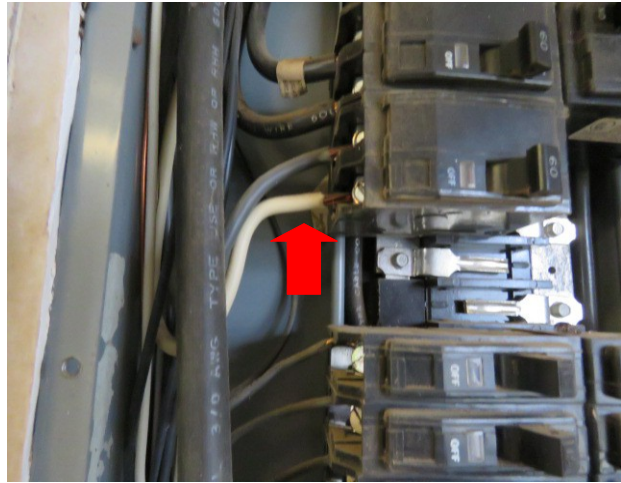
- Observed double tapping of neutral wires. This condition may be hazardous and may cause "Overheating". Insert one wire per terminal
- Neutral wires are used as HOT wires. Neutral wires can be used as HOT wires when these are properly identified: Use of colored tape such as black, red etc is acceptable
- 60 amp circuit breaker appears to have mismatched wire gauge. Recommend to consult with a licensed electrician for proper repairs.

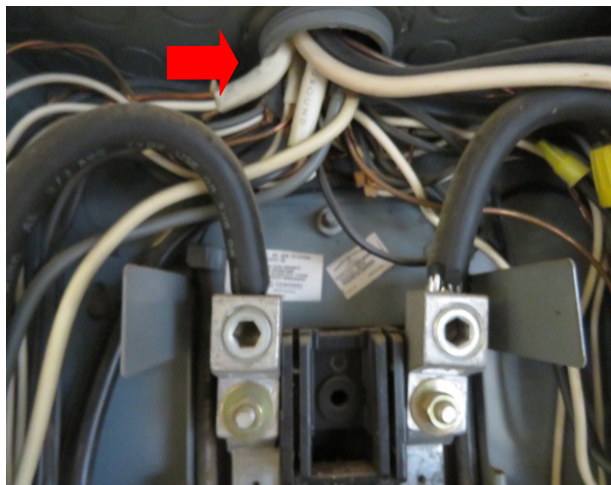
- Branch conductors were bundled and pass through a single penetration in the panel cabinet. Such constriction of conductors may generate excessive heat and de-rate the ampereage of the cables.

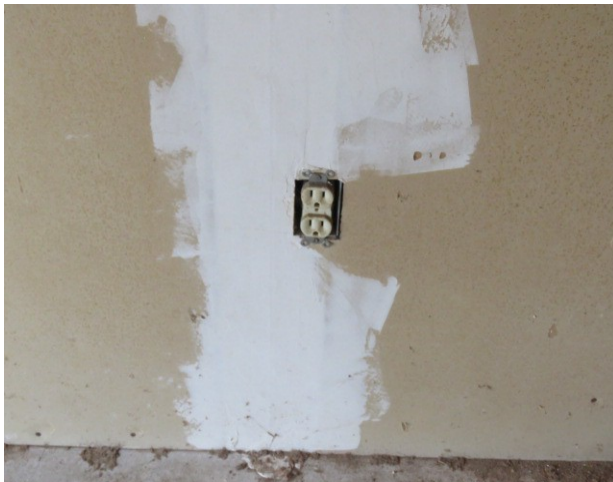
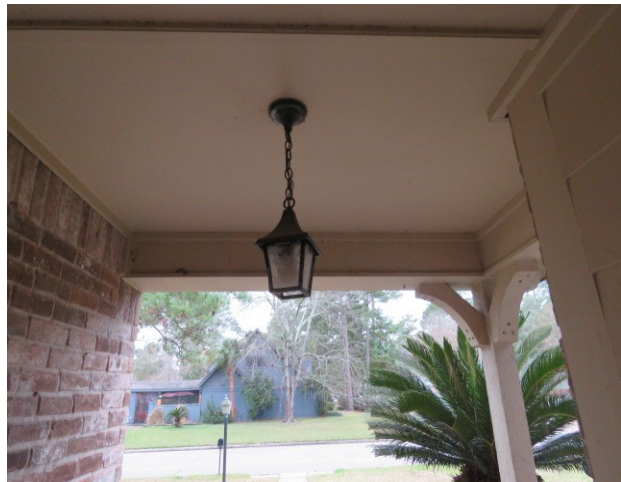
- Install missing face plate on outlets and switches for personal safety
- Repair defective light fixtures/bulbs where needed

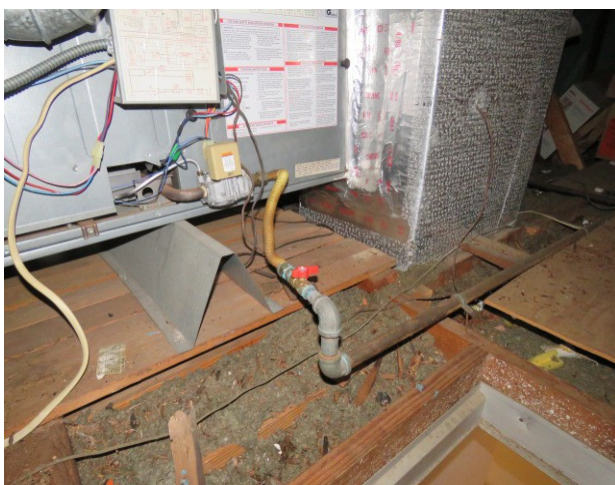
- Inspector was not able to test the gas furnace due to gas valve being in the off position at the time of inspection and only visual inspection was performed. Recommend proper testing of same.
- Inspector was not able to verify bonding of the metal gas supply piping. **Note:** The metal gas supply piping should be grounded or bonded to the electrical system. Recommend verification and/or installation of same for safety precautions.
- No sediment trap noted at gas line between shutoff valve and main gas valve. Recommend installation of same.

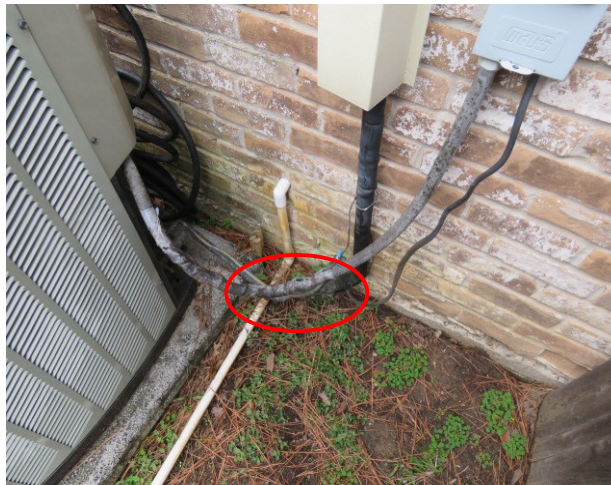
- NOTE: AC systems could not be tested at this time due to ambient temperature being approx 49°F the day of the inspection. It's recommended not to run ac systems when ambient temperatures are below 60°F to prevent damage to system components such as compressor unit, etc. Only a visual inspection was performed. Recommend proper testing/inspection of same by a qualified HVAC contractor.
- The condenser unit is not secured to pad. Properly mount to prevent damage from movement/vibration.
- The liquid line dryer is not evident at this time. Note: the filter dryer is an accessory that performs the function of filtering out particles and removing and holding moisture to prevent it from circulating through the system

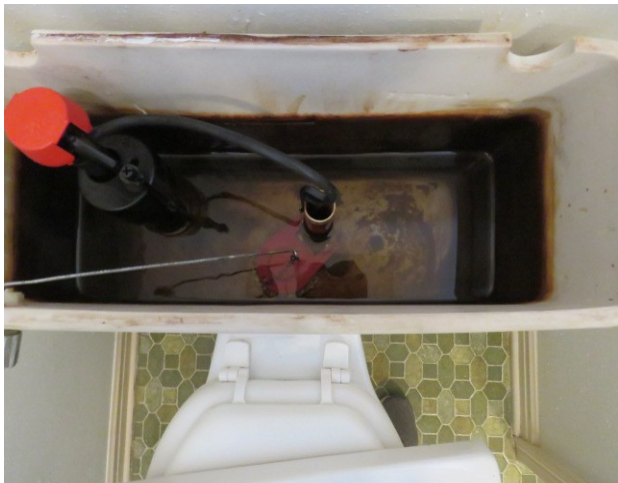
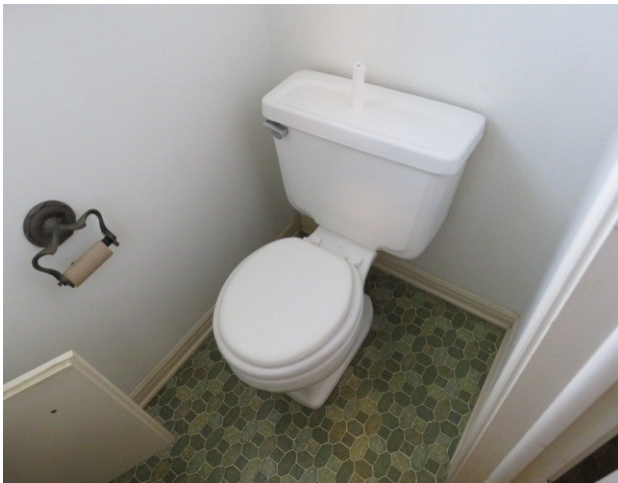
- Sediment/rust noted in multiple toilet tanks. This condition may be caused by rust in galvanized water supply piping. Recommend to consult with a licensed plumber for thorough inspection of piping and properly repair or replace as needed.
- Also noted loose toilet in utility room bathroom. Properly secure it to avoid water leaks
Note: If excessive movement of toilet is noticed, we recommend that the wax ring be replaced.

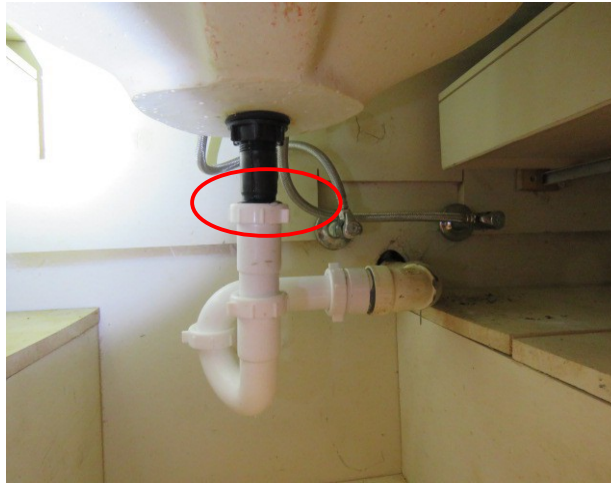
- Leak noted in the hallway bathroom. Properly repair to prevent damage to property.
