PROPERTY INSPECTION REPORT

Concerning: Kleinwood Dr. Spring, TX 77379
(Address or Other Identification of Inspected Property):

By: Giovanni Angel, 22909 12/29/2018
(Name and License Number of Inspector) (Date)

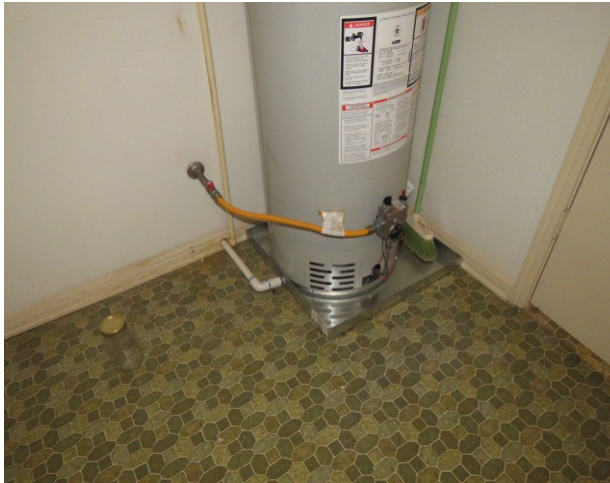
- Missing “Sediment Trap” (or drip leg). The idea is to trap all debris running through the gas line to prevent damage to main gas valve
Note: Sediment traps should be installed ahead of shut off valves to water heater.

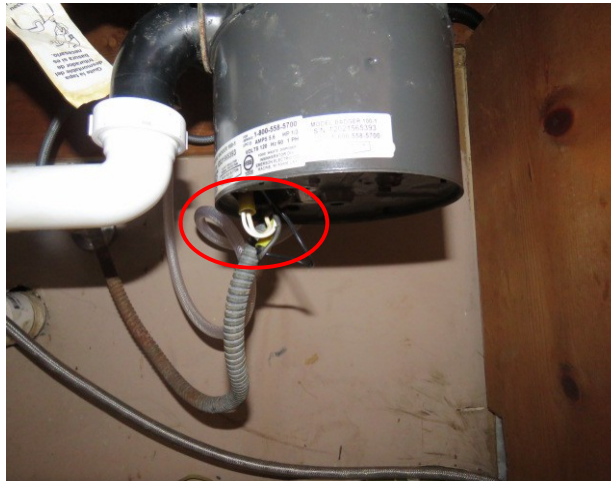
- Install missing clamp on power cord to protect cable from damage due to excessive movement
