VISTA R. E. INSPECTIONS

PROPERTY INSPECTION REPORT

Prepared For:	R. W.	
	(Name of Client)	
Concerning:	xxxx Nacogdoches Valley Dr, League City, Tx 77573	
	(Address or Other Identification of Inspected Property):	
By:	Felix Angel, 20185	10/16/2018
	(Name and License Number of Inspector)	(Date)
	N/A	
	(Name, License Number of Sponsoring Inspector)

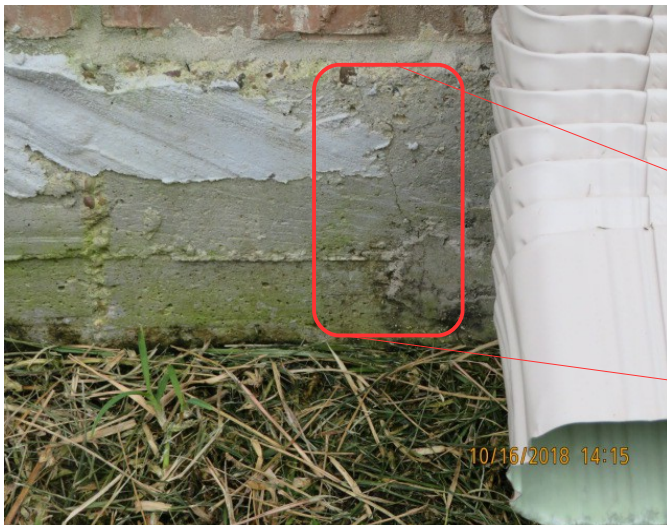
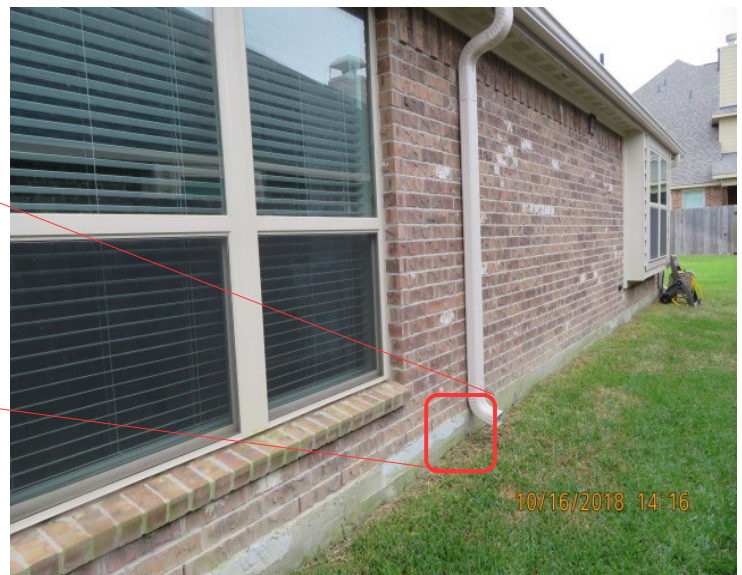
- Observed a hairline crack on right slab wall.
Consult a professional such as a structural engineer, to further assess the integrity of the foundation and determine corrective actions to be taken if any at this time. Engineer's report may serve as baseline against future observations of movement.

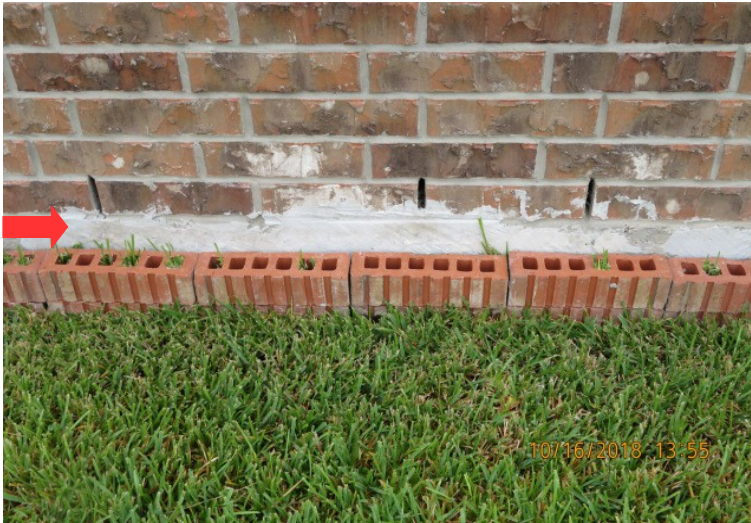
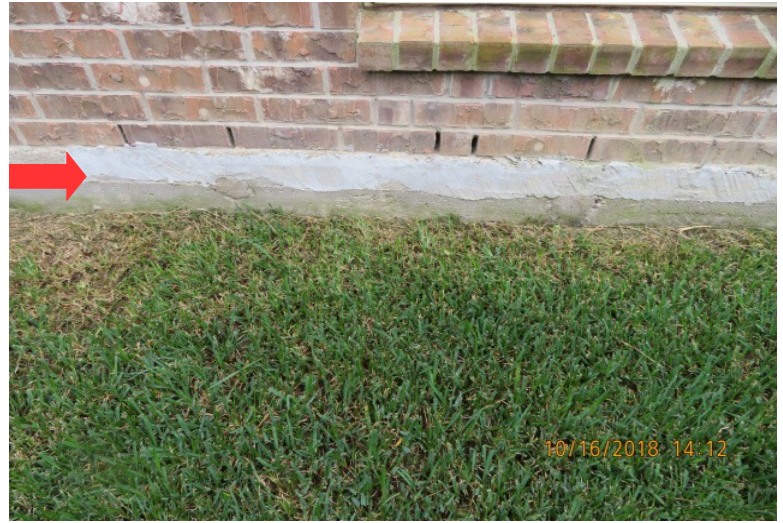
- Evidence of slab repairs. Repairs could have been cosmetic type such as “popcorn concrete, etc Investigate further as needed

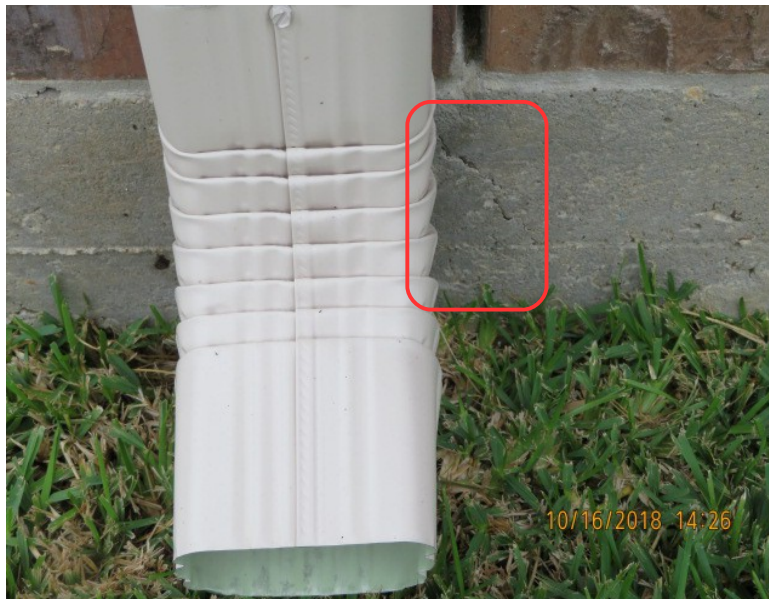
- Observed what appeared to be spalling on left rear corner.
Note: This usually is caused by thermal expansion of the brick wall and a typical tight connection connecting the brick and concrete surface. The brick will expand in the hot weather and will put forth a force adequate to shear the corner from the foundation. This is quite common and is not to be considered a structural defect. If concerned, consult a professional for a second opinion

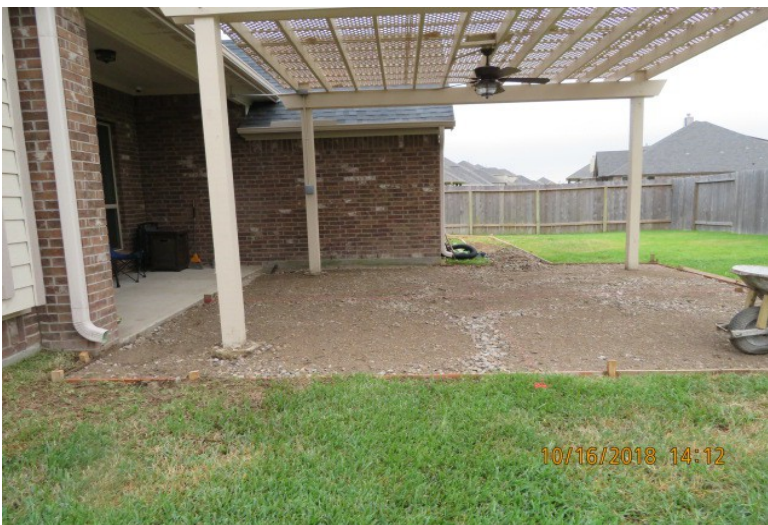
- Work in progress of patio doesn't seem to be properly sloped. Inspector doesn't know or cannot determine what the final slope will look like at this time. Recommend proper sloping (away) to avoid standing water near the structure which could possibly affect the foundation.

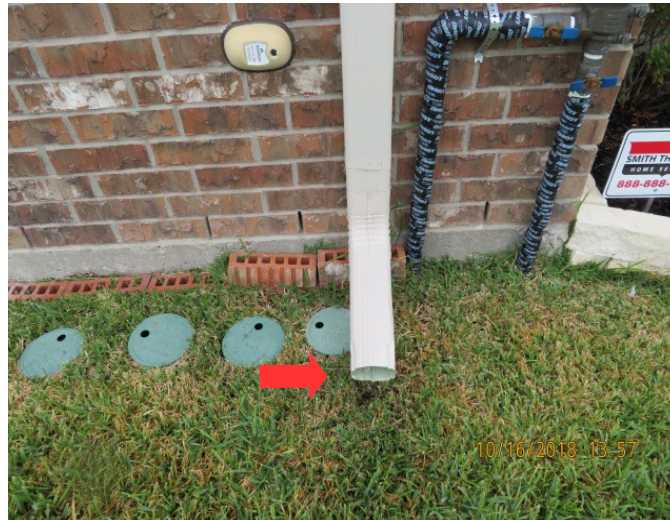
- Install missing splash blocks at all gutter spouts to properly divert water away from the foundation

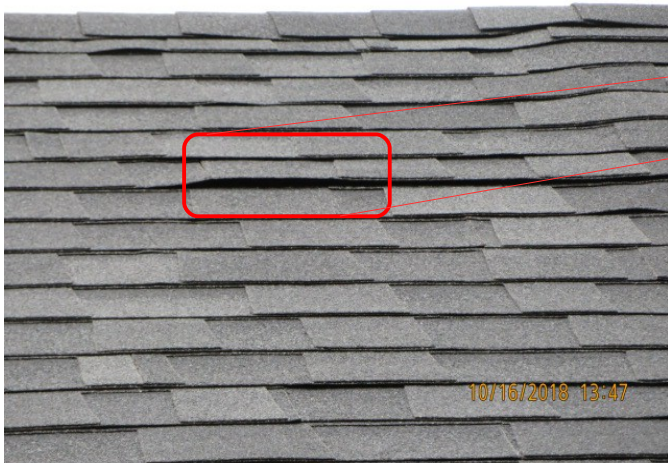
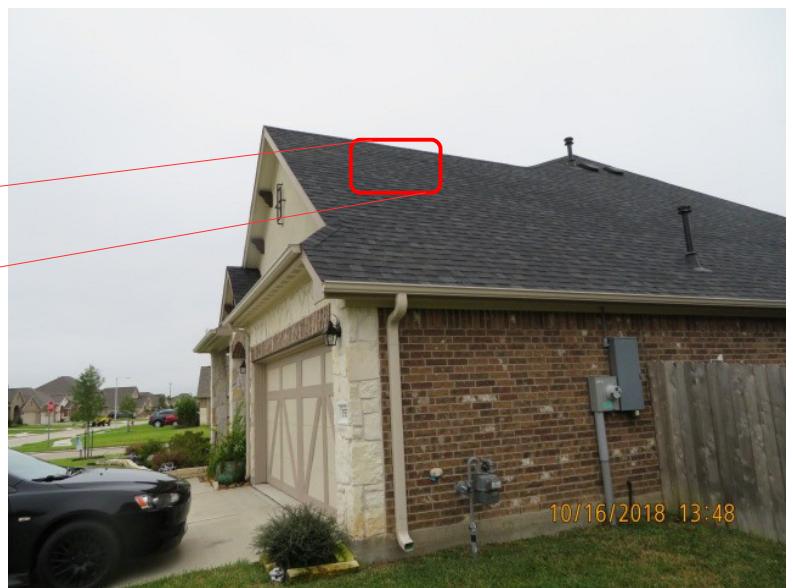
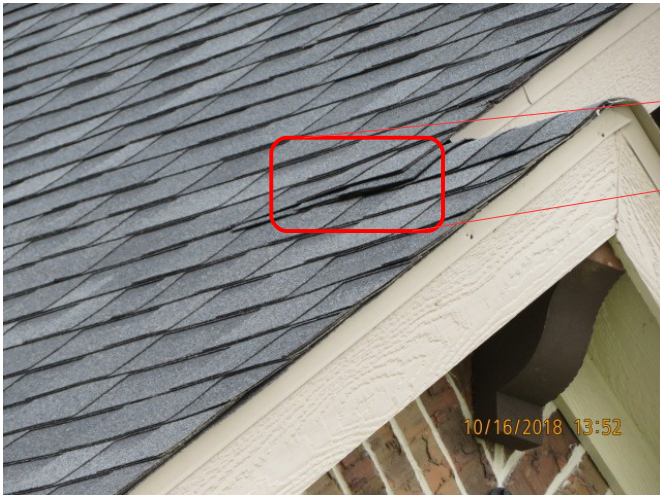
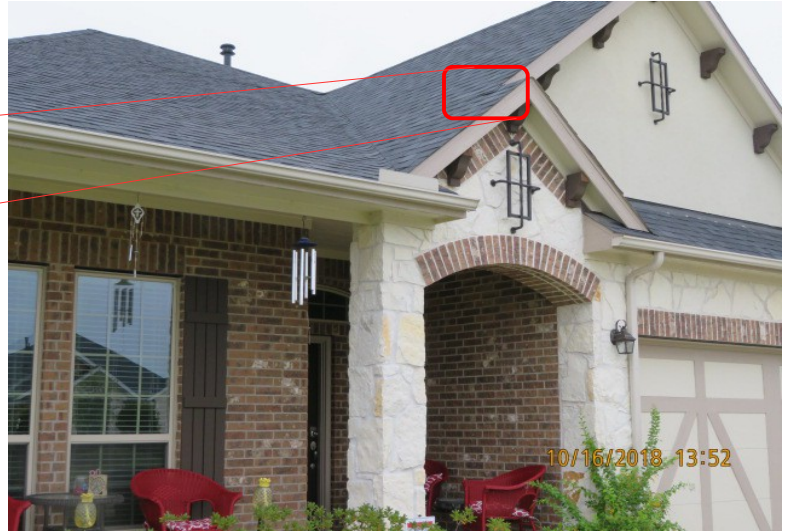
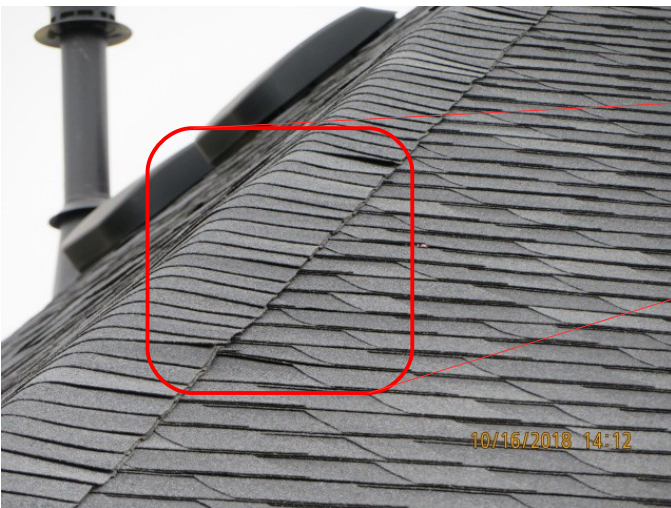
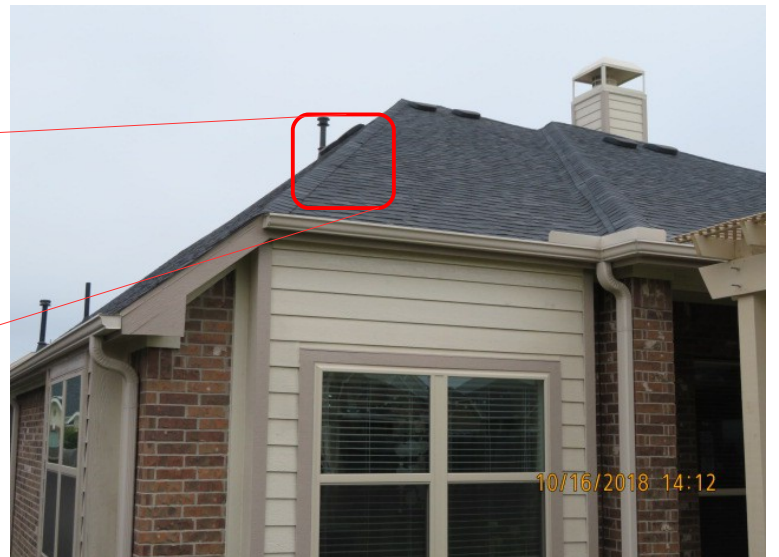
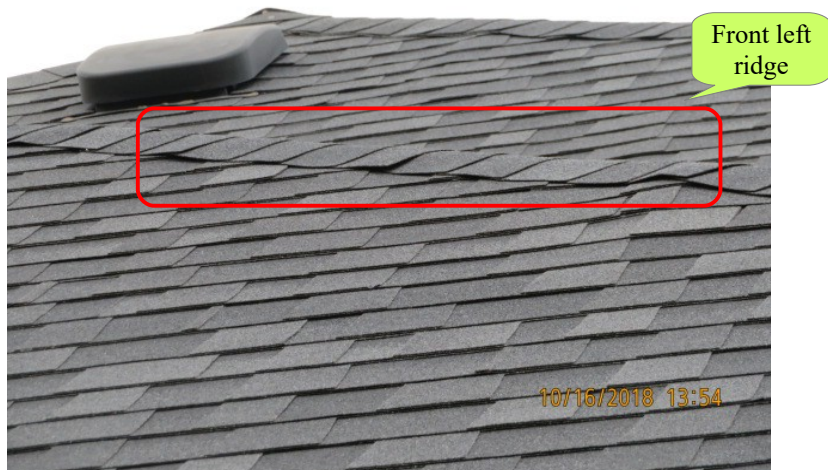
- Observed slightly lifting shingles at multiple locations . Properly repair to avoid further deterioration and possible water intrusion

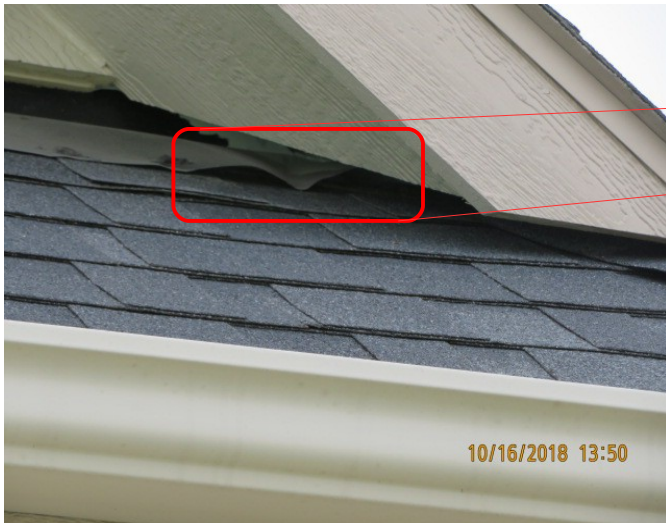
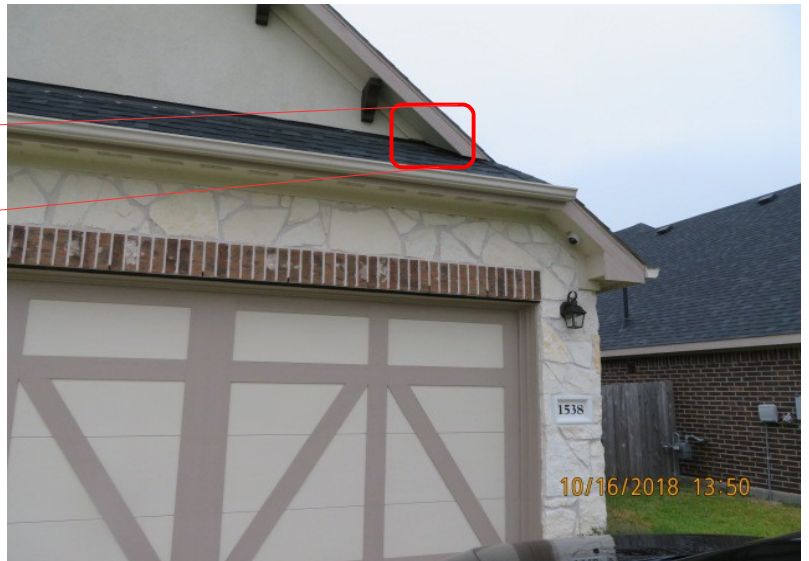
- Observed also, lifted/damaged flashing on front right corner/gable. Properly repair to prevent further deterioration and possible future water intrusion.

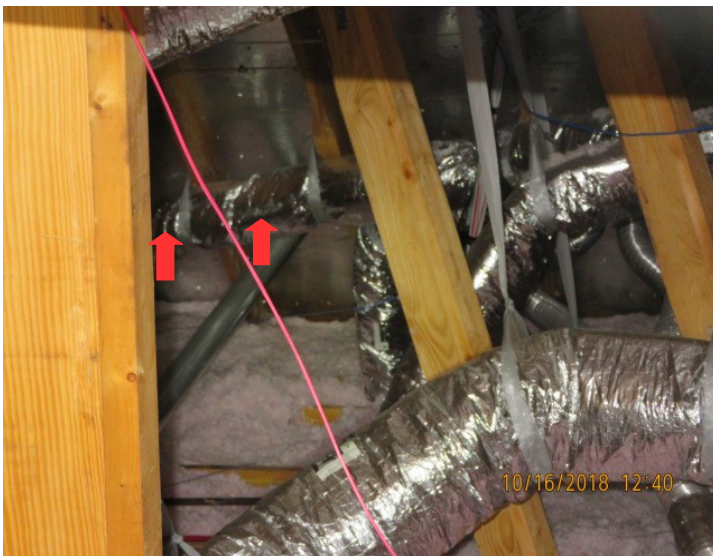
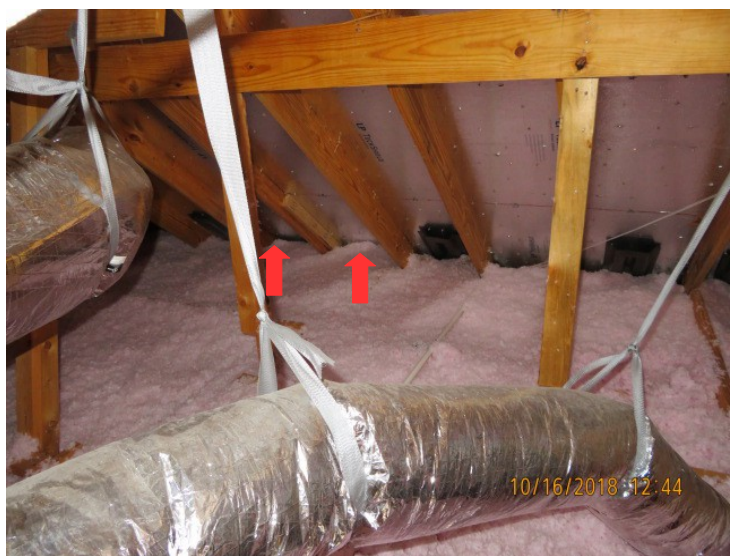
- Noted missing baffles on at least two locations. Install them where needed to avoid blocking of soffits and for proper attic ventilation

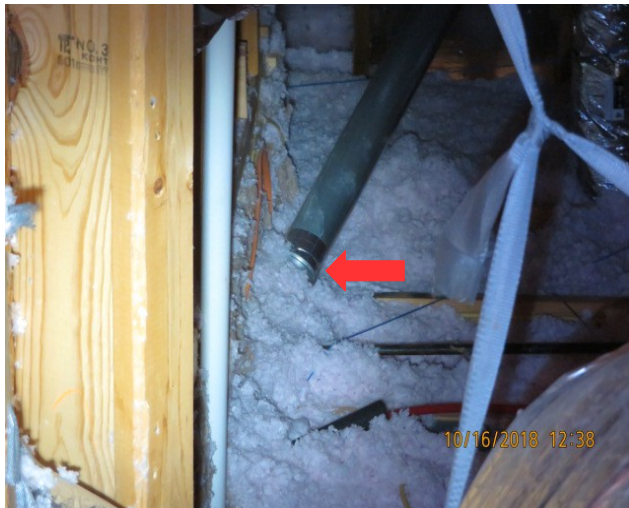
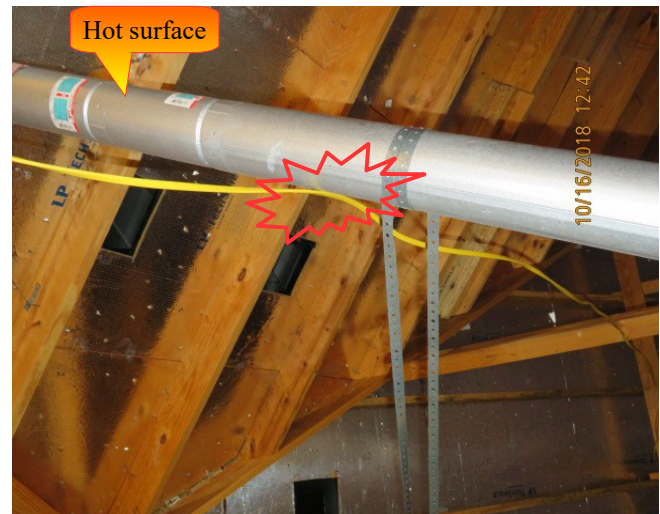
- Observed insulation in contact with an exhaust. There should be a min clearance of 1" for double wall/type "B" and 3" for single wall exhausts. In need of repair
- Yellow wire in contact with furnace exhaust. Recommend enough clearance for safety

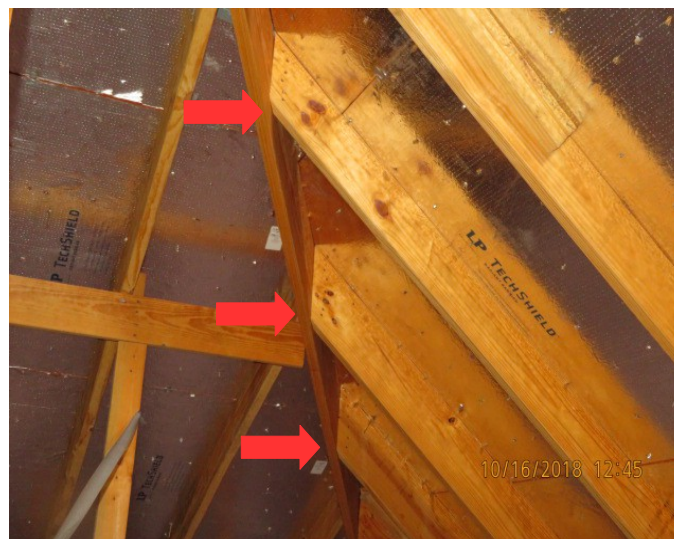
- Observed different width on rafters installed, ex: 2x10 and 2x12" (above kitchen/breakfast area). Consult with a structural engineer for assessment and or possible required corrections as needed

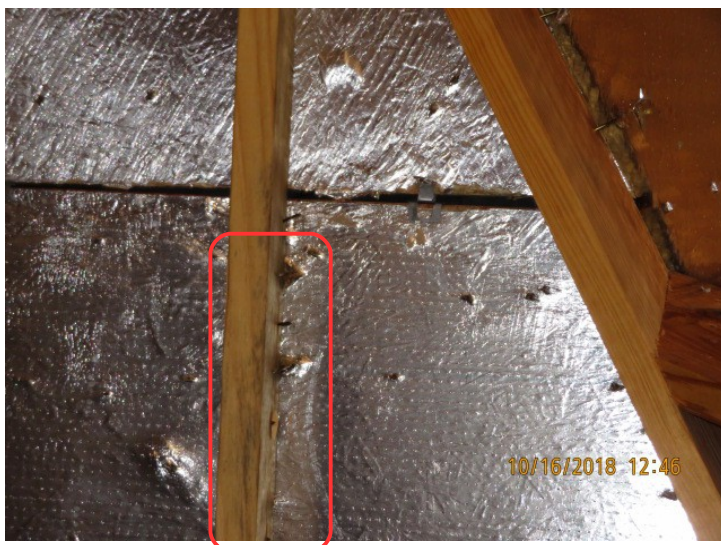
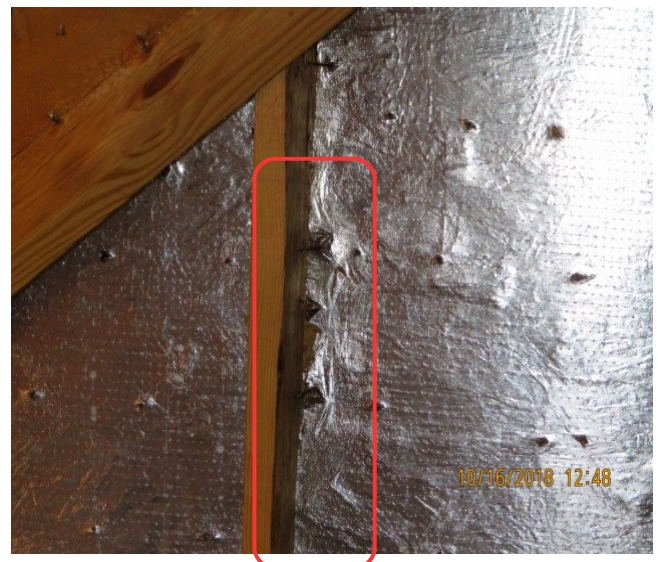
- Noted damaged radiant barrier by nails and bubbling foil at more than two locations. Properly monitor for possible future water infiltration at these locations and or repair at this time as needed

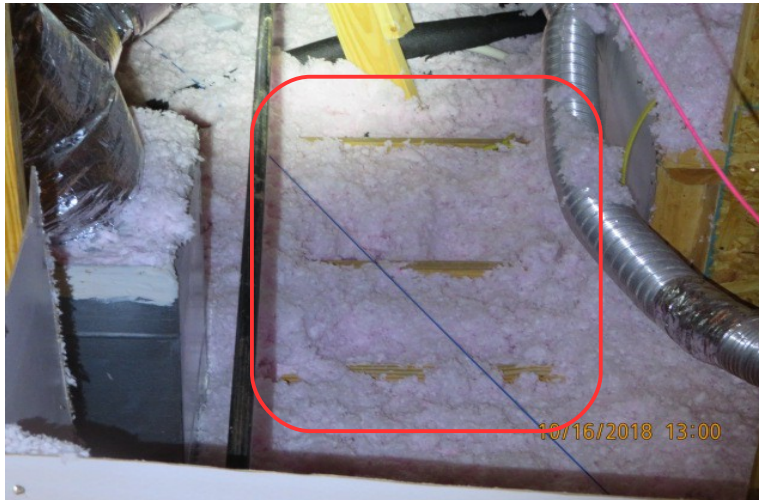
- Observed also, shallow insulation behind ac/heat equipment. Add required amount for energy efficiency

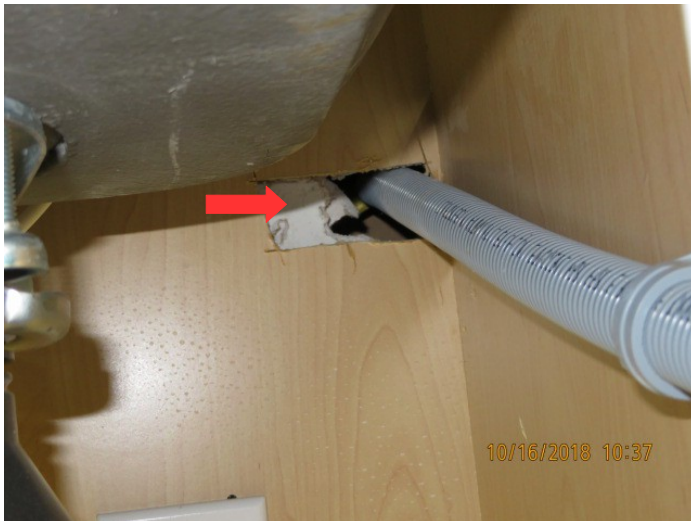
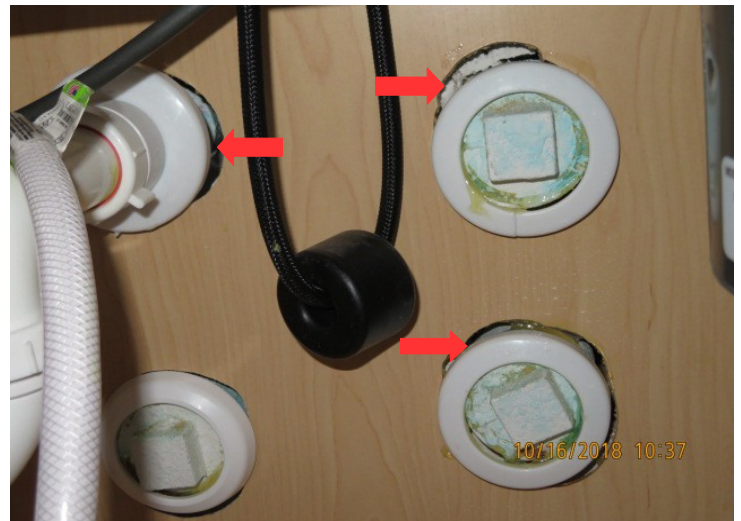
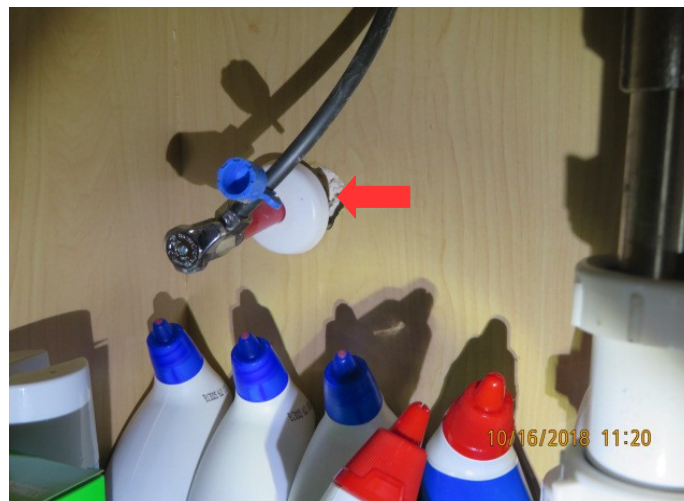
- Recommend to properly seal holes and gaps on interior walls such as on plumbing line penetrations for energy efficiency.

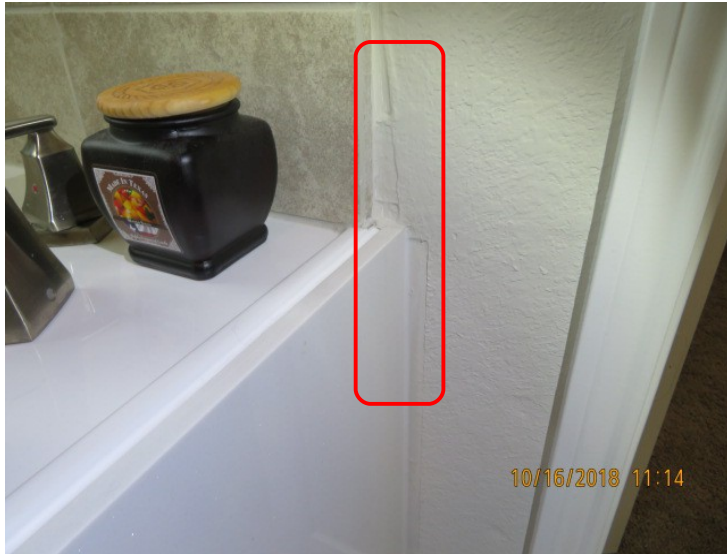
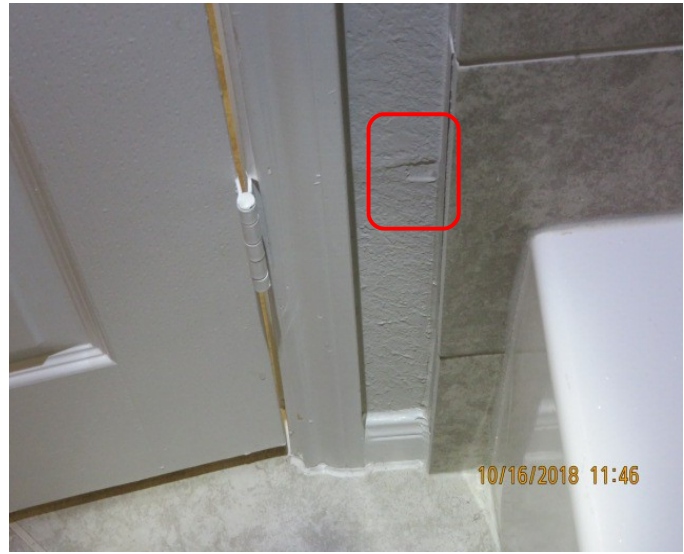
- Noticed poor workmanship on bathroom walls. Properly finish wall surface as needed

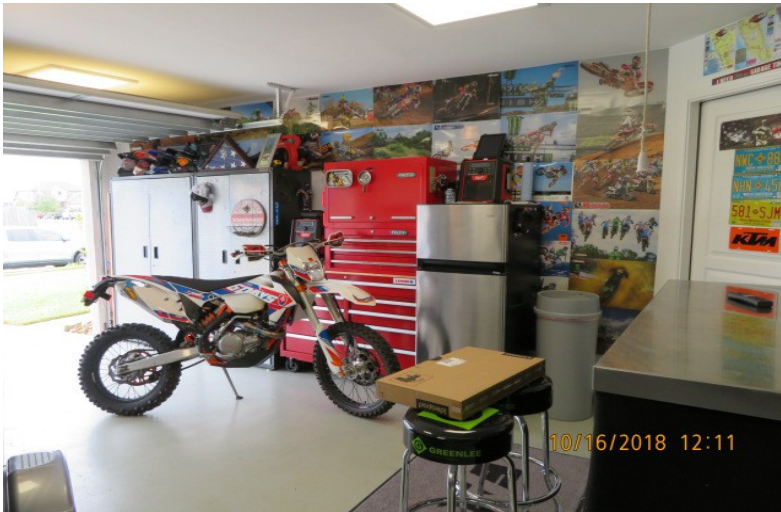
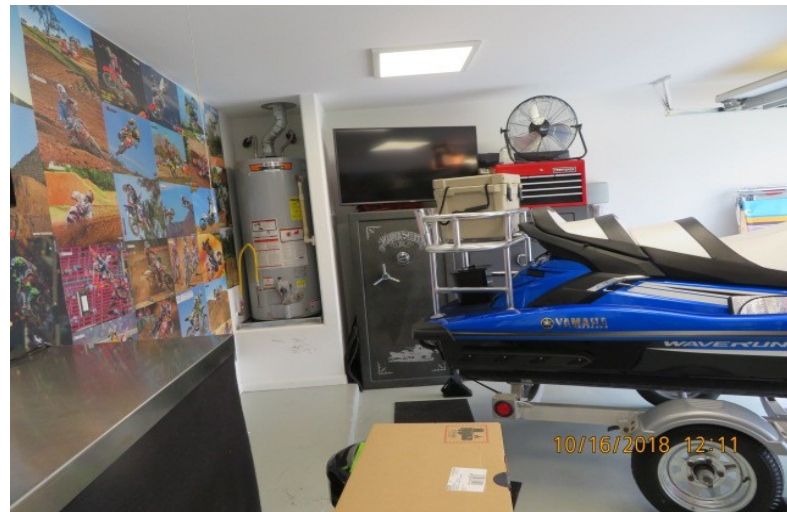
- Walls in garage were not fully accessible to check condition of walls, outlets, etc, at this time.

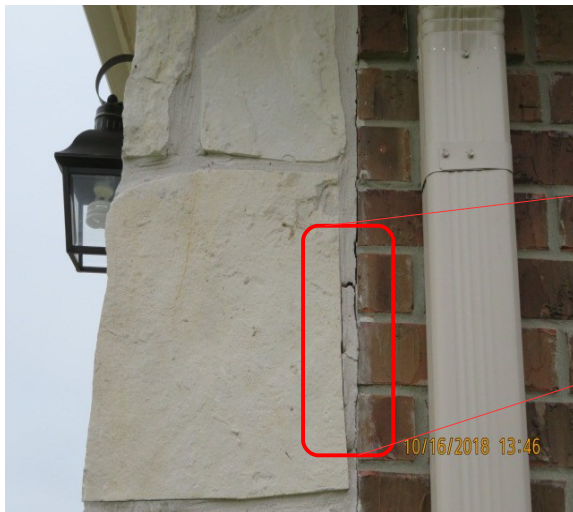
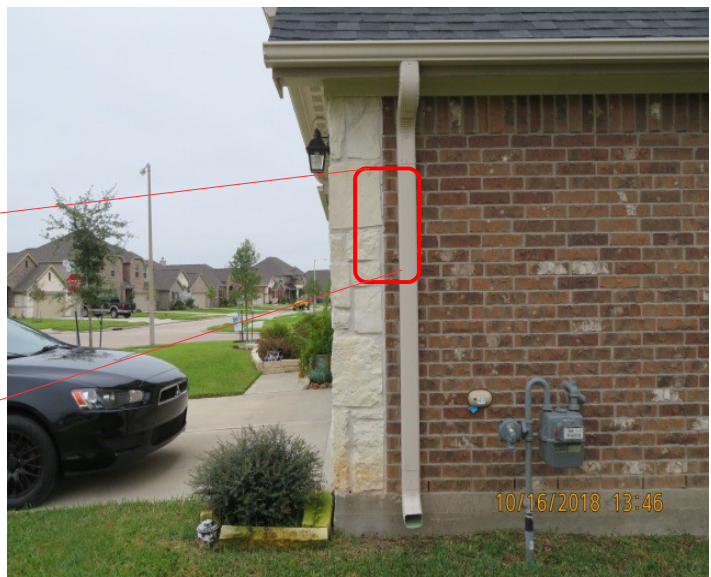
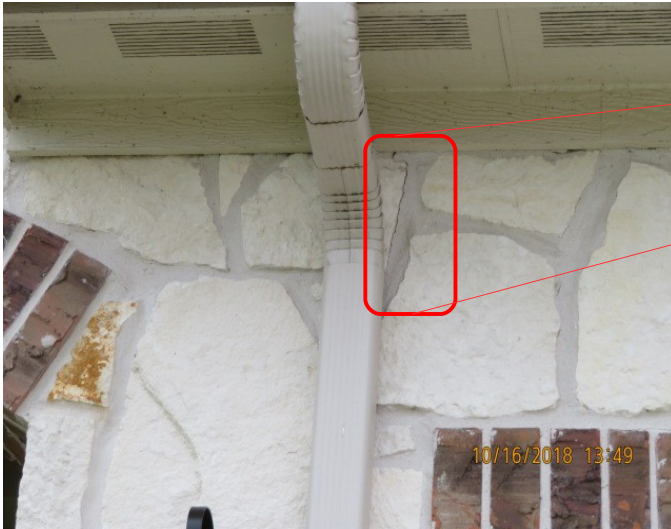
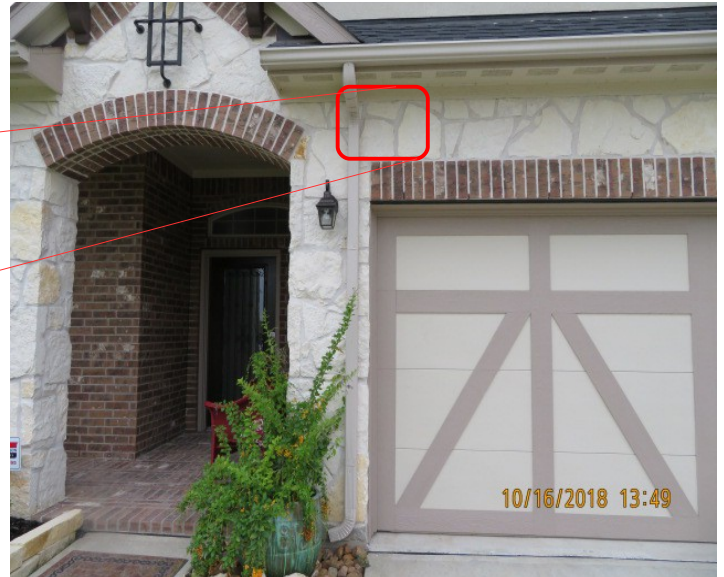
- Noticed cracking mortar on right and front corners. Appeared to be caused by poor workmanship. In need of repair

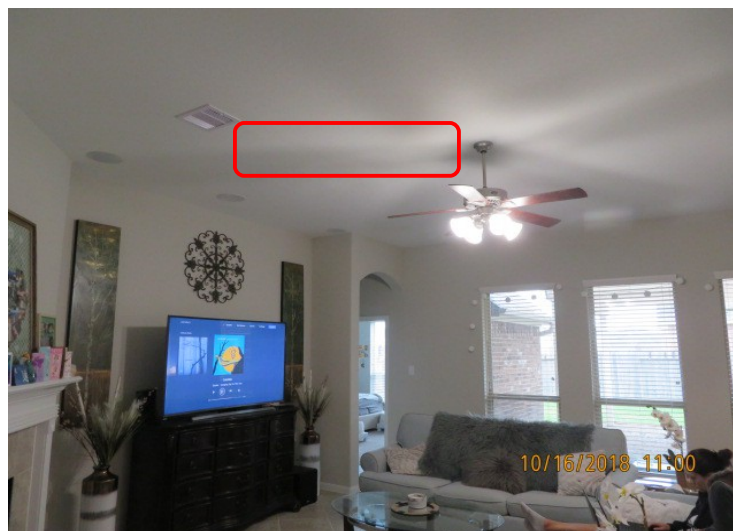
- Hairline crack was observed in living room. This could be associated with house settlement or the joint of sheetrock boards. Monitor over time and seek for professional assistance should existing condition deteriorates further

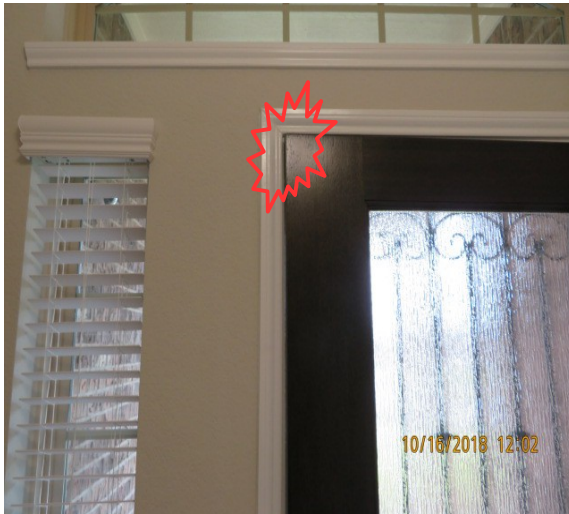
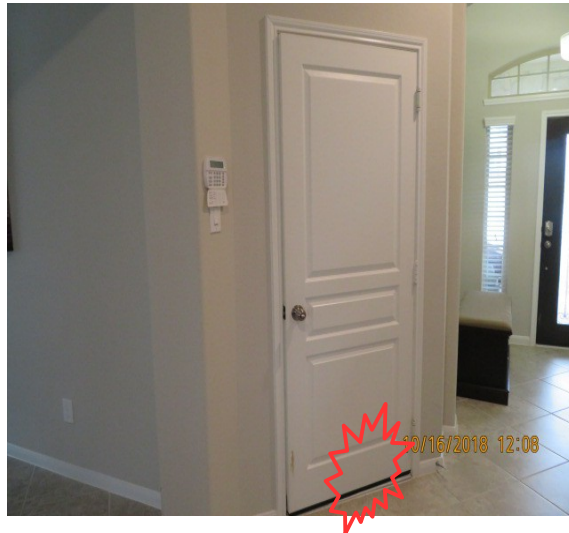
- Glass on front entrance door does not appear to be safety/tempered glass. Note: Proper use of safety glass is critical in areas that are subject to human impact. Per building code [308.3], correct safety glass must meet 16 CFR 1201 class II impact standard
- Noticed stiffness on front entrance and garage interior doors. Properly repair by a qualified person
- The garage interior door has self-closing hinges but, these do not shut door completely. Properly adjust/repair

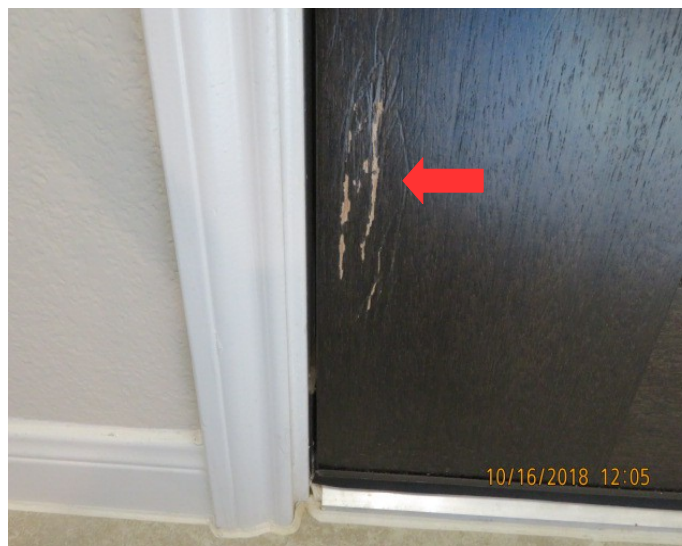
- Cosmetic: Front door surface appeared to be deteriorating. Repair as needed

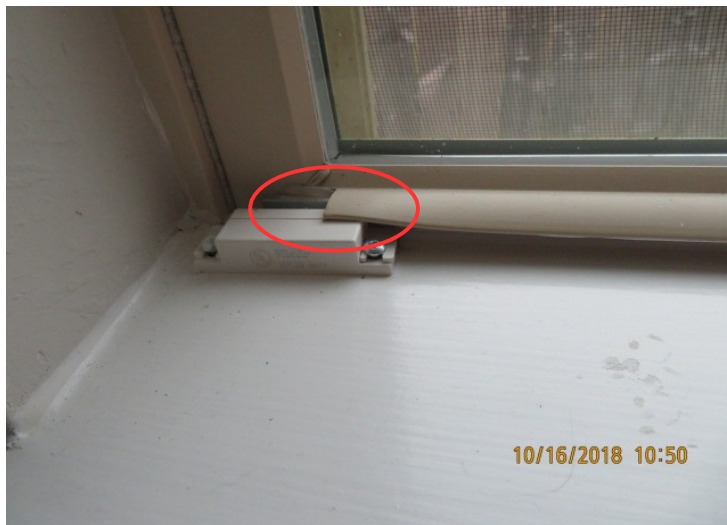
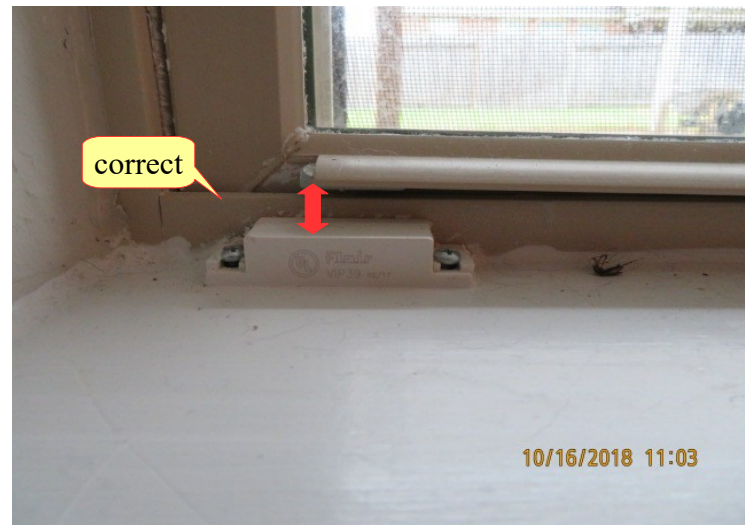
- Breakfast area windows: Bottom frame of window is resting on security system sensors. Properly repair to prevent damage to sensors and frame.

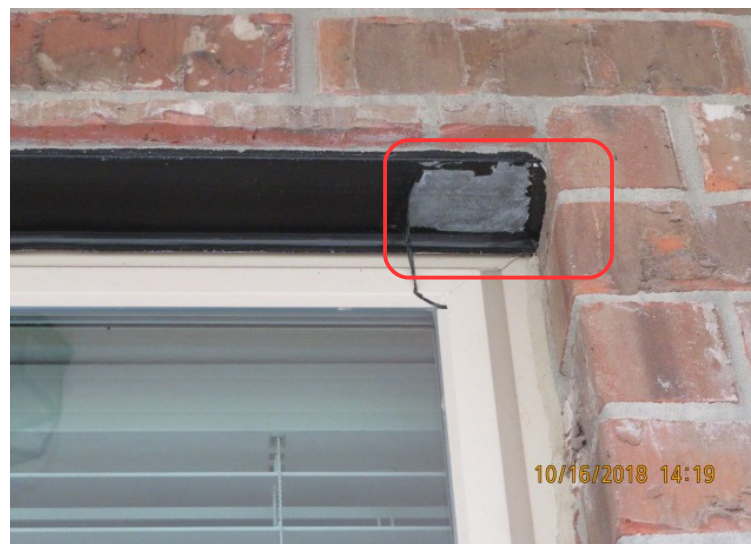
- Paint is coming off the metal lintel on at least one rear window. It appeared that window was not properly prepared with primer before applying the paint (final finish). Confirm that anti-corrosive primer and paints area utilized when repairing this and other exterior windows with similar issue. Note: The expansion or failure of corroded steel during this process may cause brick and mortar cracks and affect the wall integrity.

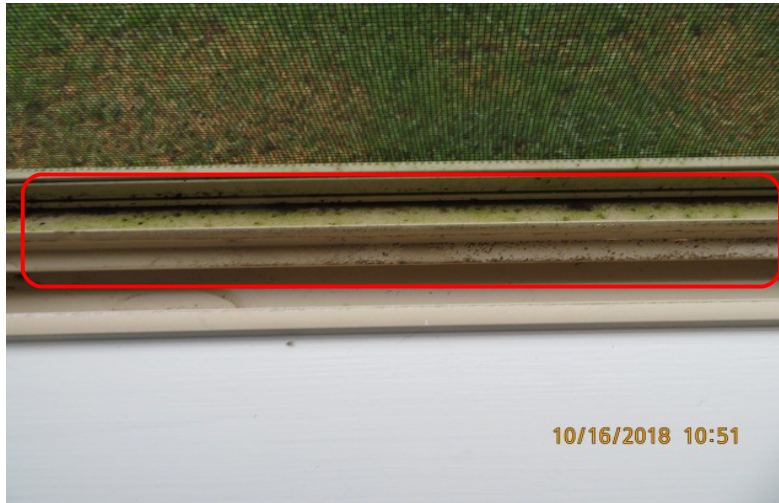
- Noticed mildew/algae on a right window frame. Investigate root cause and properly repair

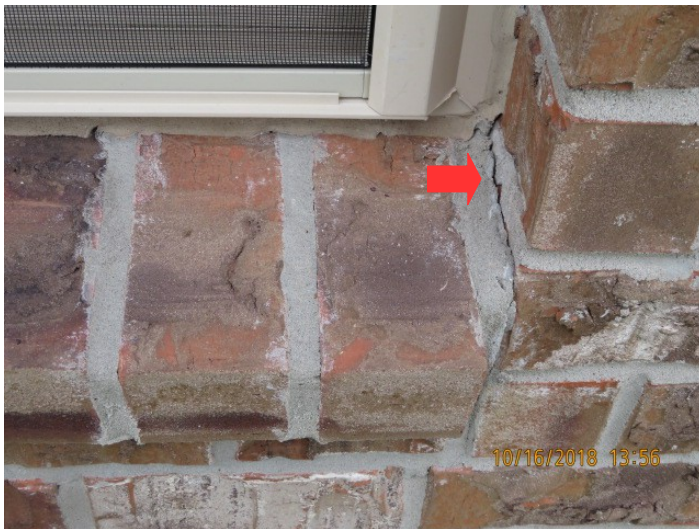
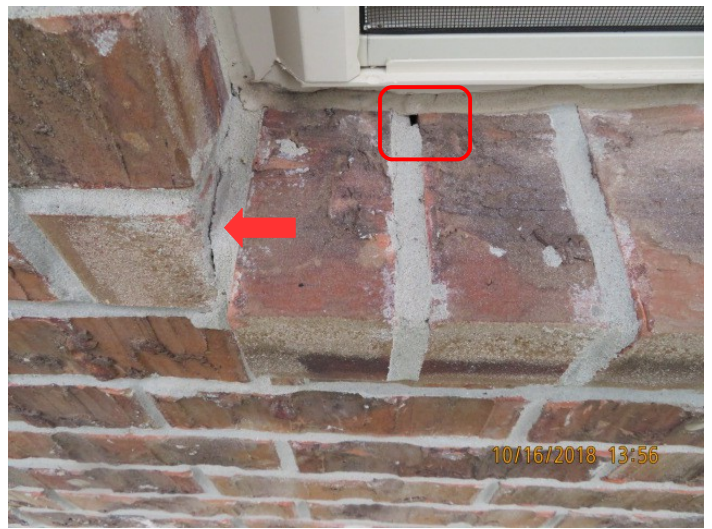
- Properly replace deteriorated mortar/caulking on exterior windows to avoid water infiltration and damage to framing

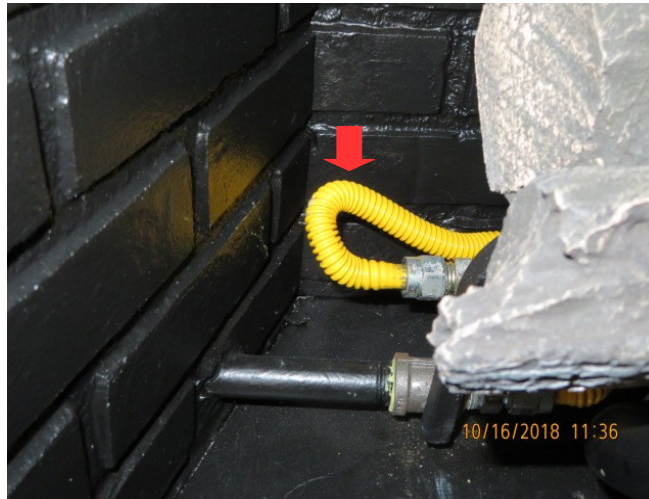
- Fireplace was not functional at this time. Inspector tried to light it with no success. Homeowner stated that builder/contractor could not light it on two previous occasions either. Investigate root cause and service/repair by a qualified contractor or manufacturer
- Noticed what appeared to be csst gas connector inside the firebox. Top layer of connector is plastic and perhaps flammable. In need of proper repair for safety

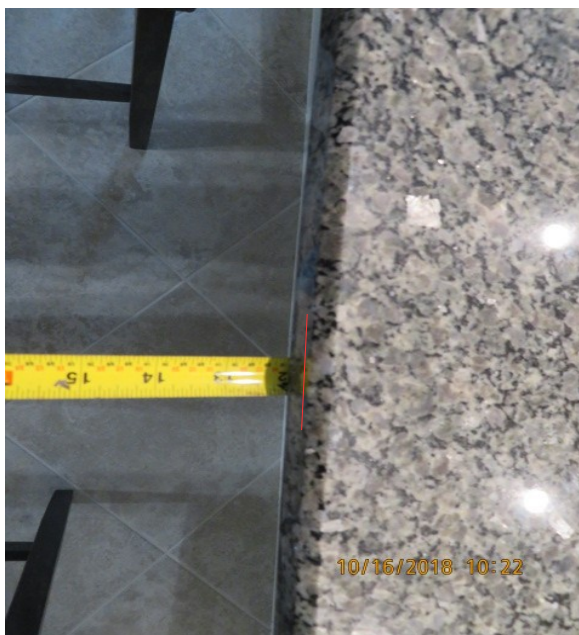
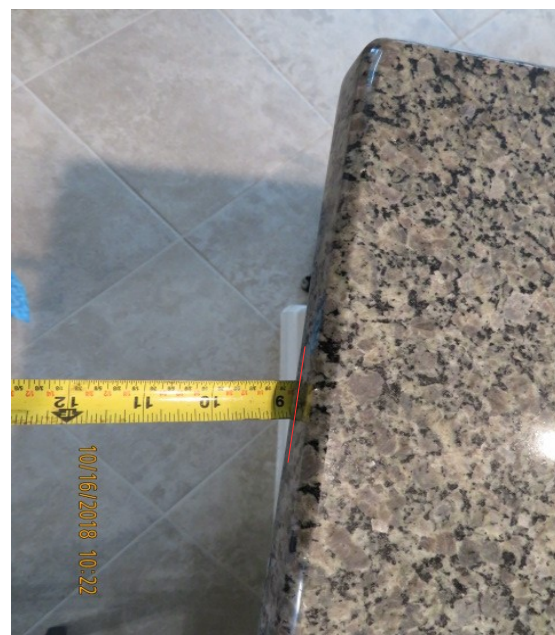
- Noted no decking under the kitchen sink countertop/island
Note: For granite countertops or breakable materials without decking or proper bracing, it is recommended that the overhang should not exceed 6". Recommend proper repair to avoid damaging of granite surface

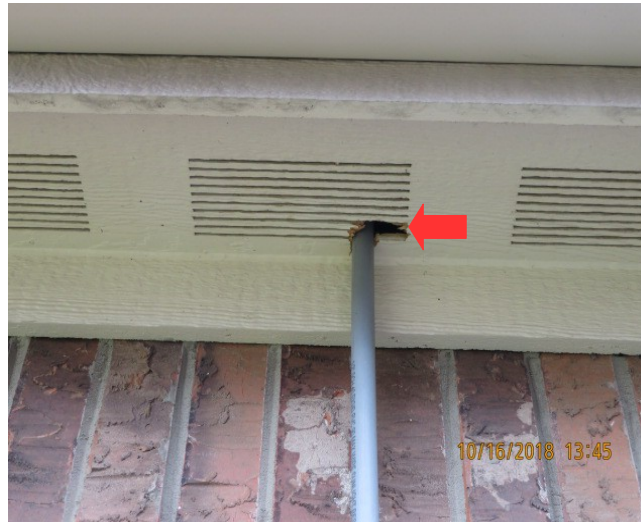
- Properly seal hole on right soffit to deter entry of insects, moisture, rodents, etc to attic space

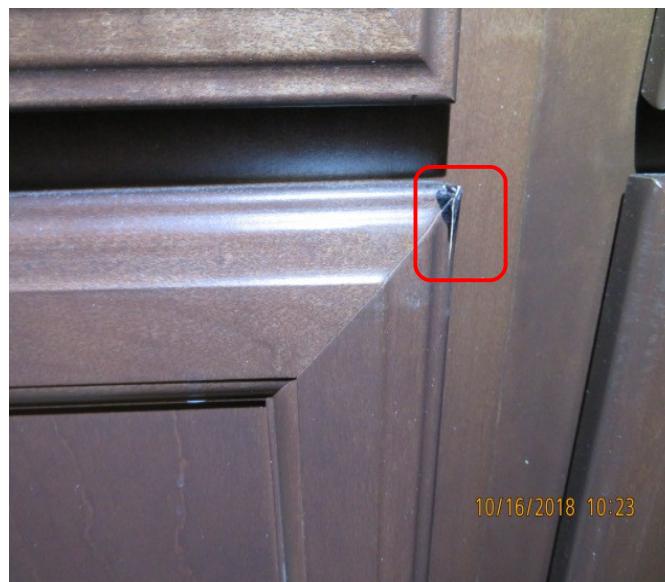
- Repair damaged cabinet door in kitchen island

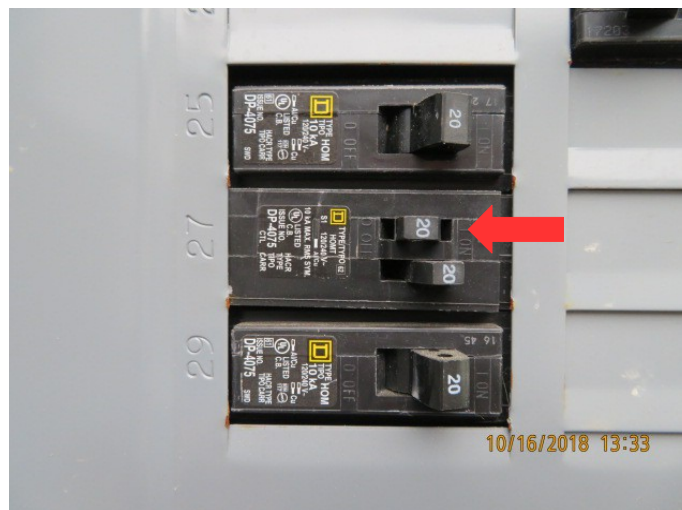
- Noticed a tandem breaker in use. These are typically used after a service panel has been filled to capacity with the standard c. breakers.
Note: The use of tandem circuit breakers could be an acceptable practice, as long as the service panel is designed for tandem circuit breakers and they're installed in locations within the service panel where they're allowed.
Consult a licensed electrician for further assessment and or confirm with local jurisdiction for acceptance/disapproval of such method and repair as needed
- Noticed also, tripped circuit within the tandem. Investigate root cause and repair

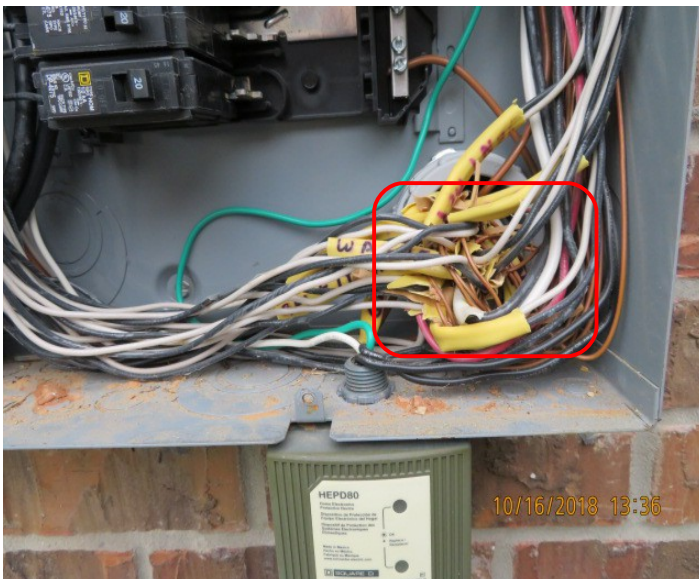
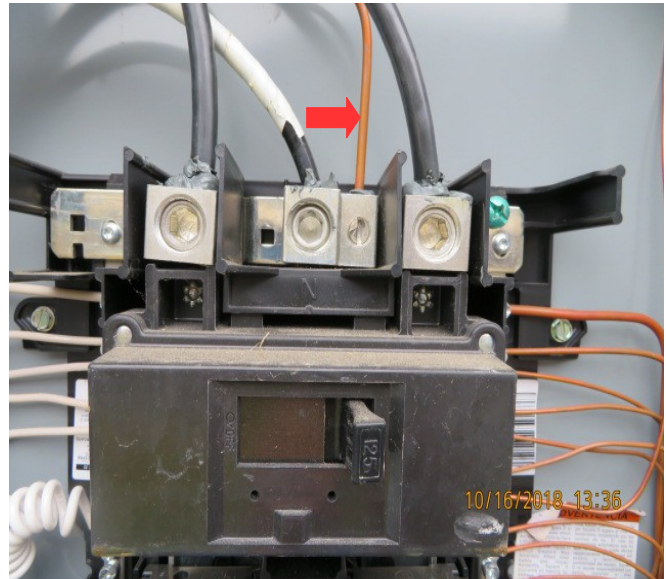
- Branch conductors were bundled and pass through a single penetration in the panel cabinet. Such constriction of conductors may generate excessive heat and de-rate the amperage of the cables. Recommend 1~3 wires per knockout.
- Inspector noticed grounding wire connected with service conductors instead of on the neutral bus bar. Inspector is not certain this is a proper connection. Consult with an electrician and repair as needed

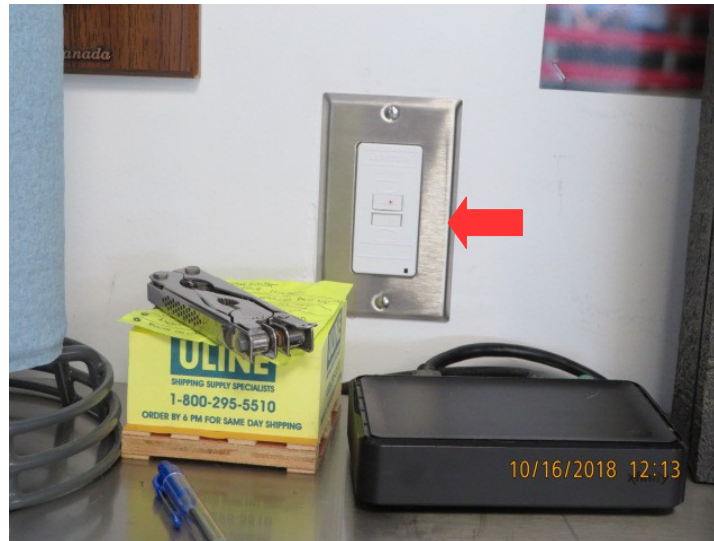
- Inspector could not determine function of a “Reset” receptacle located in the garage. Receptacle could not be reset. Investigate and repair as needed

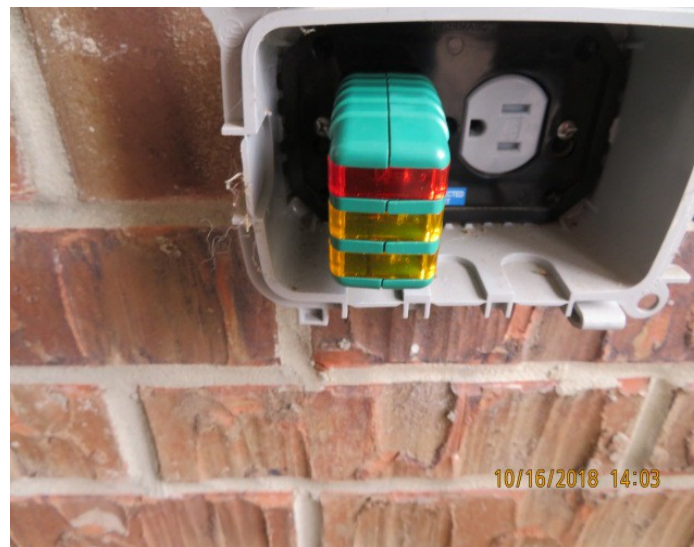
- Noticed NO power on exterior outlets. Gfci reset located in the garage had power
Note: Homeowner stated that occasionally, they had gone through the same situation. Investigate root cause and repair appropriately

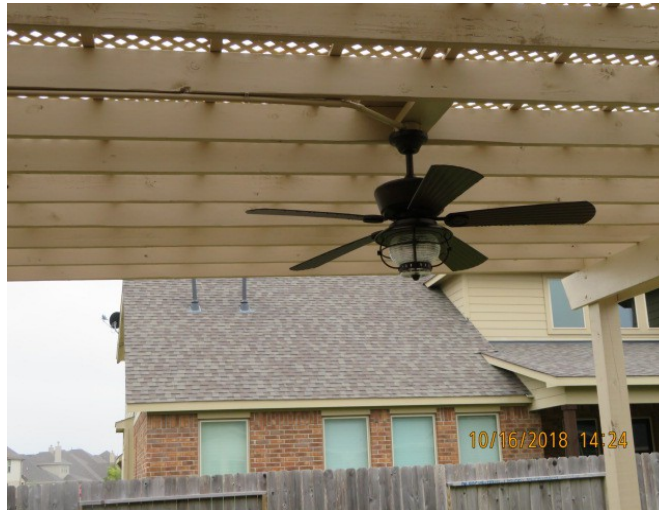
- Patio fan was not functional at this time. In need of repair
