VISTA R. E. INSPECTIONS

PROPERTY INSPECTION REPORT

Prepared For:	R. W.	
	(Name of Client)	
Concerning:	xxxx Nacogdoches Valley Dr, League City, Tx 77573	
	(Address or Other Identification of Inspected Property):	
By:	Felix Angel, 20185	10/16/2018
	(Name and License Number of Inspector)	(Date)
	N/A	
	(Name, License Number of Sponsoring Inspector)

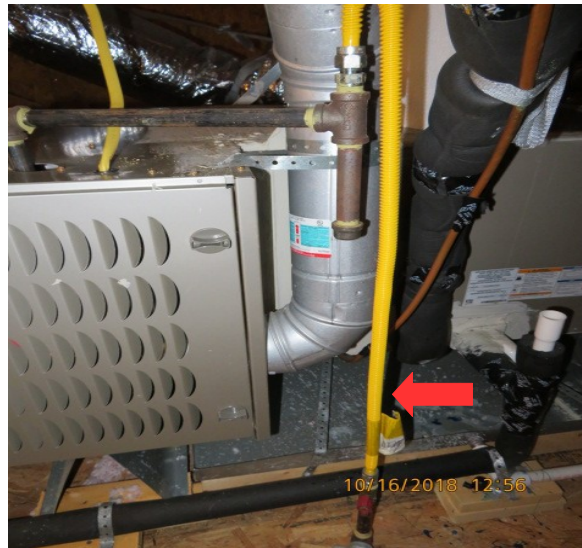
- Required bonding on gas piping was not evident at this time.
Note: The flexible gas connection between the black iron gas pipe and the appliance (Any Gas Appliance) must have a #6 copper "Bonding Jumper" installed from the end connected to the black gas pipe, to the other end connected to the appliance. Consult an electrician for appropriate bonding

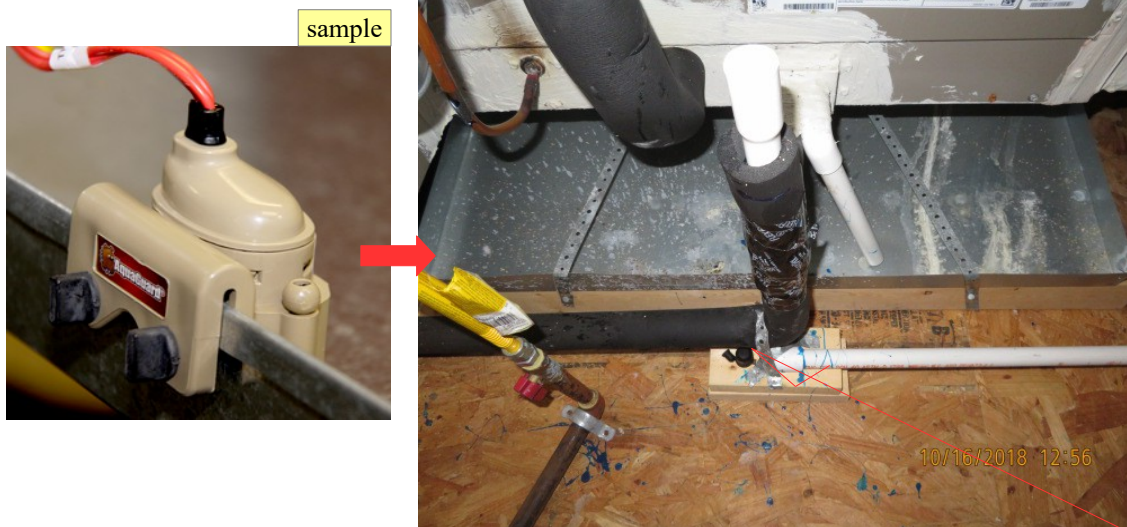
- Recommend the installation of an “Overflow” switch on emergency drain pan to prevent inadvertent condensate spills

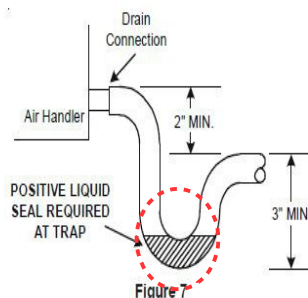
- There was no *visible* trap within the primary condensate drain line. Both the international Plumbing Code (IPC) and the Uniform Plumbing Code (UPC) require that the condensate piping, as an indirect drain line, be trapped.

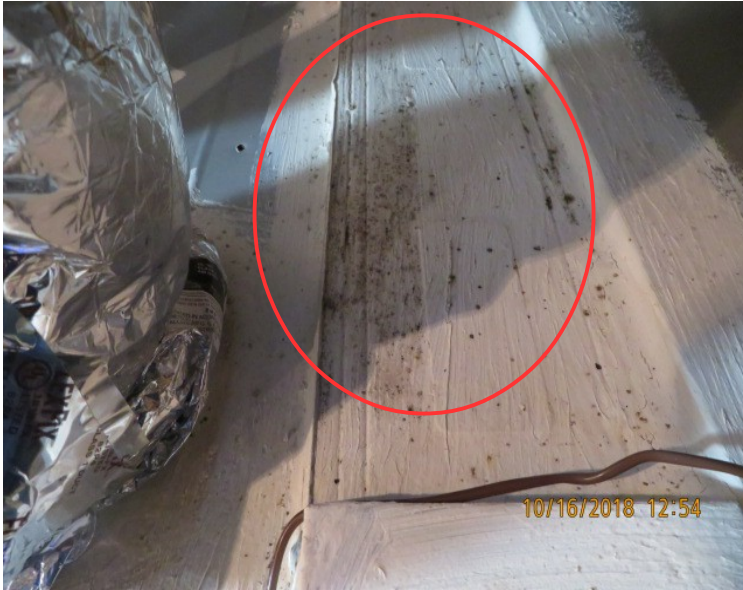
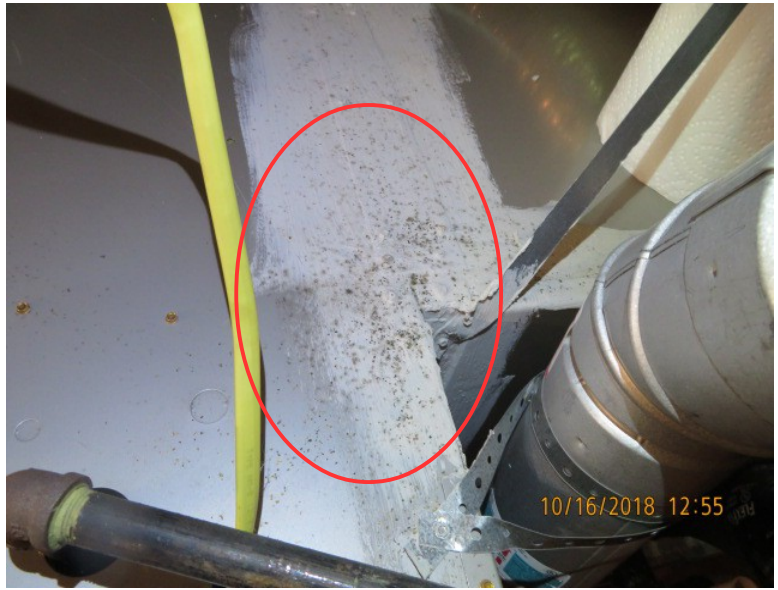
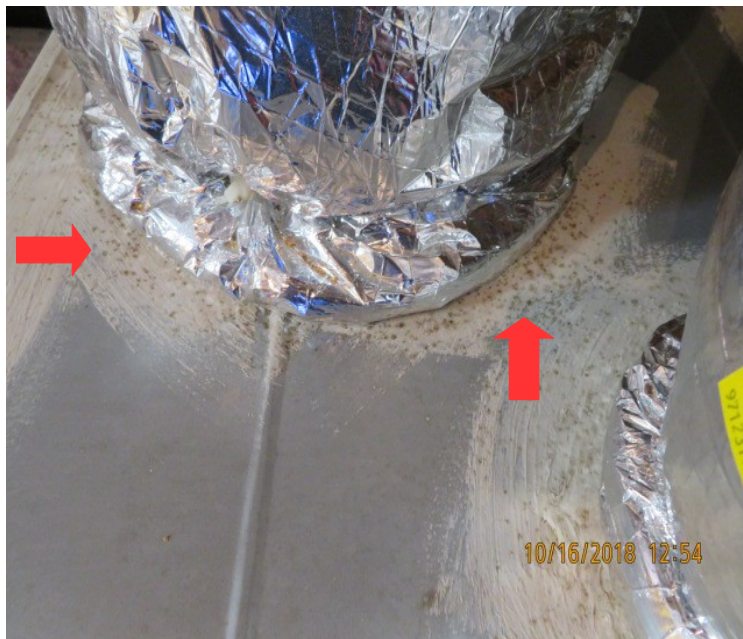
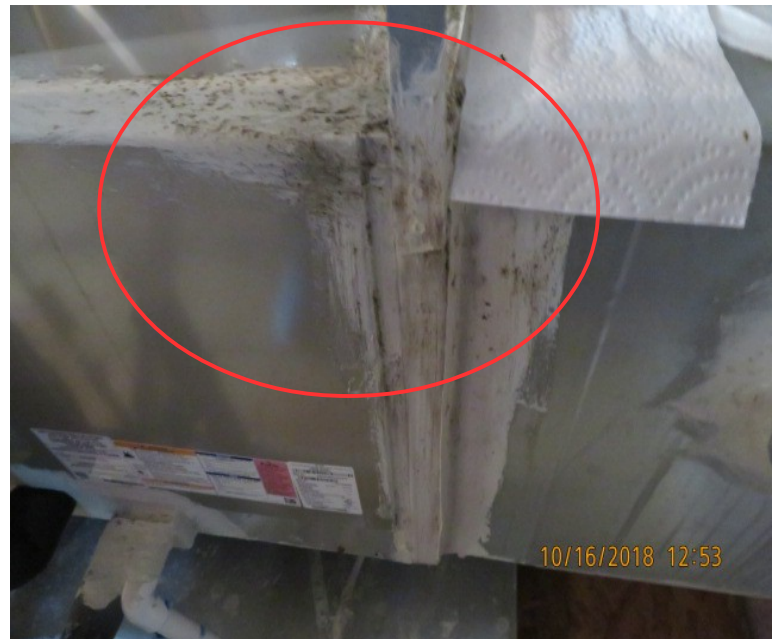
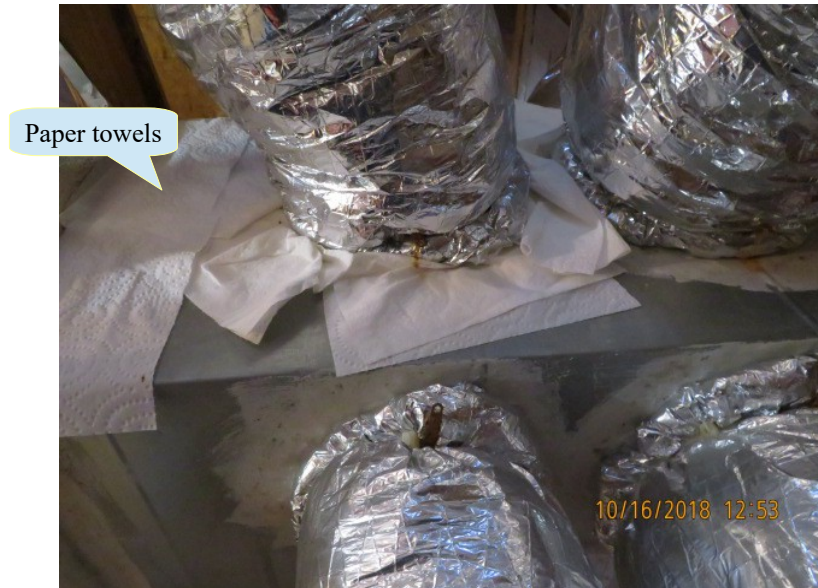
examples

- Bacterial growth was observed at various locations of the AC/Heat equipment located in attic including at the duct connecting points.
- Paper towels were also noticed at duct connecting points. Homeowner placed towels there to absorb the water/condensate previously found at those locations and to prevent property damage.
* A licensed HVAC technician should be consulted to thoroughly assess the integrity of the system, a proper system design is in place and be able to determine root cause and for proper repair of such. Also, a professional that handles bacterial growth may need to be consulted to assess all affected areas such as but not limited to surface of equipment, inside ductwork, etc and treat as needed

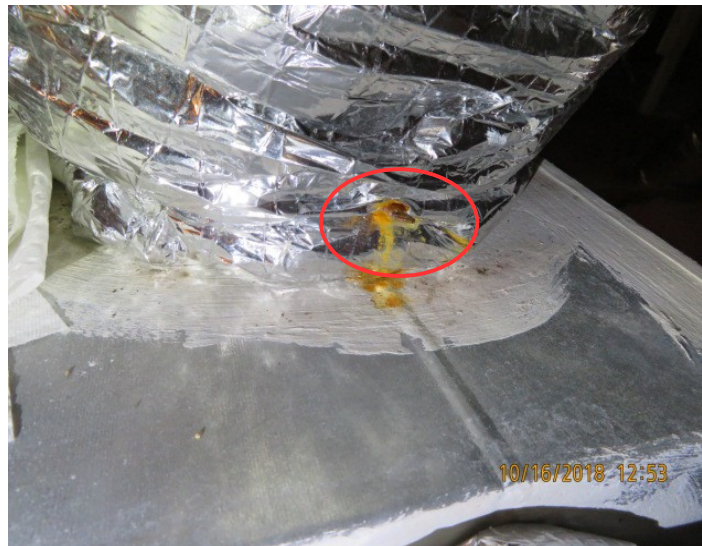
- Observed rust on duct damper bracket possibly caused by condensate. Thoroughly investigate for possible air leak at this and other possible locations

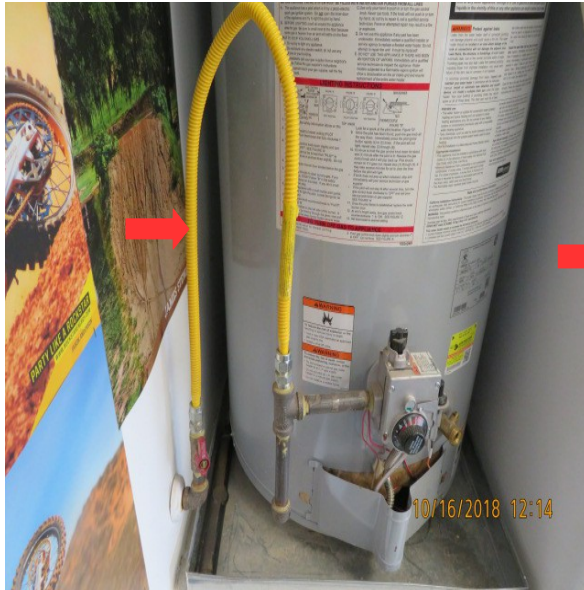
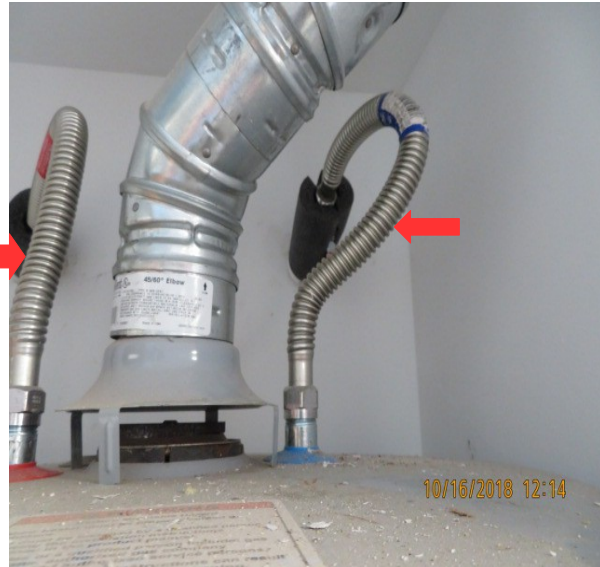
- Proper bonding of gas piping is not evident.
Note, Also, the Hot and Cold water, supplying the water heater gas or electric, must have a #6 copper "Bonding Jumper" Installed from one water pipe to the other water pipe

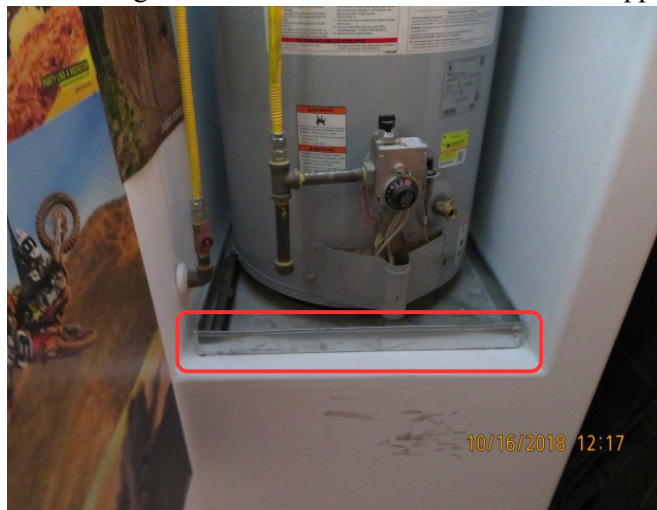
- Drain pan appeared to be missing the drain line. Install and route it to an approved location.

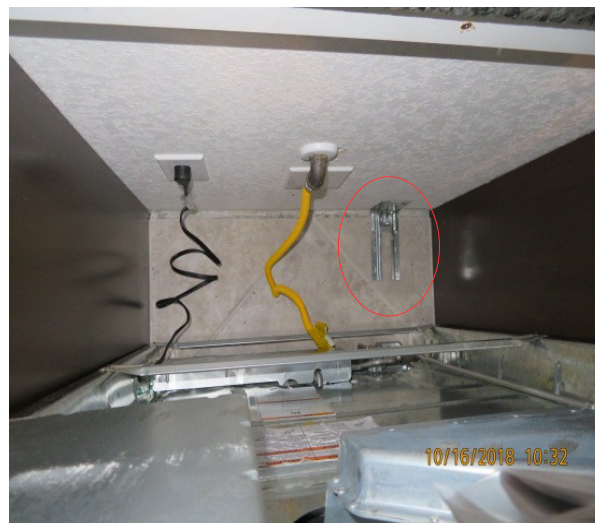
- Range oven standard: 350°F +/- 25°F, **Actual: 350°F** (approx)
- Noted one missing anti-tip device on range. Recommend installation
