PROPERTY INSPECTION REPORT

Concerning: Kleinwood Dr. Spring, TX 77379
(Address or Other Identification of Inspected Property):

By: Giovanni Angel, 22909 12/29/2018
(Name and License Number of Inspector) (Date)

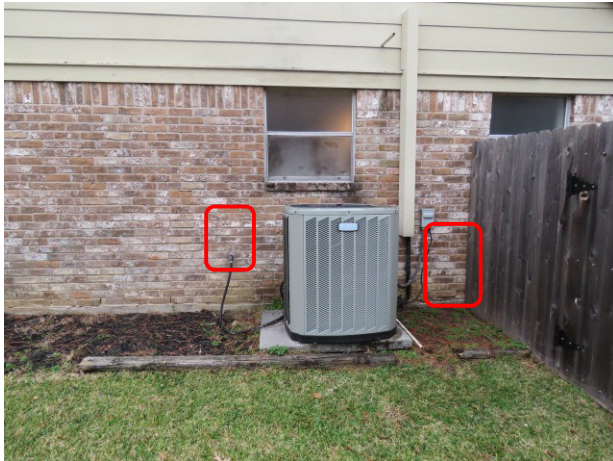
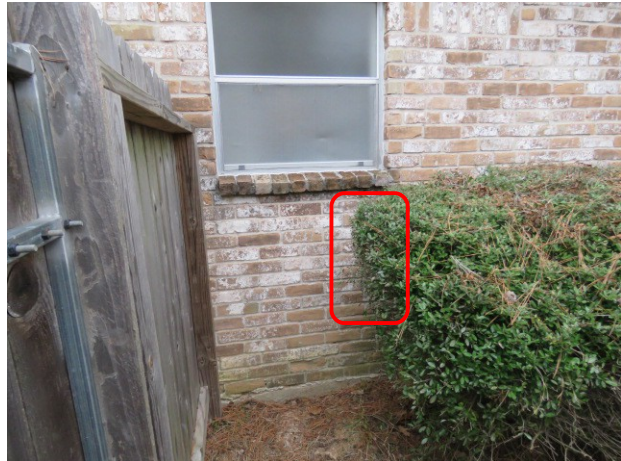
- Observed cracks on foundation slab exterior walls that may be associated with the evident foundation repair. Recommend to monitor cracks over time. If concerned at this time, or should the condition continue to deteriorate, we recommend to consult with a structural engineer to further assess the integrity of the foundation slab. Samples below.

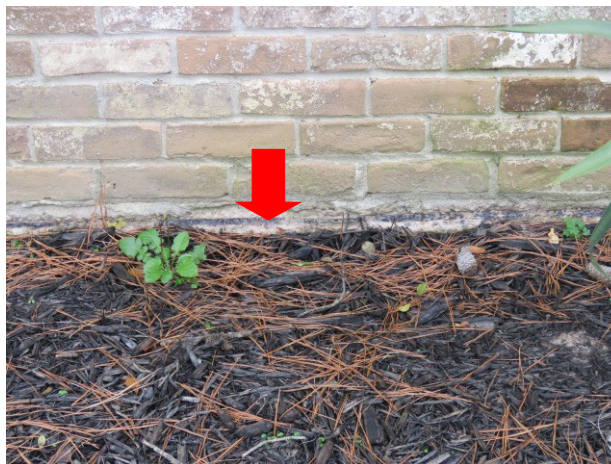
- Noted exposed rebar on the left side of the house. Note: Steel when rusted will expand pressing against the concrete putting it in tension and causing it to crack and pop off. Recommend to properly clean and reseal to prevent deterioration of slab.

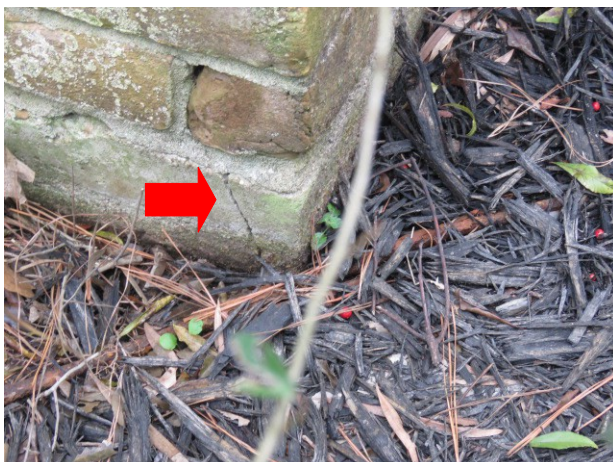
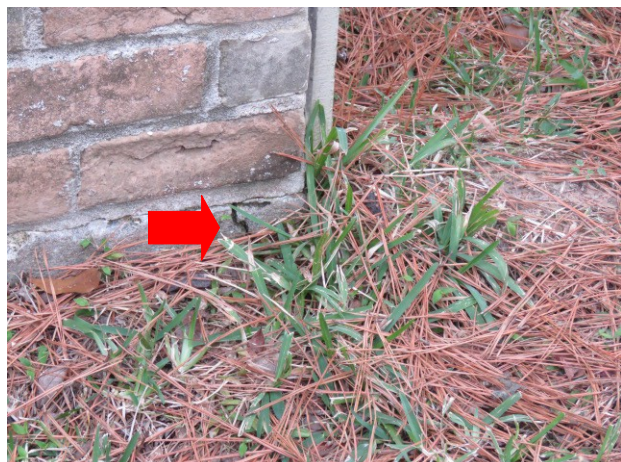
- Noted spalling on at least one corner. Note: This usually is caused by thermal expansion of the brick wall and a typical tight connection connecting the brick and concrete surface. The brick will expand in the hot weather and will put forth a force adequate to shear the corner from the foundation. This is quite common and is not to be considered a structural defect. Recommend to properly seal gaps to avoid any further damage and deter the possible entrance of termite or other bugs

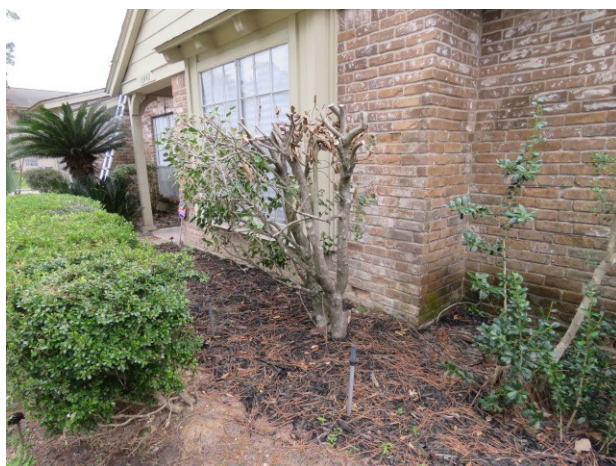
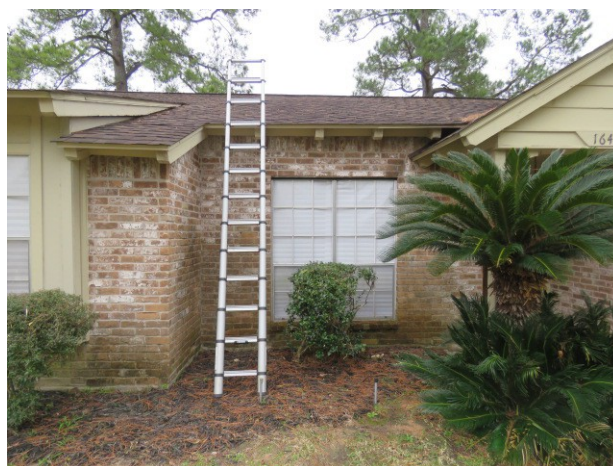
- The soil level was high on multiple sides of the house. When soil levels and vegetation are high against the face of the foundation it promotes water penetration, siding rot and insect infestation. Brick veneer wall cladding should have about *4" of clearance between the soil and the first of bricks*, and other materials should have *6" of clearance between other materials and the soil*. We recommend lowering the grade. See illustration in this document's Addendum

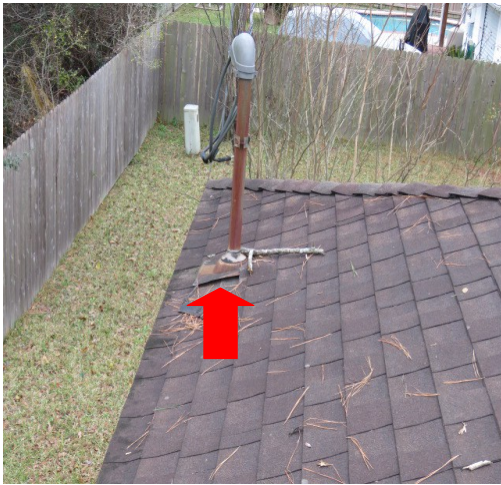
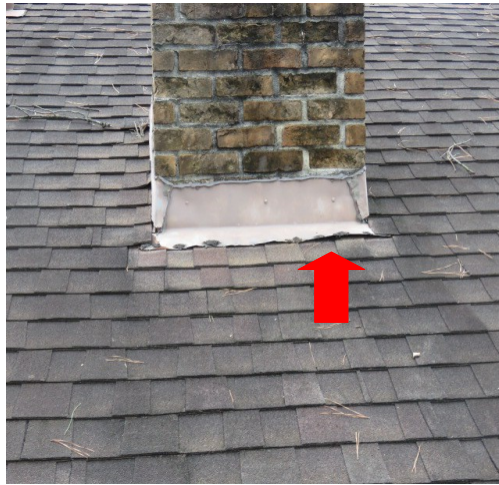
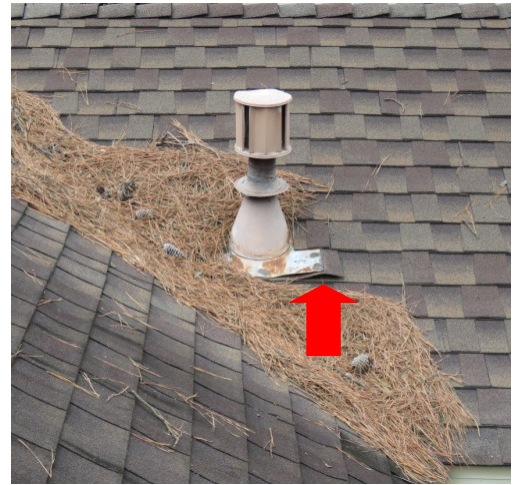
- Lifting flashing on service mast, chimney, and multiple roof jacks/vents. Properly repair to avoid further deterioration and possible water intrusion

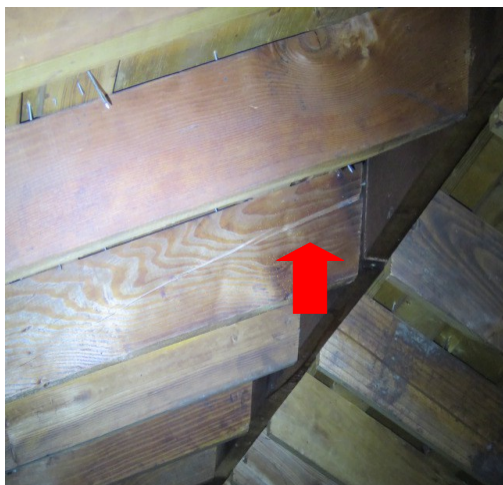
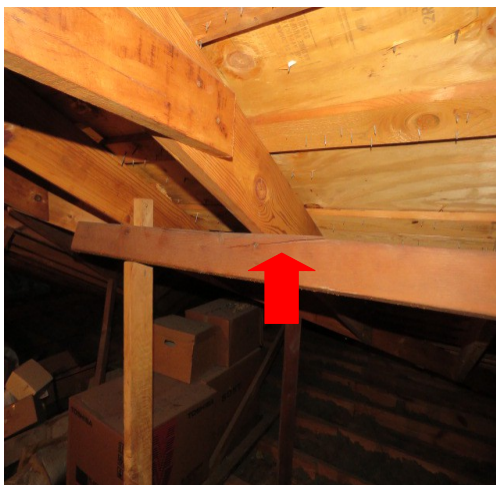
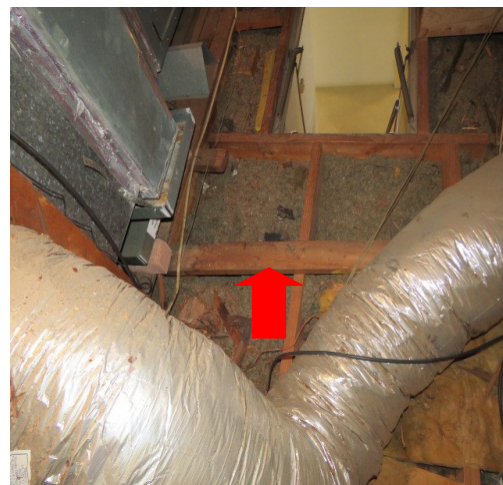
- Noted cracked roof rafter, purlin, and support member in the attic space. Properly repair by a qualified contractor.

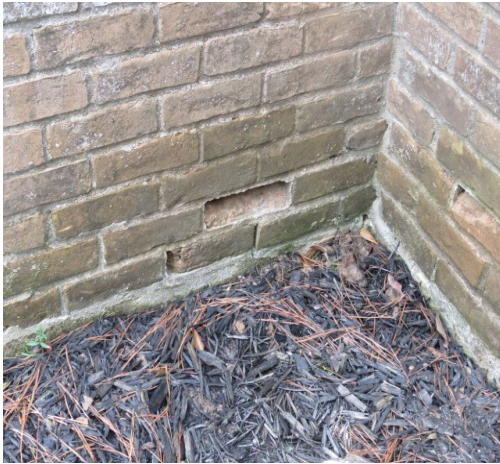
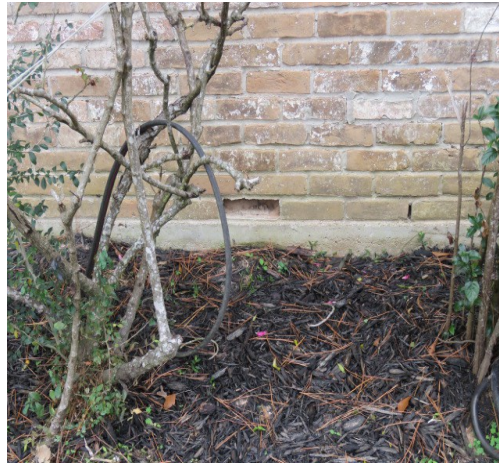
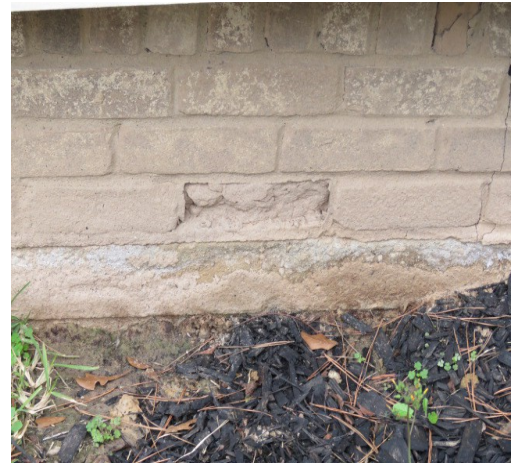
- Damaged bricks noted on multiple sides of the house. In need of proper repair by a qualified contractor. Samples below.

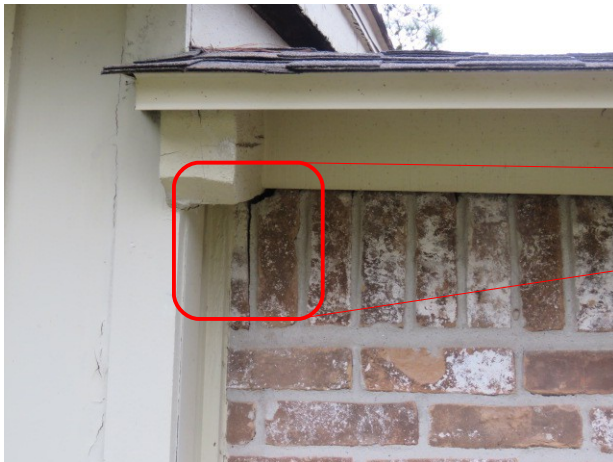
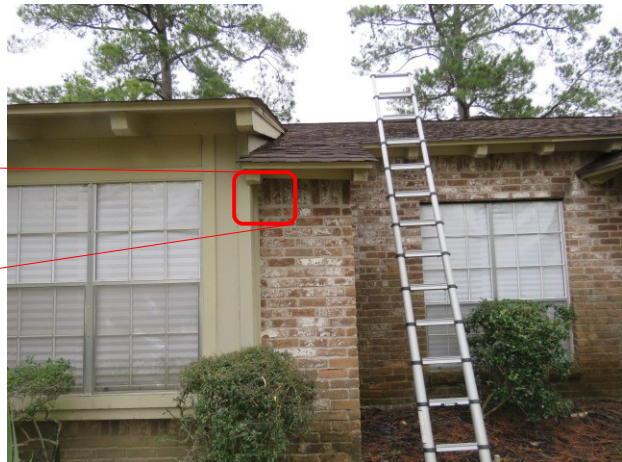
- Properly seal gap on front side of the house to prevent possible insect/animal entry into the attic space.

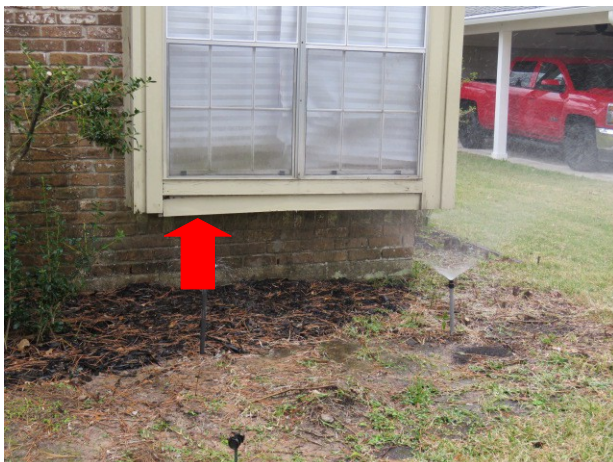
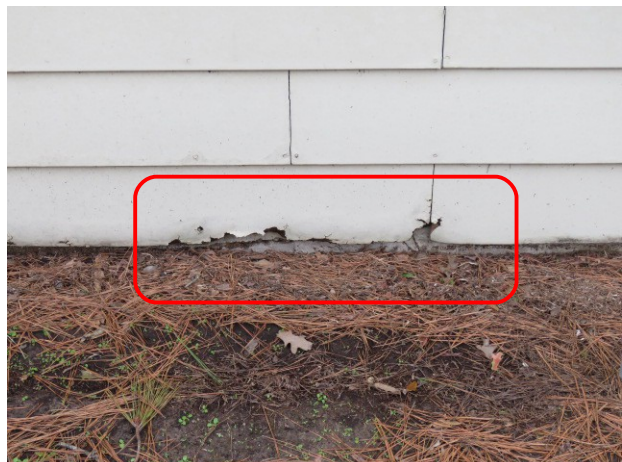
- Damaged/rotted siding on multiple sides of the house. Recommend proper repair of damaged sections. Samples below.

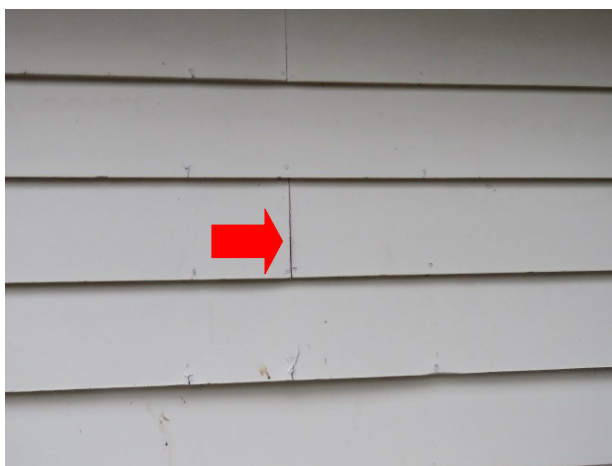
- Properly seal gaps at siding butt joints to prevent deterioration and moisture/water intrusion

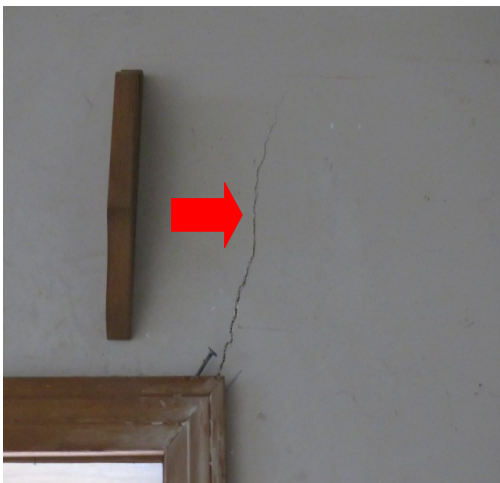
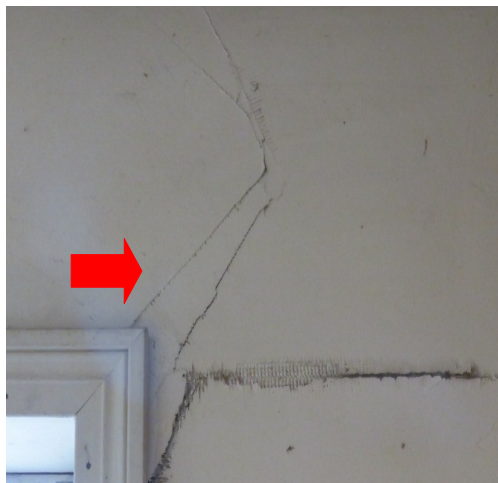
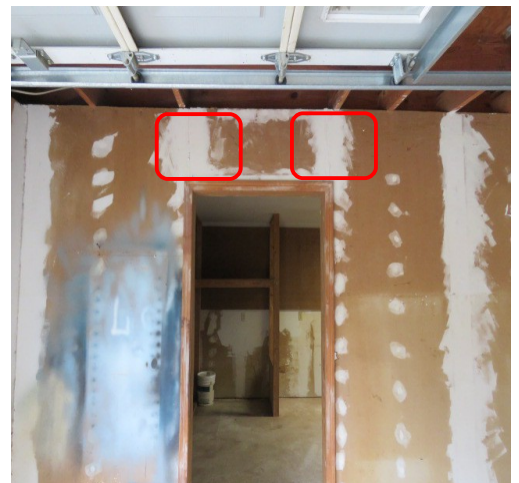
- Also noted cracks on garage walls that may be indicative of foundation failure. Consult with a qualified foundation repair company to properly repair as needed. Samples below.

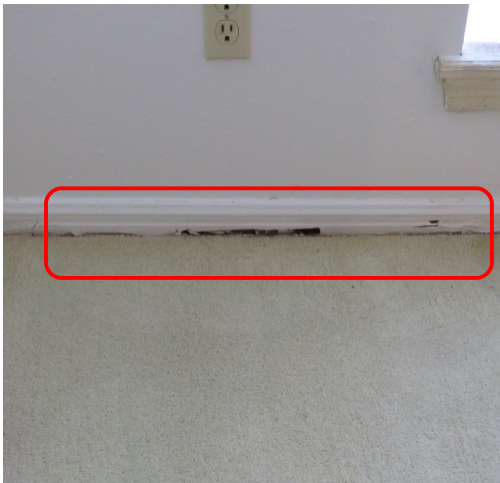
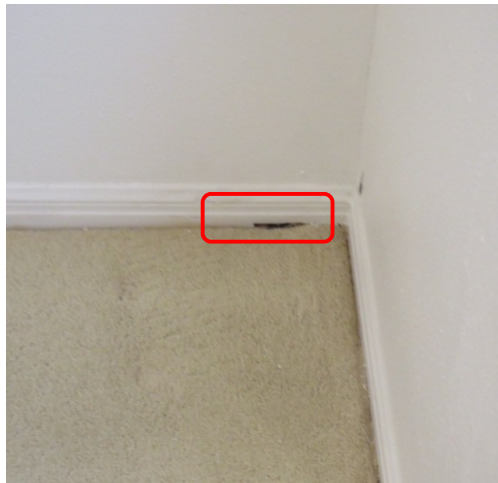
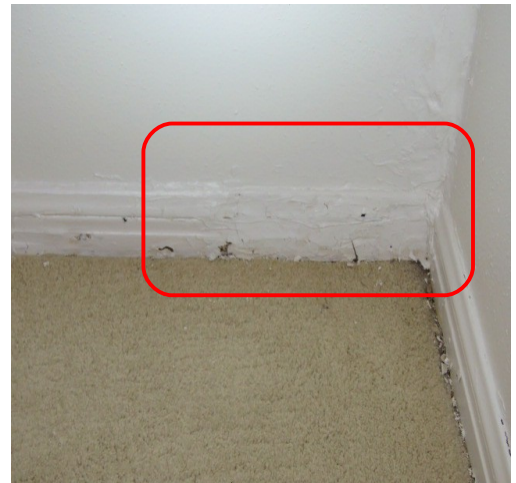
- Noted damaged wall trim in multiple areas of the house. This condition may be indicative of wood destroying insect activity. Recommend to consult with a qualified pest control company to further investigate condition and properly treat/repair as needed. Locations: Dining room, utility room, and front left bedroom. Samples below.

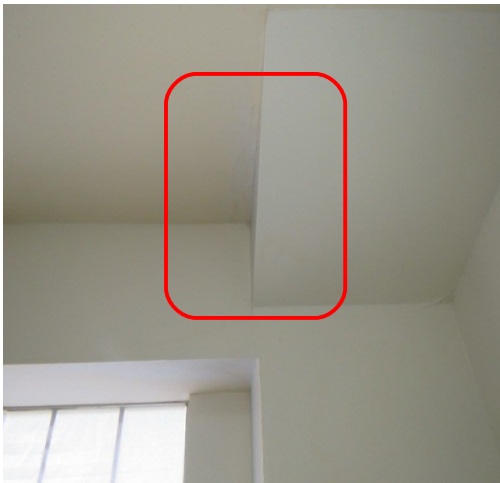
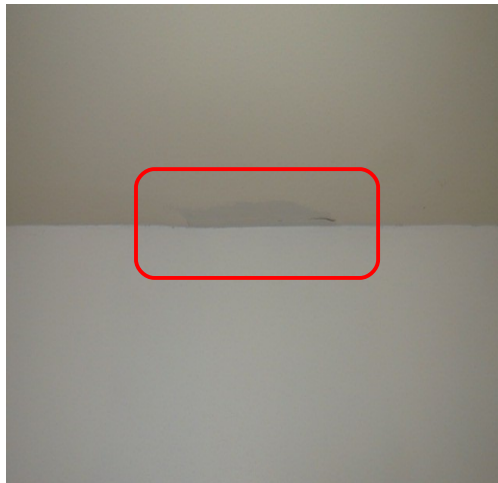
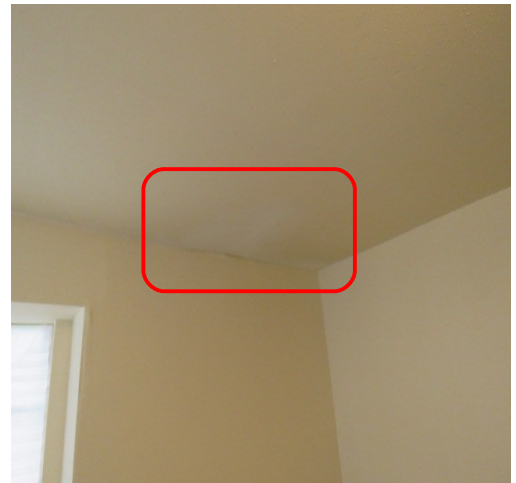
- Noted evidence of paint patches/repairs on multiple ceilings throughout the house. Further investigate root cause as needed. Samples below.

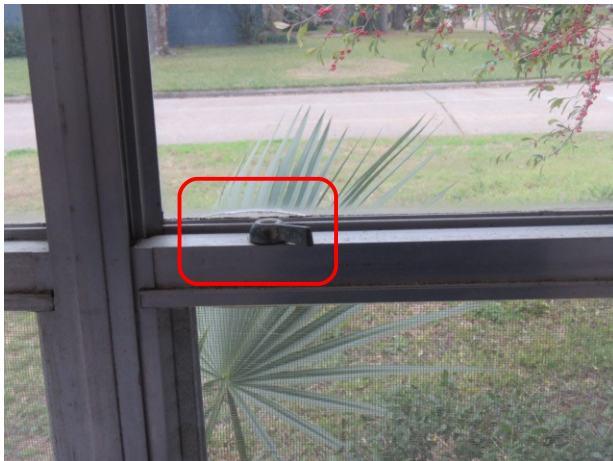
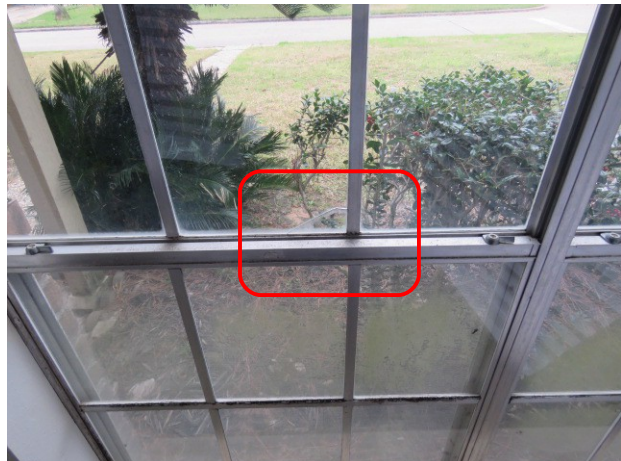
- Cracks noted in dining and utility room windows. In need of repair for safety.
- Multiple windows did not stay in the open position. Also in need of repair for safety. Locations: Front left bedroom and dining room

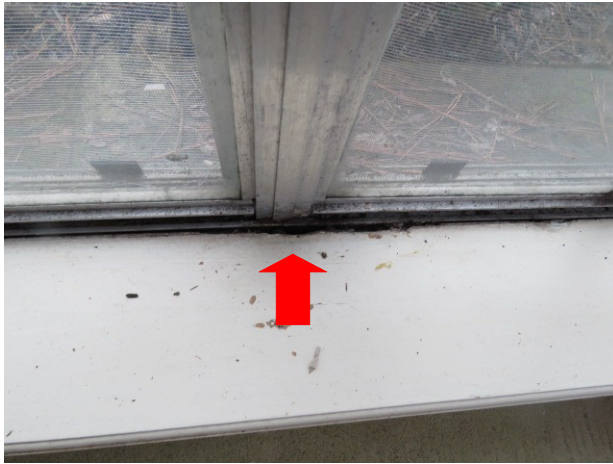
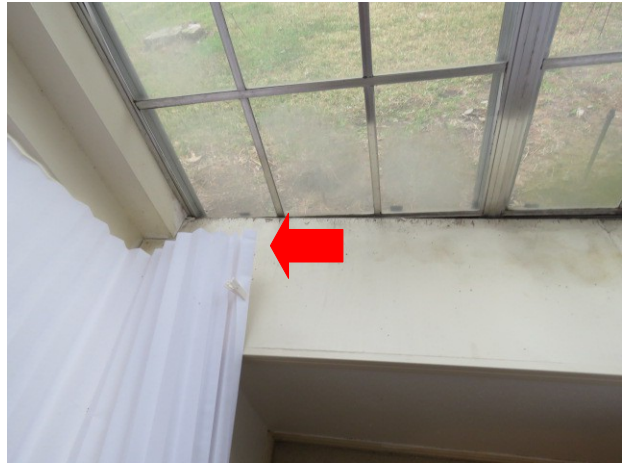
- Recommend to seal around windows for energy efficiency.
- Inspector was unable to operate window in front right bedroom due to bowing window sill. Further investigate root cause and properly repair damage sill as needed. Also recommend testing of window.

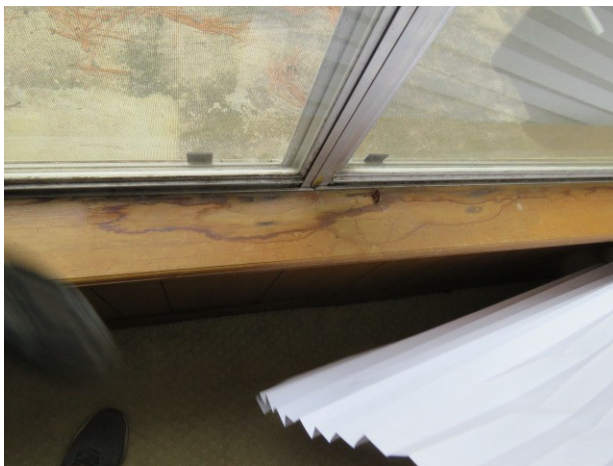
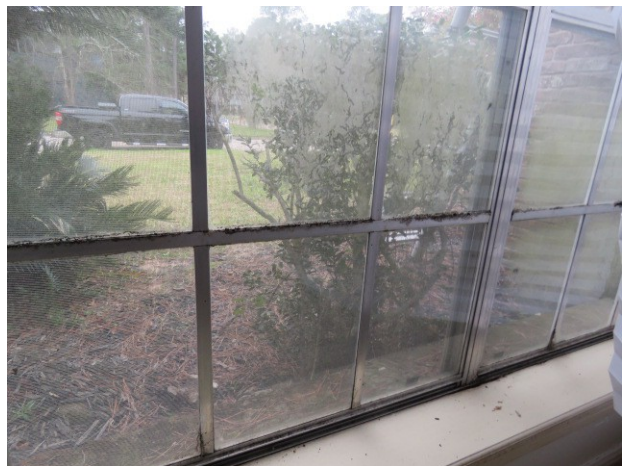
- Water/moisture damage noted on multiple window sills throughout the house. This condition may be caused by condensation. Further investigate root cause and repair and properly repair as needed.
- Evidence of microbial growth on utility room windows. Recommend cleaning/treating of same.

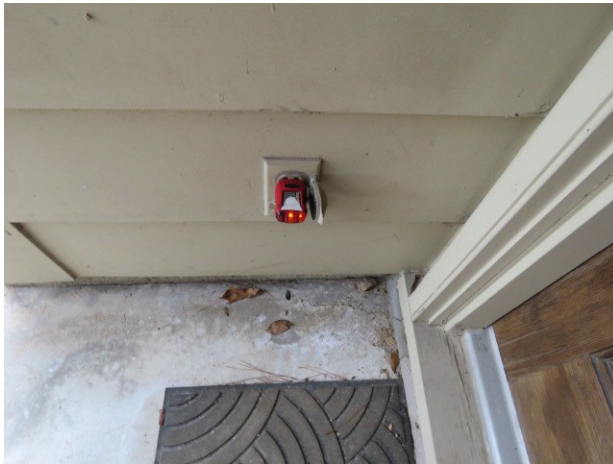
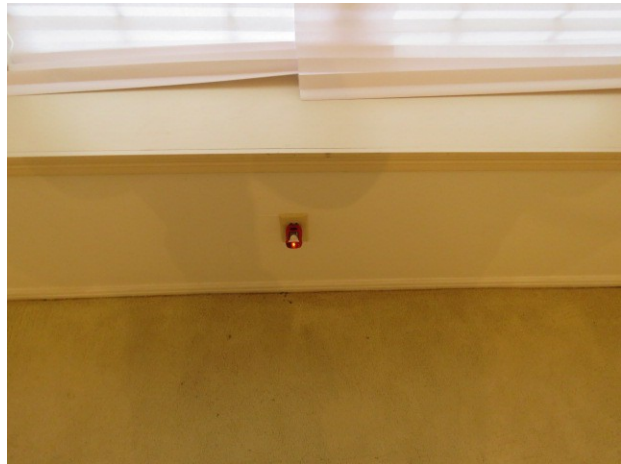
- Open ground on outlet located in the dining room. Recommend to consult a licensed electrician for proper repairs.

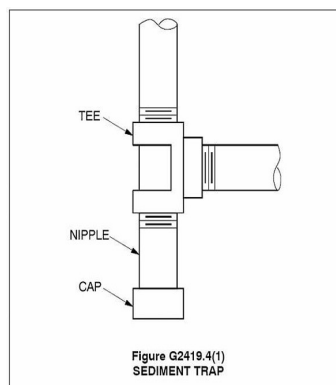
- Inspector was not able to test the gas furnace due to gas valve being in the off position at the time of inspection and only visual inspection was performed. Recommend proper testing of same.
- Inspector was not able to verify bonding of the metal gas supply piping. **Note:** The metal gas supply piping should be grounded or bonded to the electrical system. Recommend verification and/or installation of same for safety precautions.
- No sediment trap noted at gas line between shutoff valve and main gas valve. Recommend installation of same.

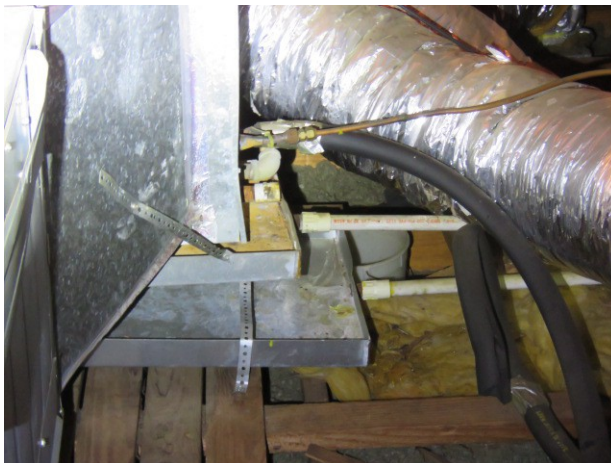
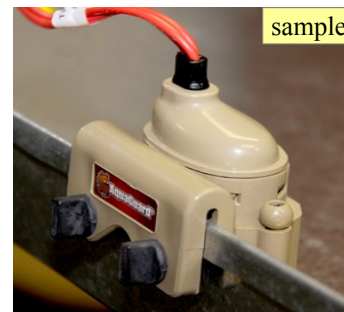
- Observed corrosion in secondary drain pan: Usually caused by condensation from evaporator coil. Further investigate and service/repair as needed
- 2 drain pans located beneath evaporator coil. Further investigate root cause and properly repair as needed.
- Recommend the installation of an “Overflow” switch on secondary drain pan to prevent possible spills

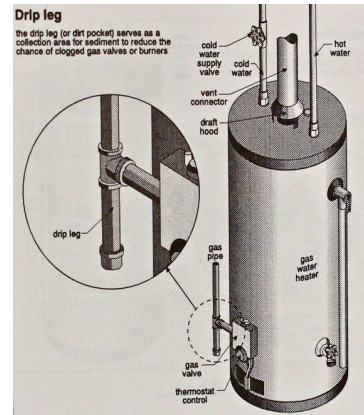
- Missing “Sediment Trap” (or drip leg). The idea is to trap all debris running through the gas line to prevent damage to main gas valve
Note: Sediment traps should be installed ahead of shut off valves to water heater.

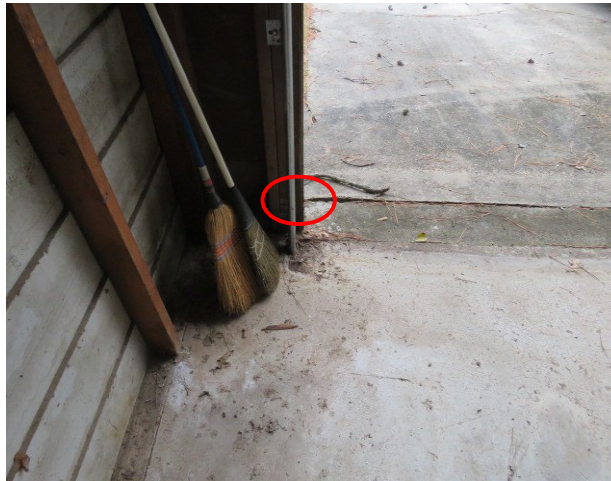
- Garage door operator did not operate at the time of inspection. Recommend to consult with a qualified contractor to further investigate root cause and properly repair as needed.
- Garage door operator is missing the photo electric sensors. Install photoelectric sensors at 6" from the floor for child safety

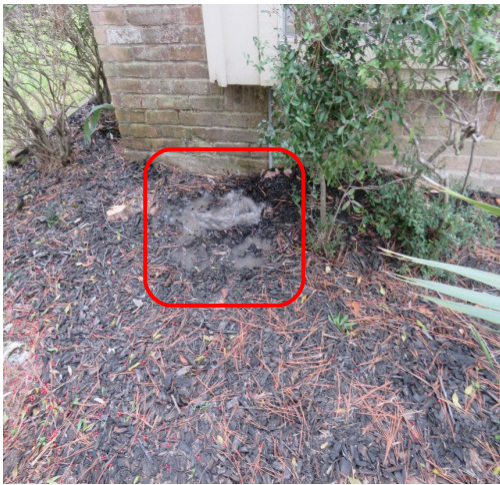
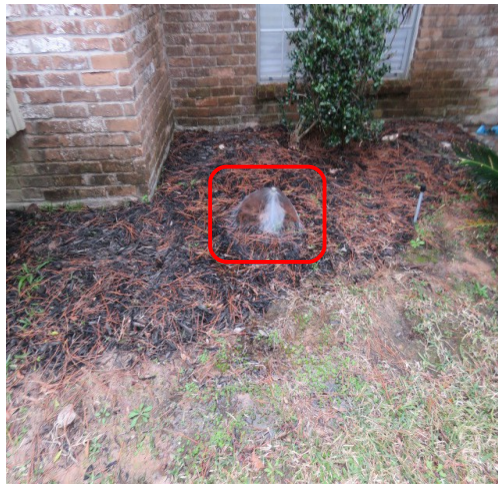
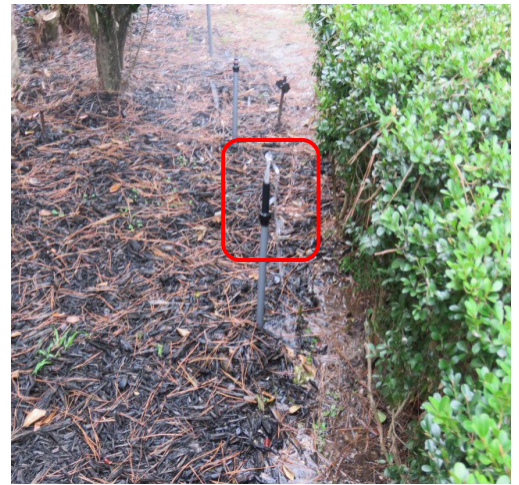
- Noted multiple sprinkler heads that did not properly operate/disperse water. Recommend to consult with a qualified contractor for thorough inspection of sprinkler system and repair/replace as needed.

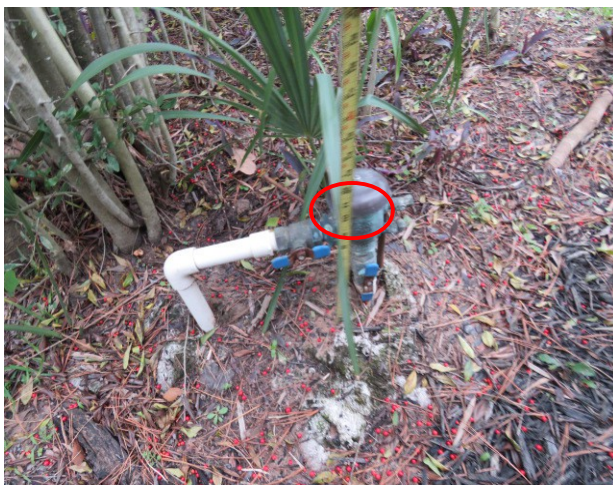
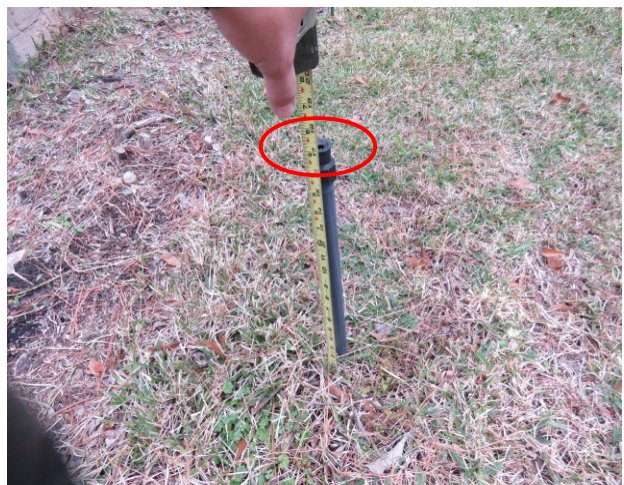
- The sprinkler system vacuum breaker is not installed at correct height. **Note:** The vacuum breaker should be Installed 12" above the highest point in the water system downstream.
