VISTA R. E. INSPECTIONS

PROPERTY INSPECTION REPORT

Prepared For:	Mr. Maradiaga (Name of Client)	
Concerning:	0000 Leafy B. New City, Tx 77000 (Address or Other Identification of Inspected Property):	
By:	Felix Angel, 20185 (Name and License Number of Inspector)	00/002018 (Date)
	N/A (Name, License Number of Sponsoring Inspector)

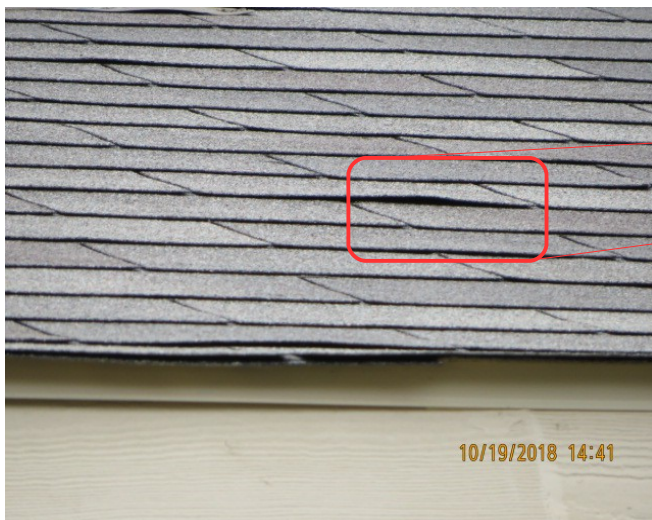
- Observed slightly lifting shingles on right roof plane. Properly repair to avoid further deterioration and possible water intrusion

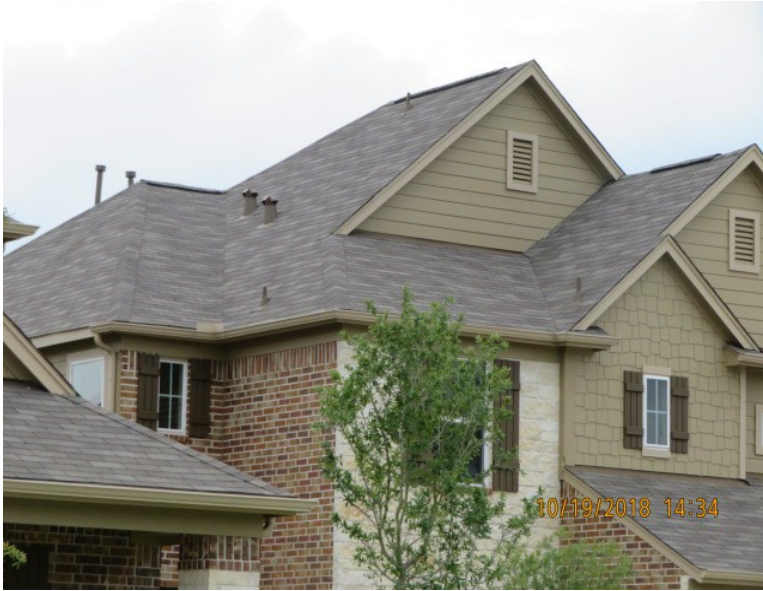
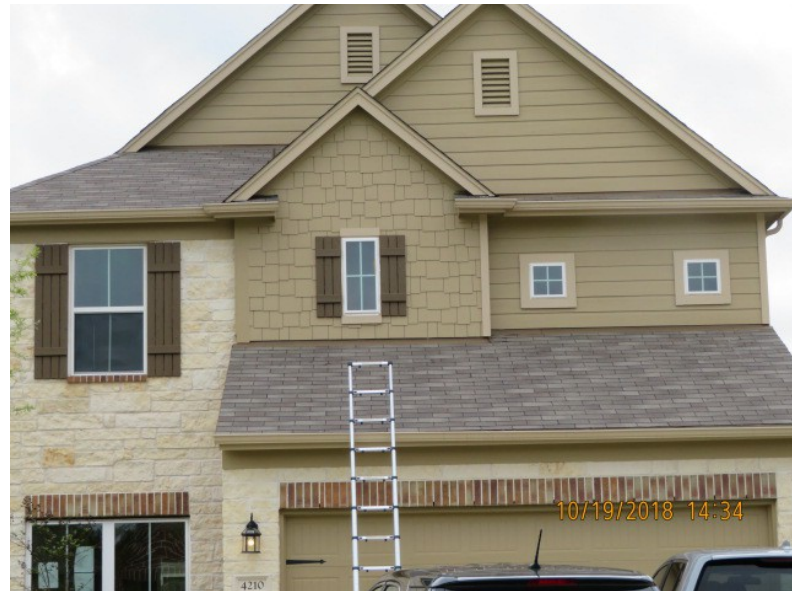
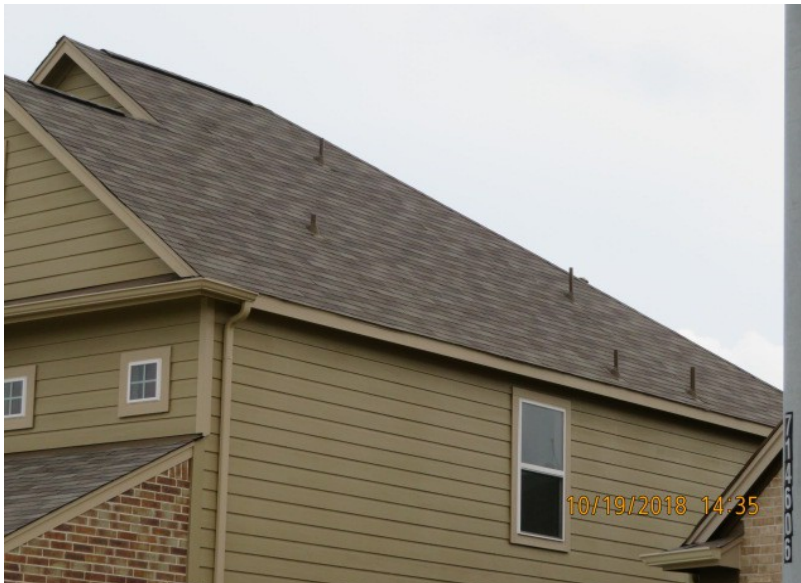
- Overview of roof condition the day of the inspection.

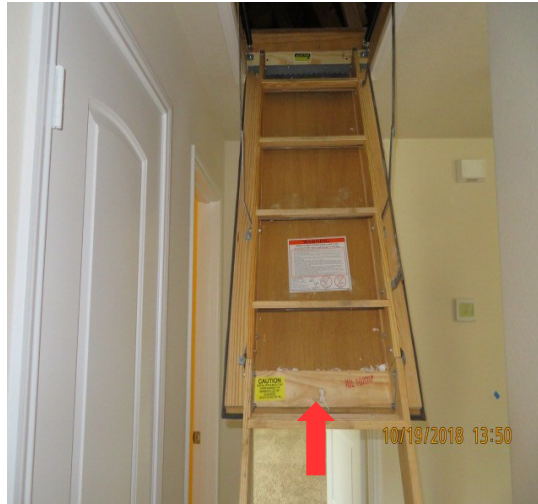
- Insulate ladder rungs for insulating value

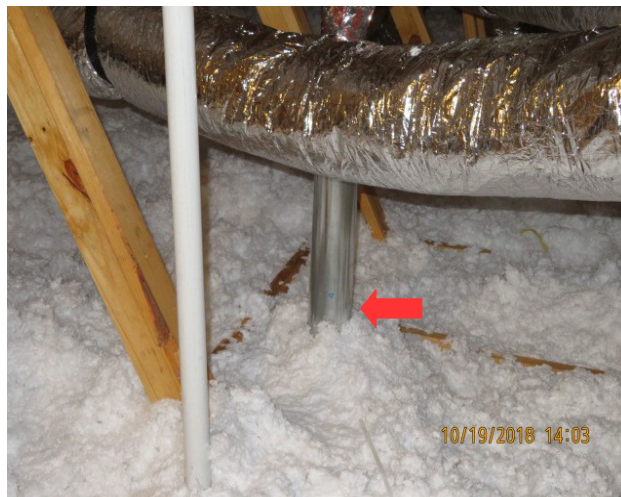
- Observed insulation in contact with an exhaust. There should be a min clearance of 1" for double wall/type "B" and 3" for single wall exhausts. In need of repair

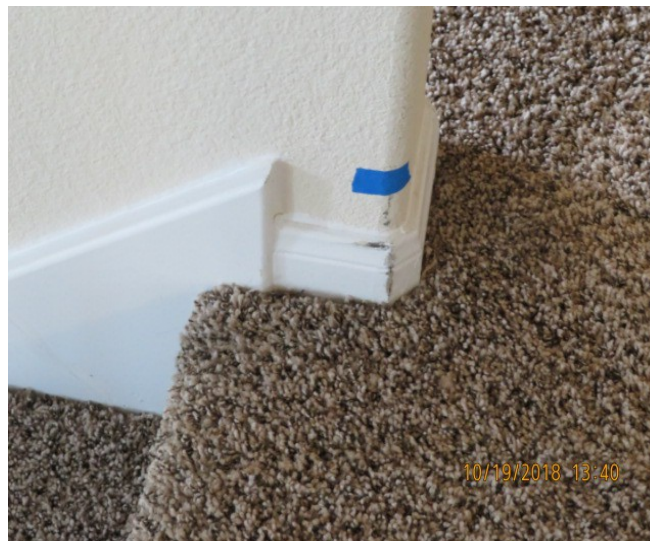
- Observed stains and defective wall paint throughout. Properly repair. Samples below

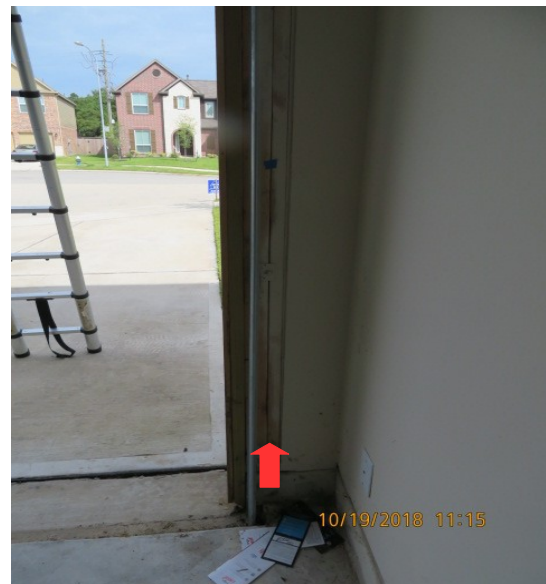
- Noticed missing filler (wood trim) above and on the sides of the garage door. In need of repair

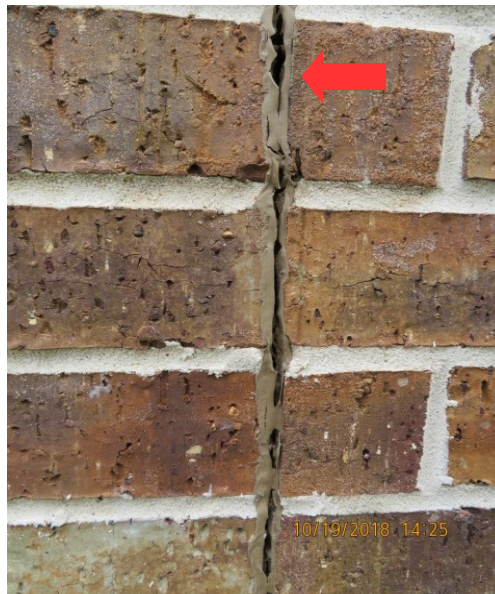
- Replace deteriorated caulking on expansion joints to avoid water infiltration

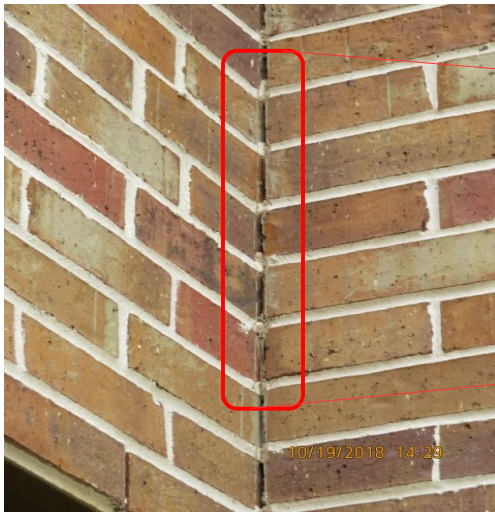
- Apply missing caulking on front exterior walls to avoid water intrusion

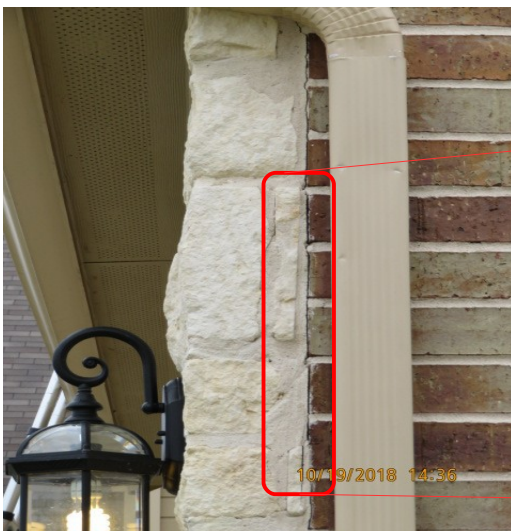
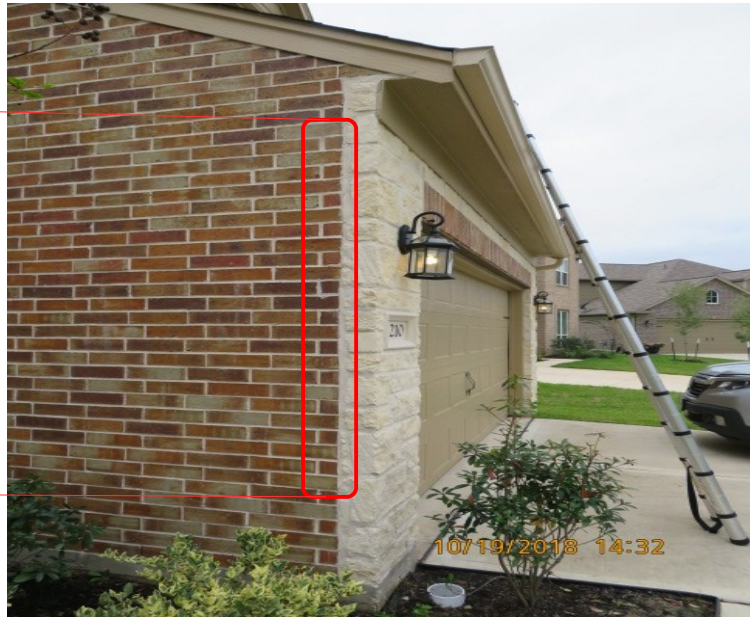
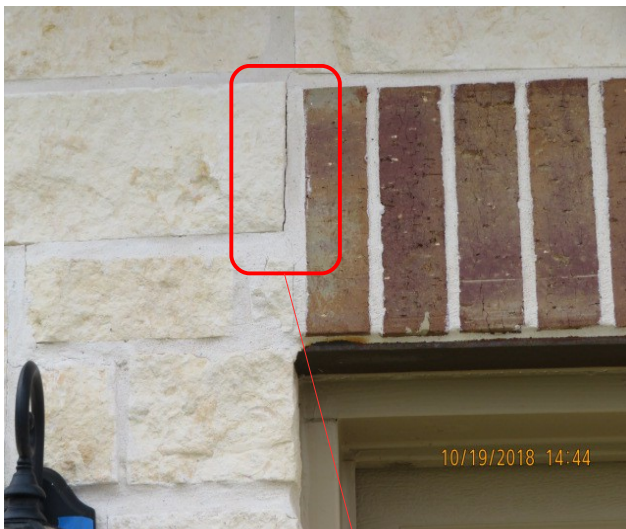
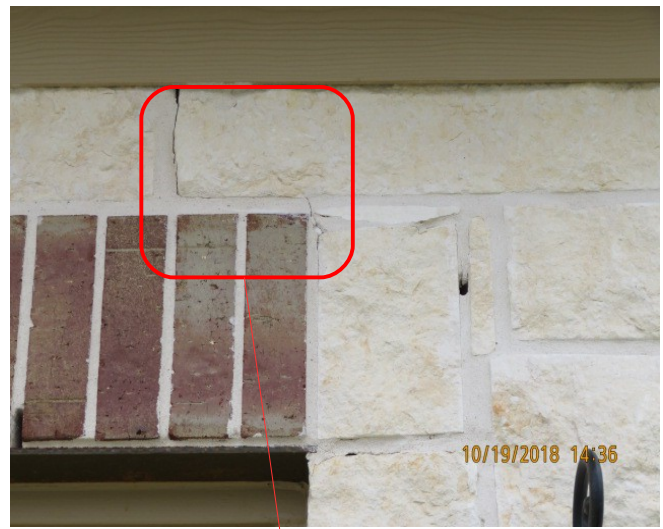
- Mortar separation in the masonry noticed in the garage area. Properly repair

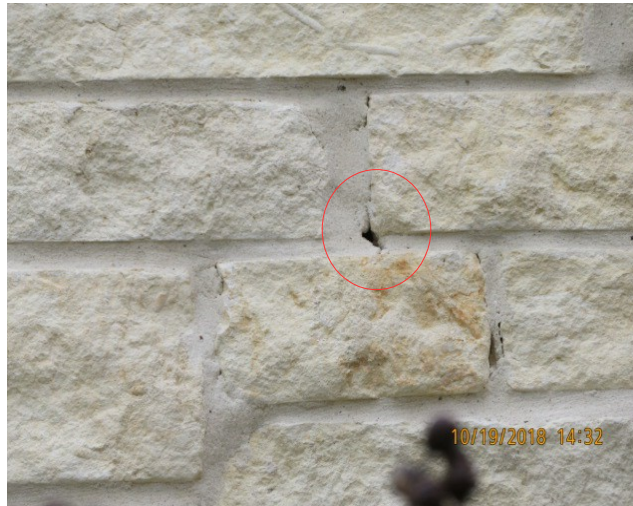
- Seal holes/gaps where needed to prevent water intrusion

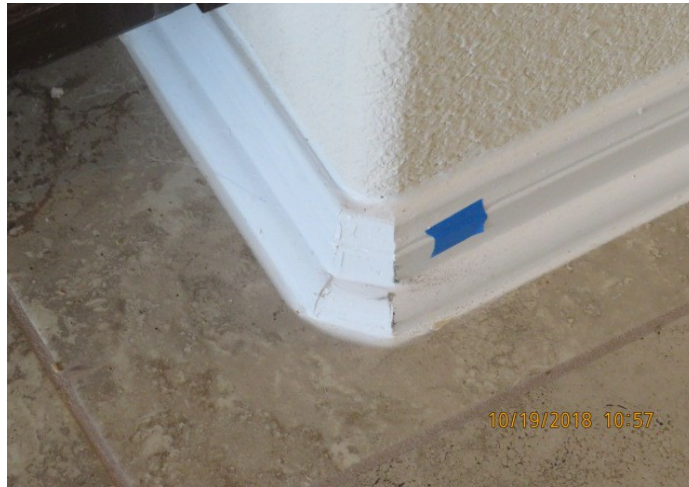
- Remove dark stains from floor molding where needed

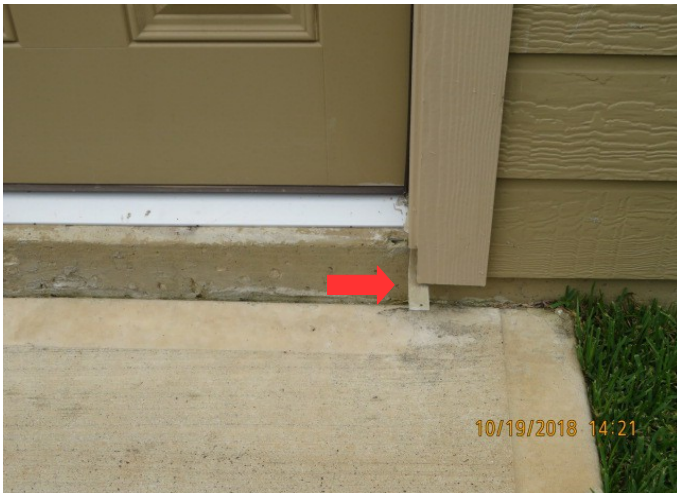
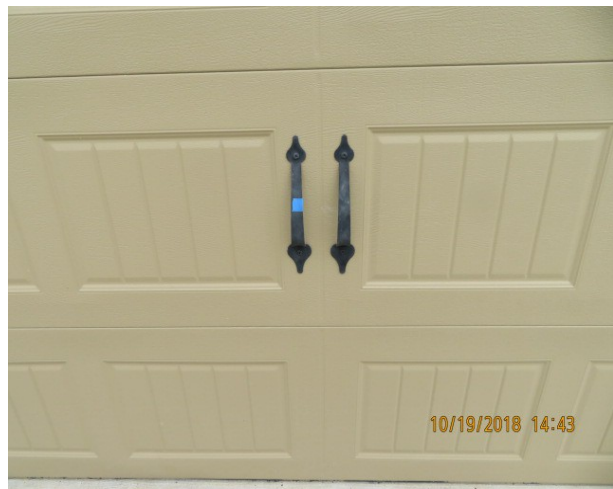
- Trim excess of metal flashing on rear exterior door for safety
- Secure loose door handles

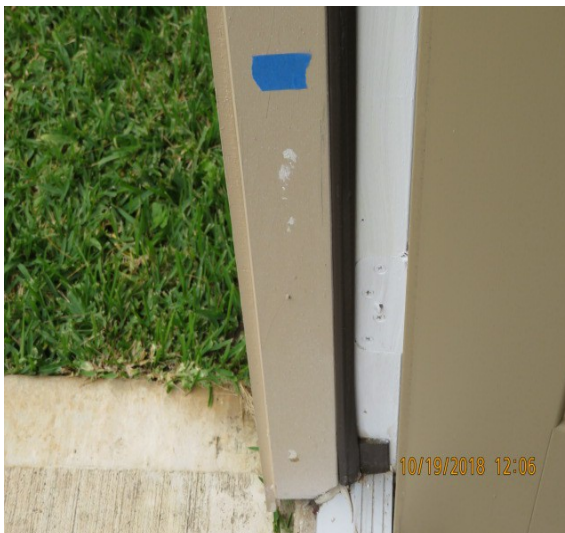
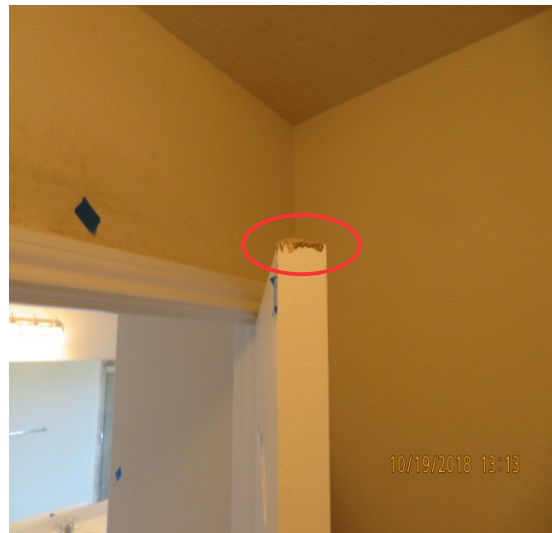
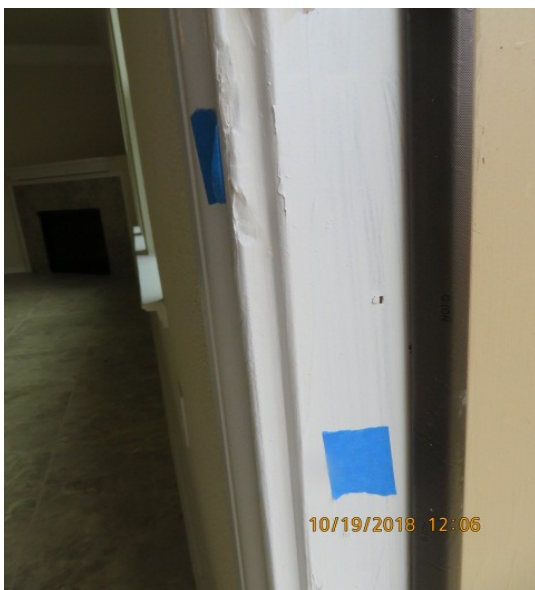
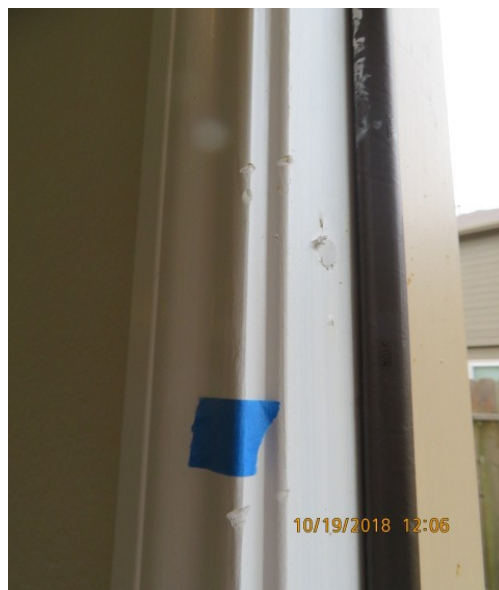
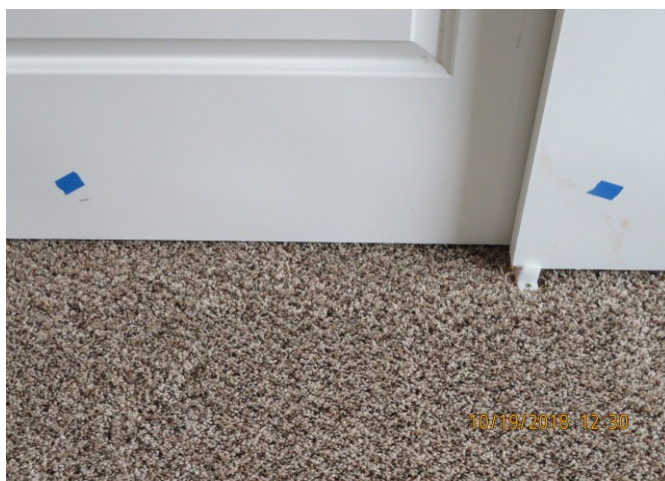
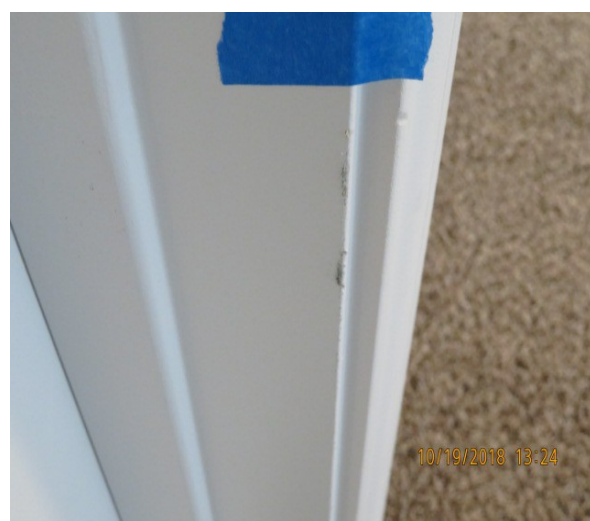
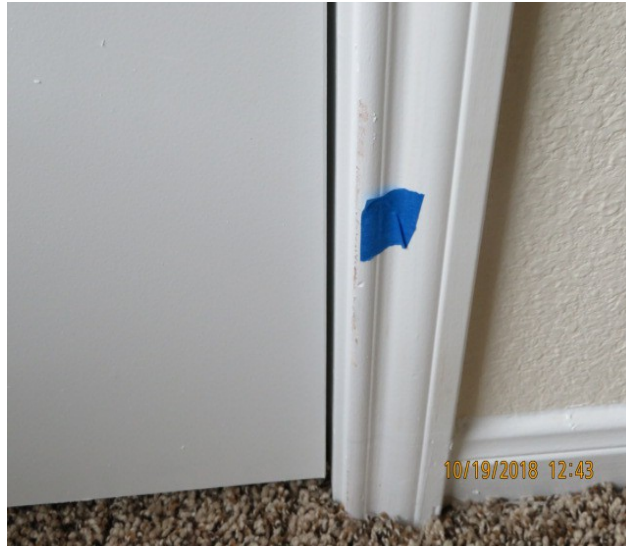
- Properly repair paint defects, dents, nicks, poor finish of door/frames

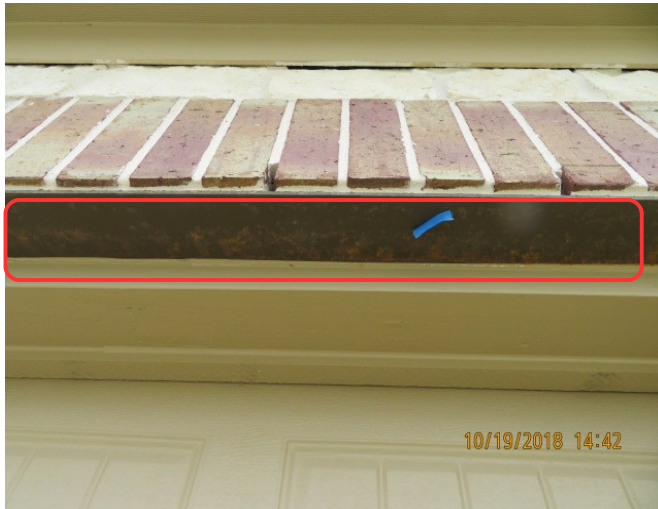
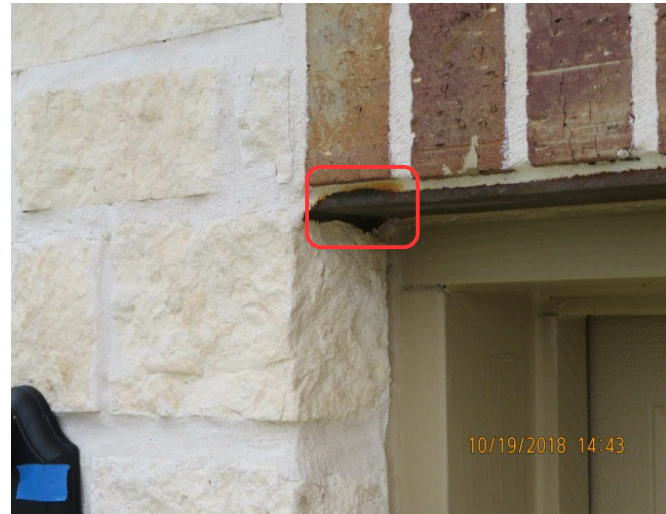
- Observed rusting garage door lintel.
Note: The expansion or failure of corroded steel during this process may cause brick and mortar cracks and affect the wall integrity. In need of proper repair

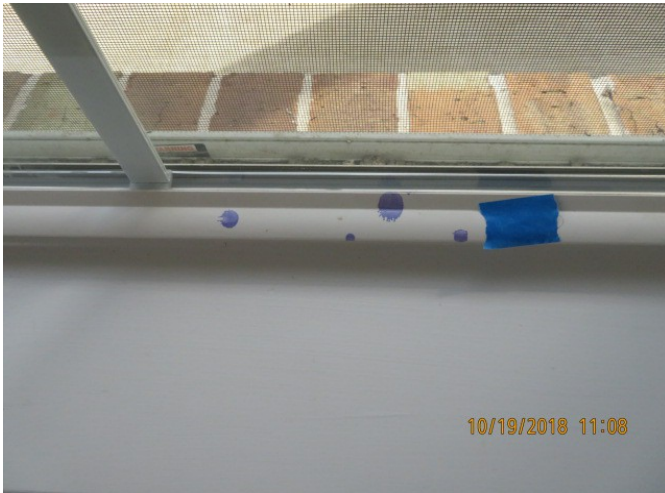
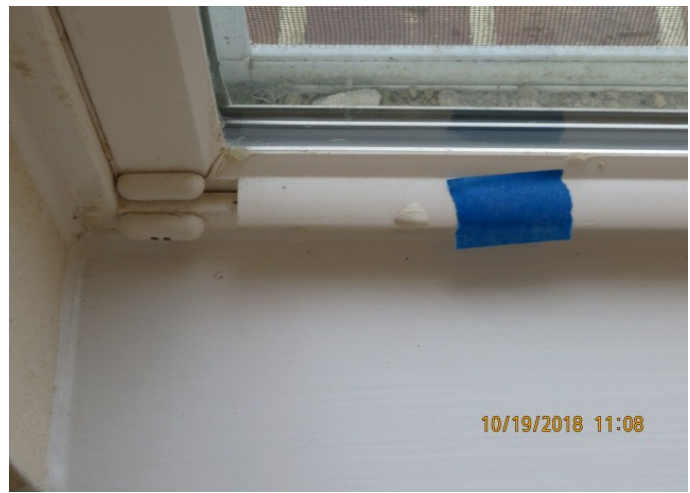
- Properly clean stains off window frames and sills

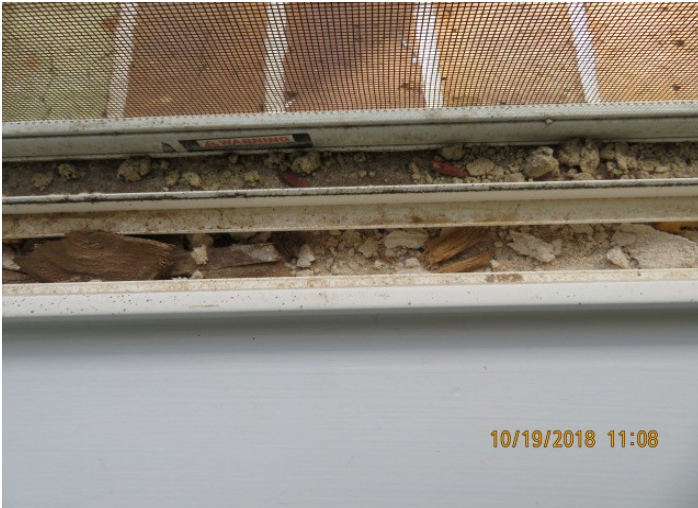
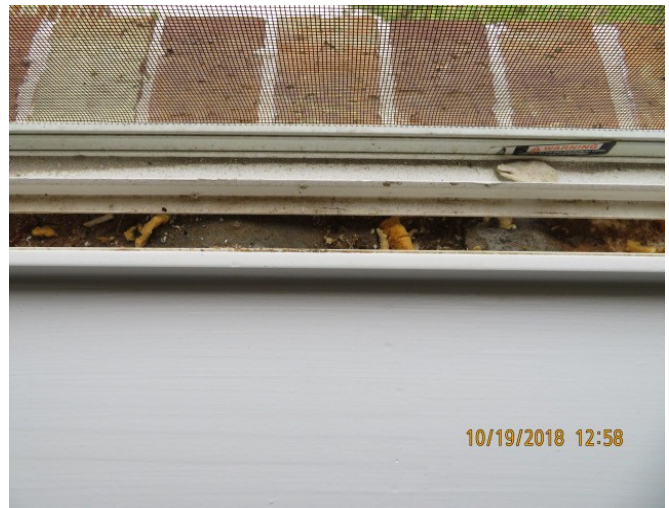
- Remove construction debris from window railing for proper drainage

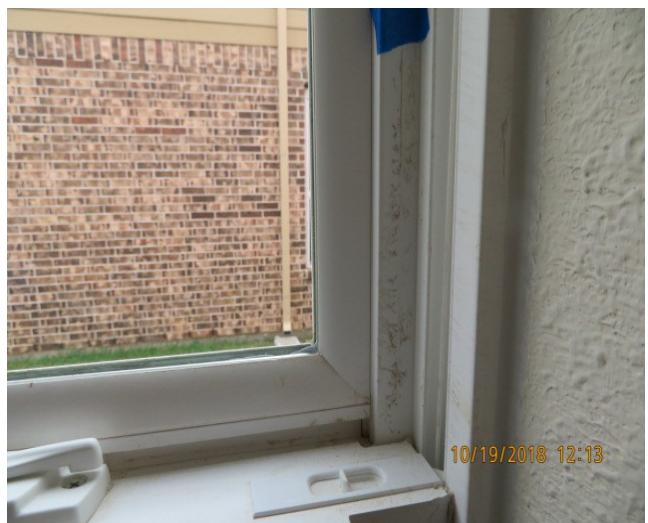
- Clean window surface/frames

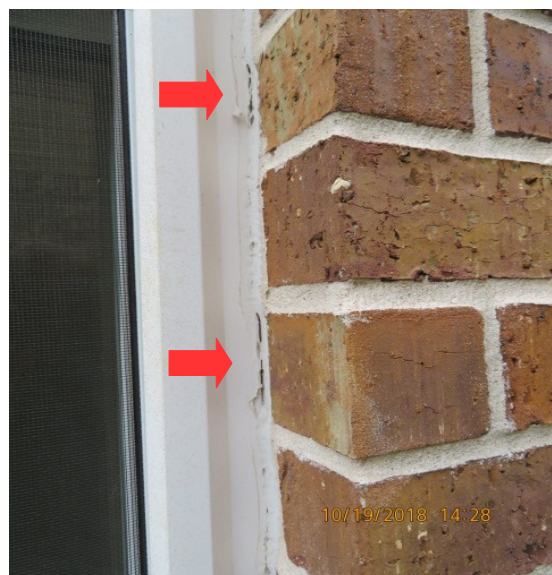
- Properly replace deteriorated caulking/mortar on exterior windows to avoid water infiltration

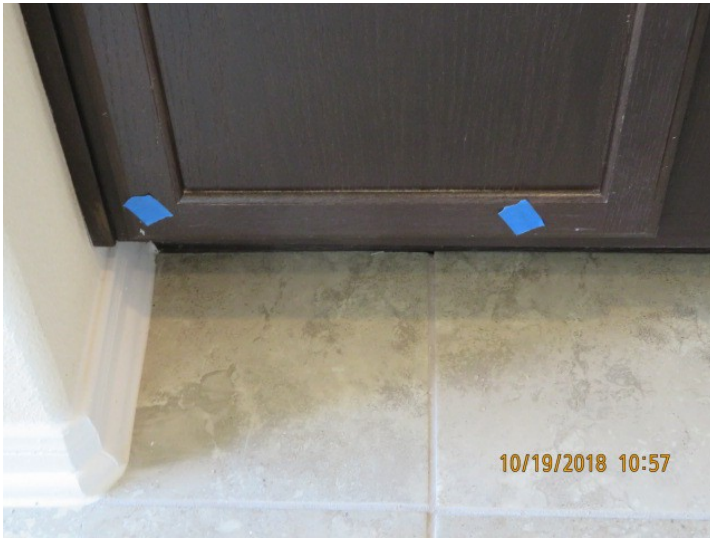
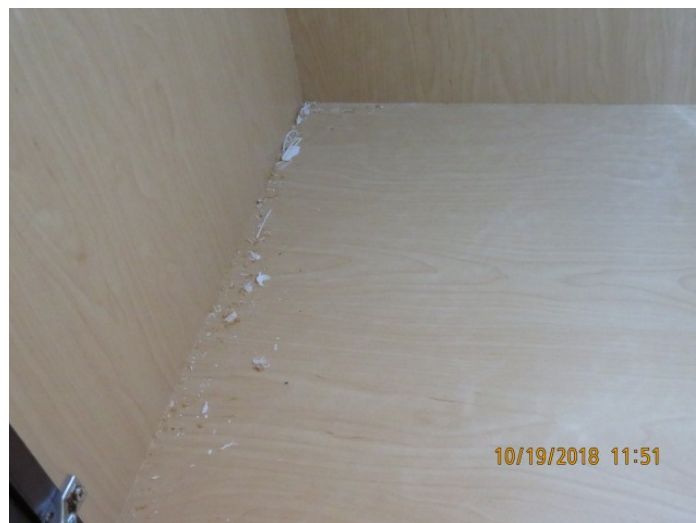
- Properly remove white paint, repair scratches, etc off kitchen and bathroom cabinetry

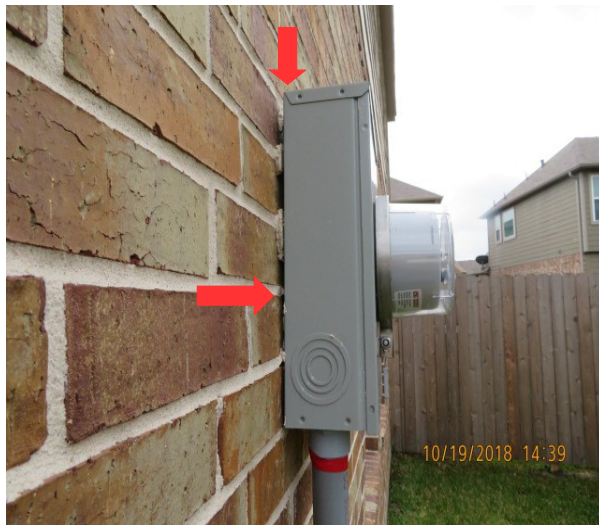
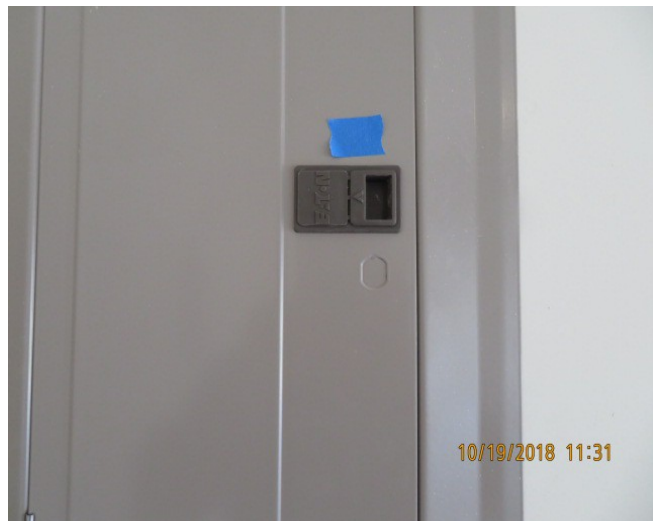
- Seal gaps around the meter box to prevent water infiltration
- Repair defective latch on service panel

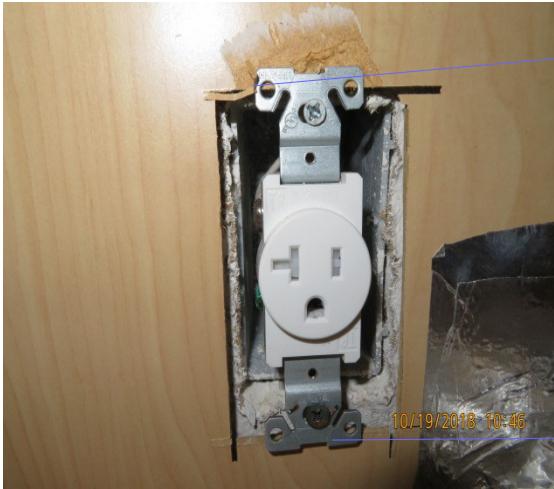
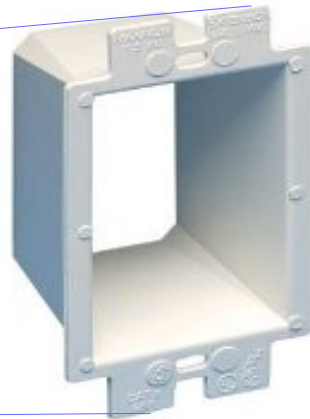
- In walls or ceilings of concrete, tile, or other noncombustible material, boxes shall be installed so that the front edge of the box will not be set back of the finished surface more than ¼" inch. (6.35 mm). Reference NEC 1993 -370.20, Reference NEC 2008 - 314.20 & IRC E3806.5. In walls and ceilings constructed of wood or other combustible material, boxes shall be flush with the finished surface or project there from. Reference NEC 1993 - 370.20, Reference NEC 2008 - 314.20 & IRC E3806.5.

- Recommend to consult a licensed electrician to perform repairs on all deficiencies appropriately
- =====

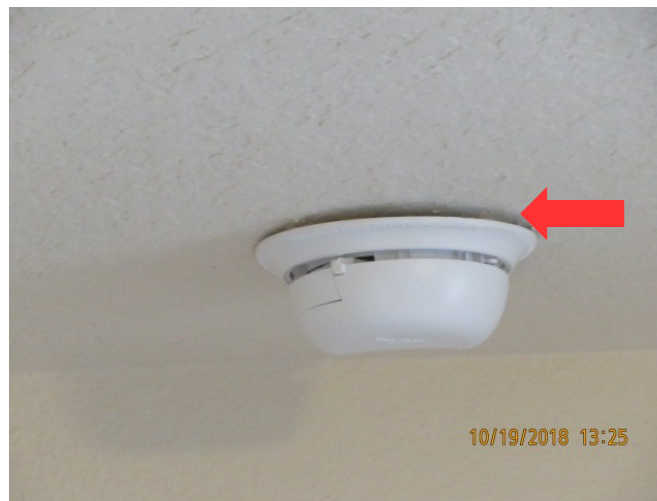
- Smoke alarm appeared to be loose. Properly secure/repair

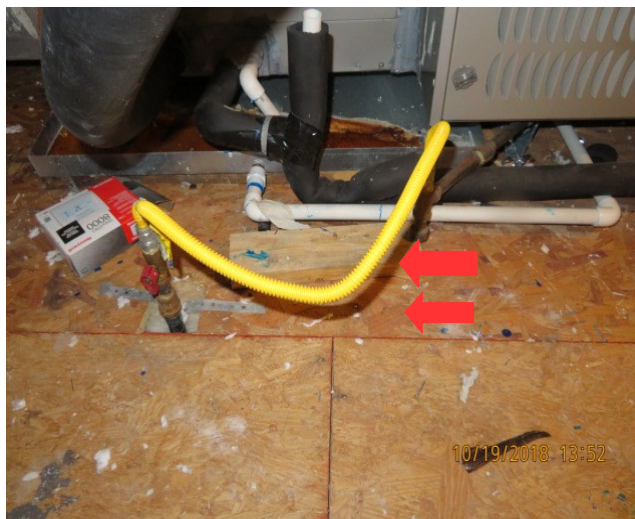
- Required bonding on gas piping was not evident at this time. Install for safety

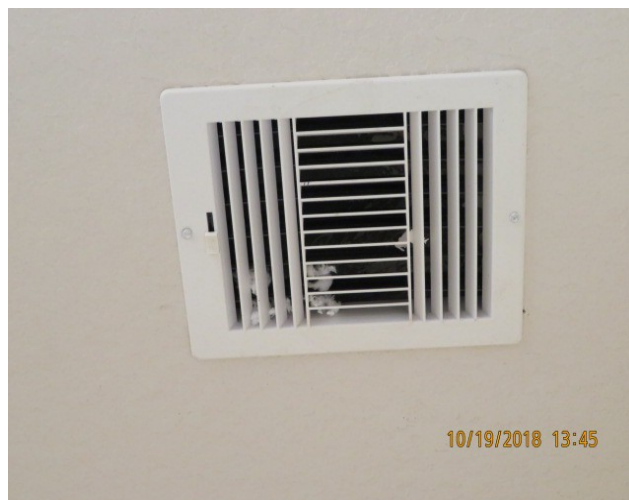
- Clean also, ac supply grills and ductwork as needed

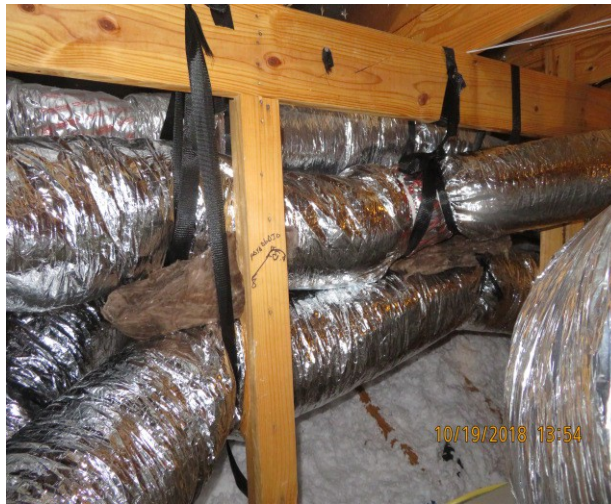
- Observed ducts in contact with each other. Properly provide sufficient clearance to prevent condensation

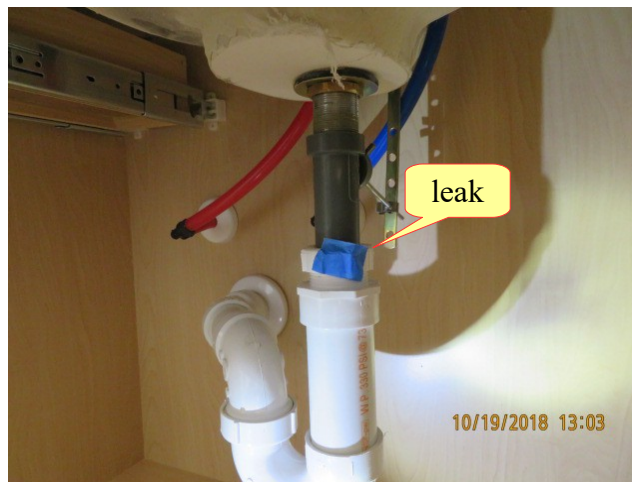
- Noticed water leak in master bathroom left sink. Connection did not appeared to be properly secured. In need of repair

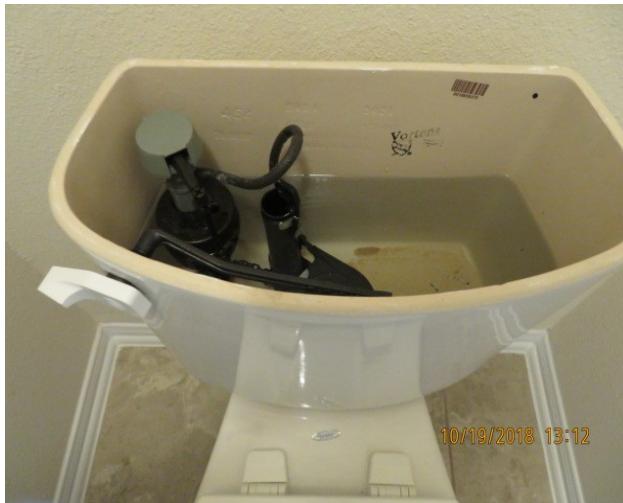
- Cold water could not be obtained in master bathroom, even at lowest setting. In need of proper repair by a licensed plumber. Note: Water needs to run continuously for several minutes in order to detect issue
- Water level is above the "Water level mark" in master bathroom. Confirm other fixtures for same/similar issue and repair .

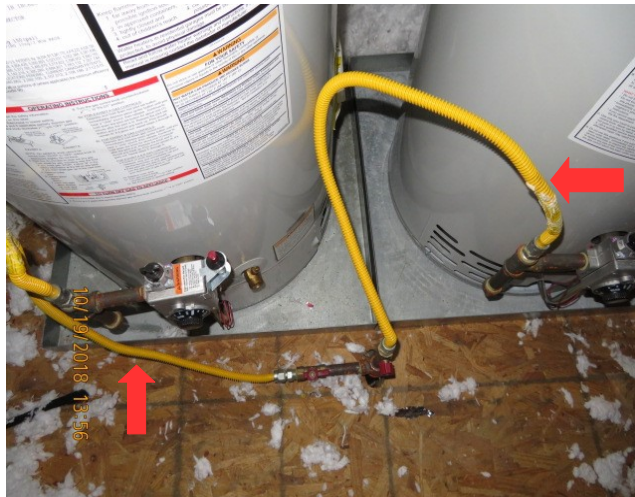
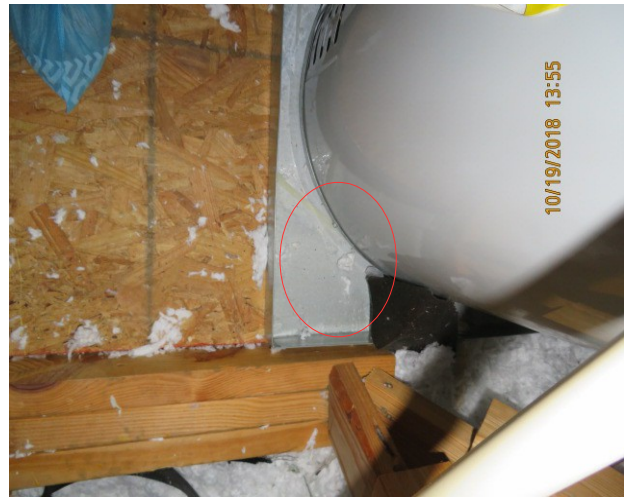
- Proper bonding of gas piping is not evident, including corrugated stainless steel tubing (CSST).
Note: The Hot and Cold water, supplying the water heater gas or electric, must have a #6 copper "Bonding Jumper" Installed from one water pipe to the other water pipe.
- Remove debris in drain pan to prevent clogging of drain line
