VISTA R. E. INSPECTIONS

PROPERTY INSPECTION REPORT

Prepared For:	R. W.	
	(Name of Client)	
Concerning:	xxxx Nacogdoches Valley Dr, League City, Tx 77573	
	(Address or Other Identification of Inspected Property):	
By:	Felix Angel, 20185	10/16/2018
	(Name and License Number of Inspector)	(Date)
	N/A	
	(Name, License Number of Sponsoring Inspector)

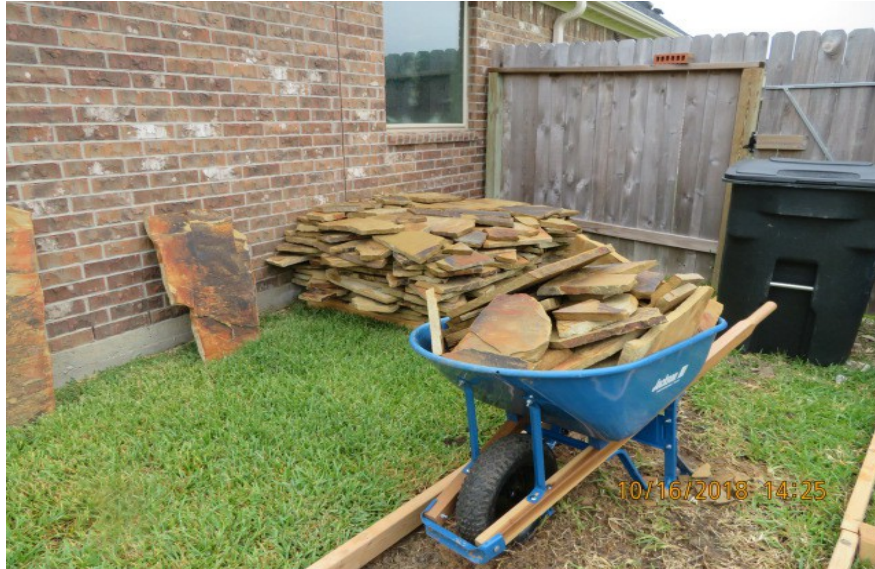
- Section of the left slab is not accessible for inspection of such.
